PROPERTY INSPECTION REPORT

123 Main St, , NY 12345

DATE OF INSPECTION: 9/14/2023

Year Built: 1946

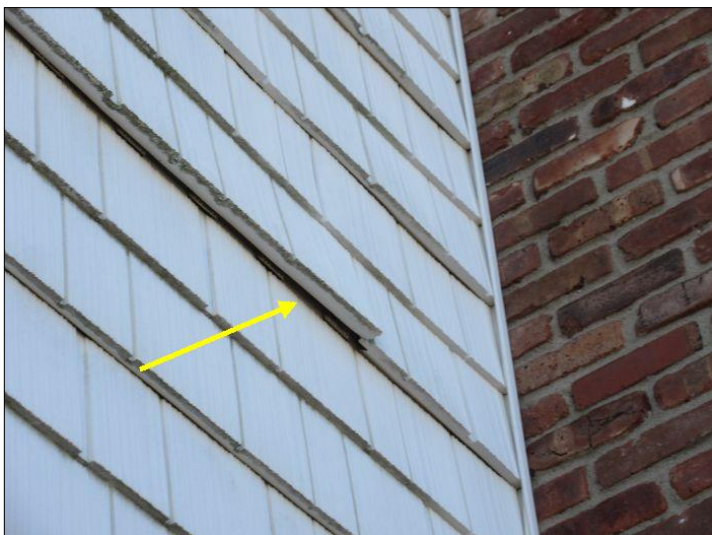
Loose material(s) noted (Right side)

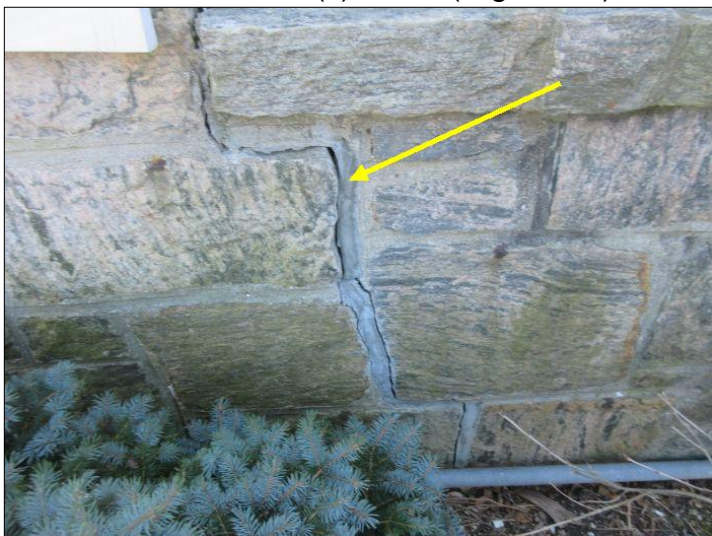
Structural crack noted at front of home. Result from undermining of foundation.

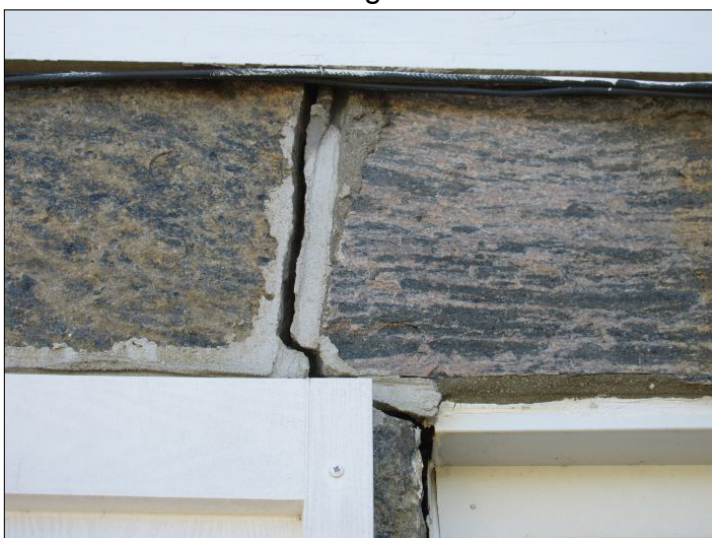
Structural crack noted at front of home. Result from undermining of foundation.

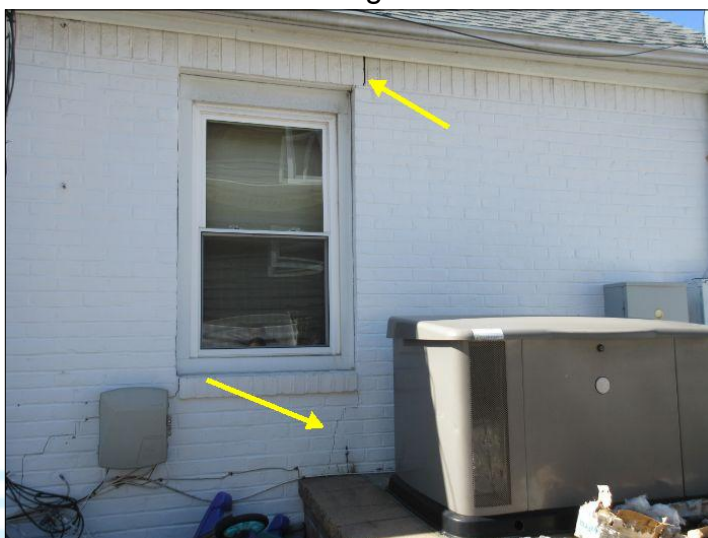
Additional cracks coinciding w/ undermined foundation

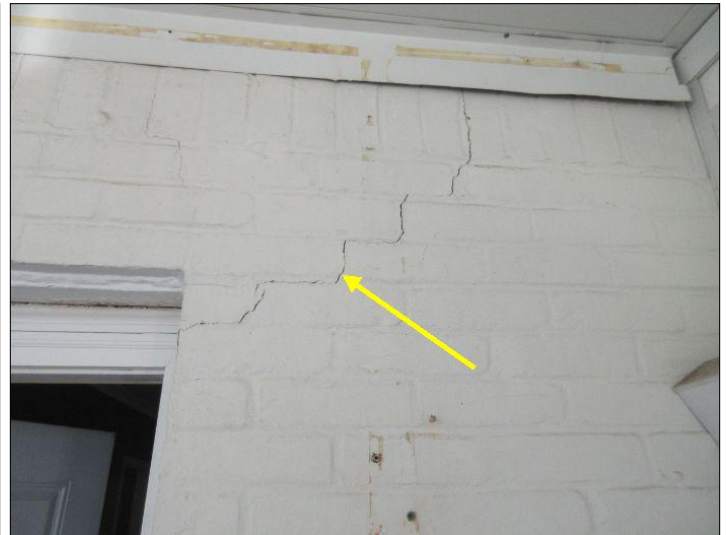
Step cracking noted - Related to damaged **sill plate** (Rear)

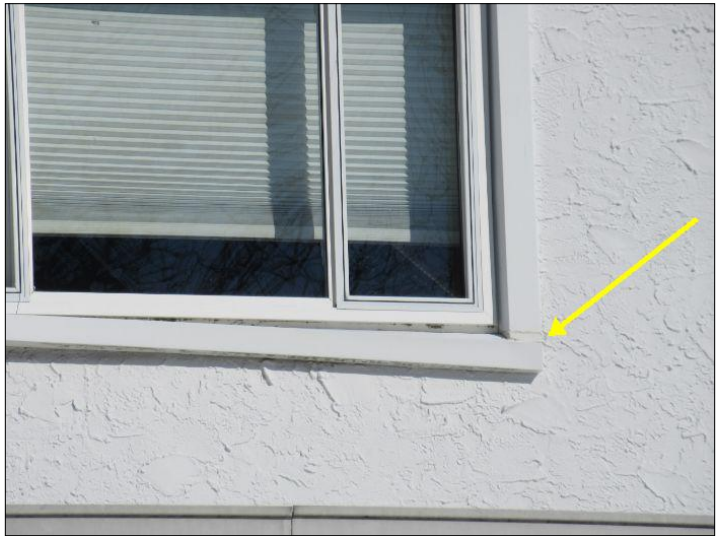
Loose / Sagging trim noted (2nd floor rear)

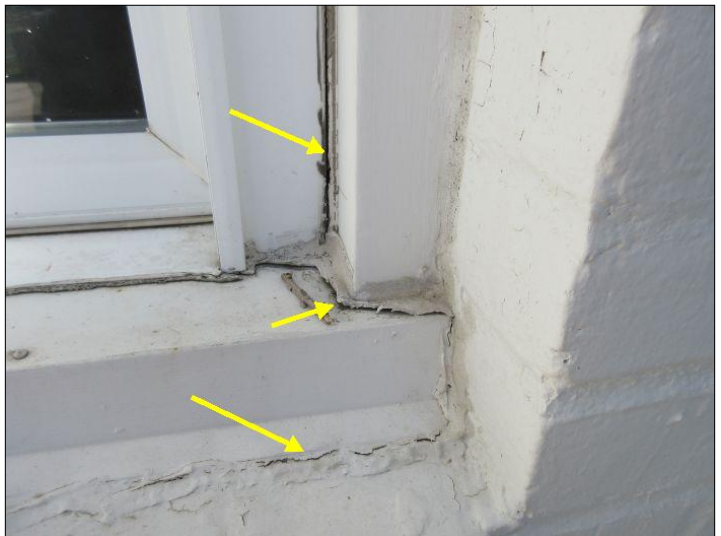
Gaps noted at rear window trim - Additional results from rear sill plate deterioration

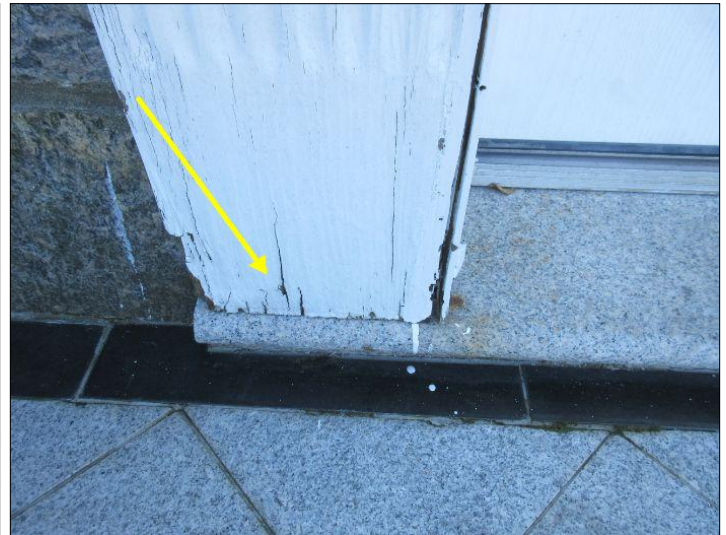
Deteriorated materials noted (Front door)

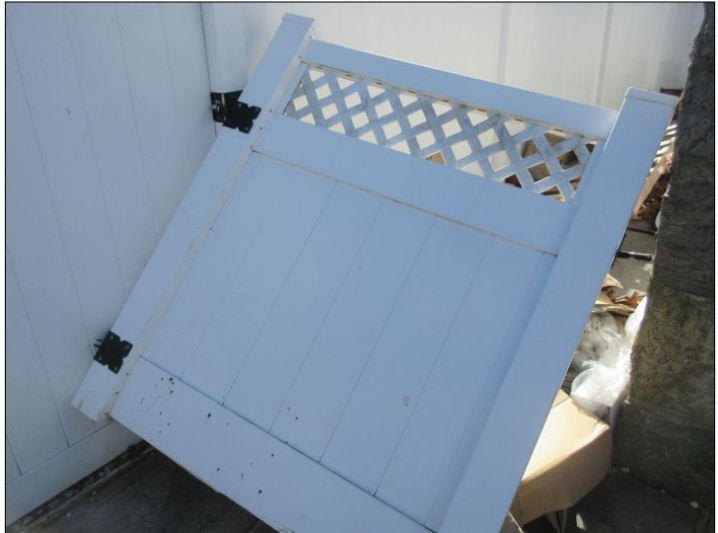
Damaged gate noted (Left of garage)

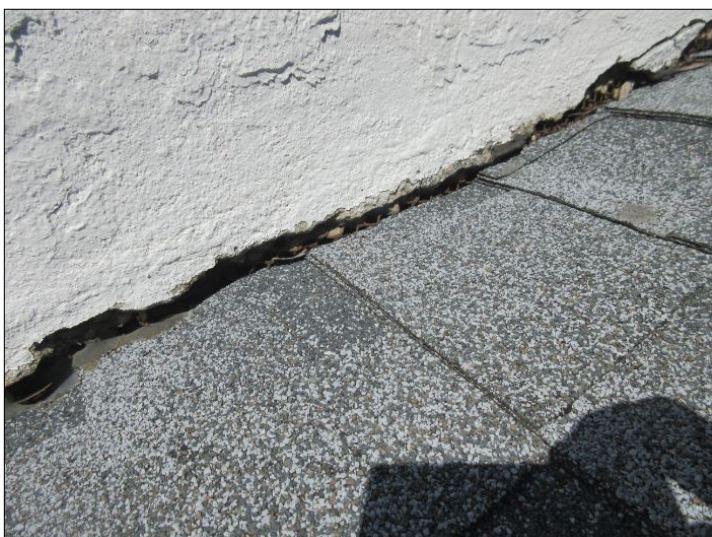
Recommend installing of step flashing to prevent water penetration

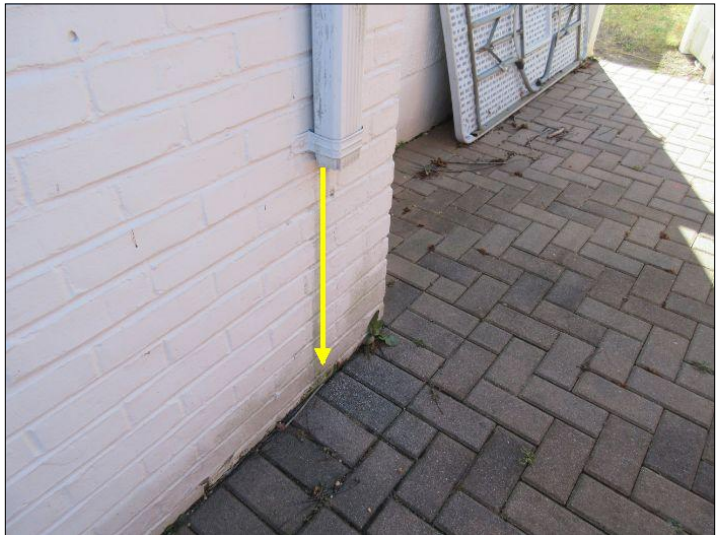
Missing parts

Recommend extending downspout(s) away from foundation

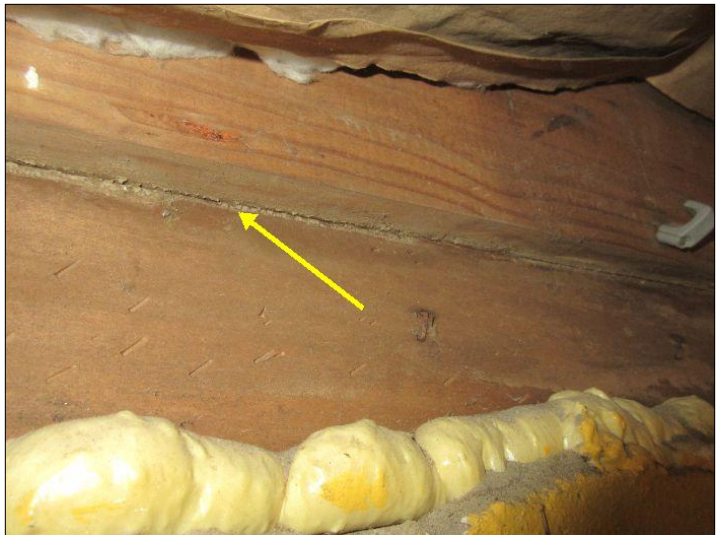
WDO evidence noted at sill plates

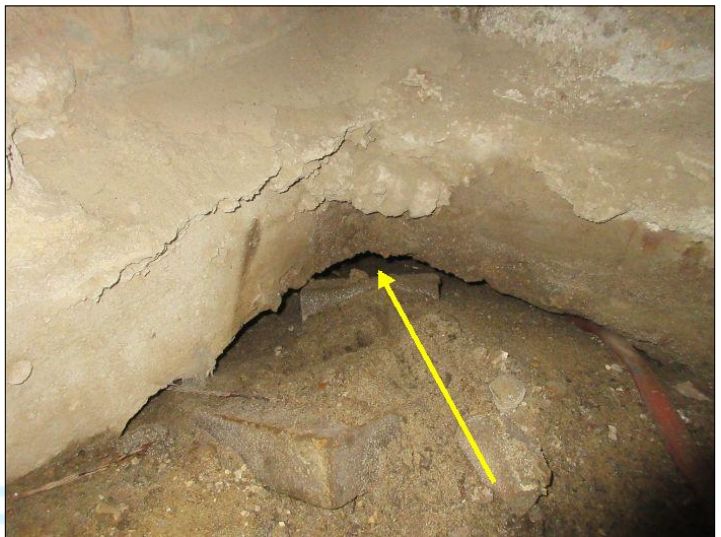
Crack at front wall extends to base of foundation

Undermining noted at front left corner of the home's foundation wall.

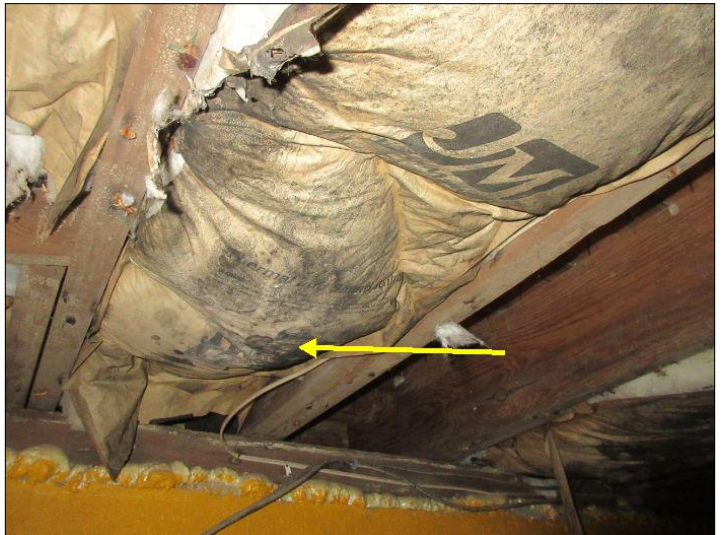
Mold-like bio growth observed. Professional testing & evaluation advised.

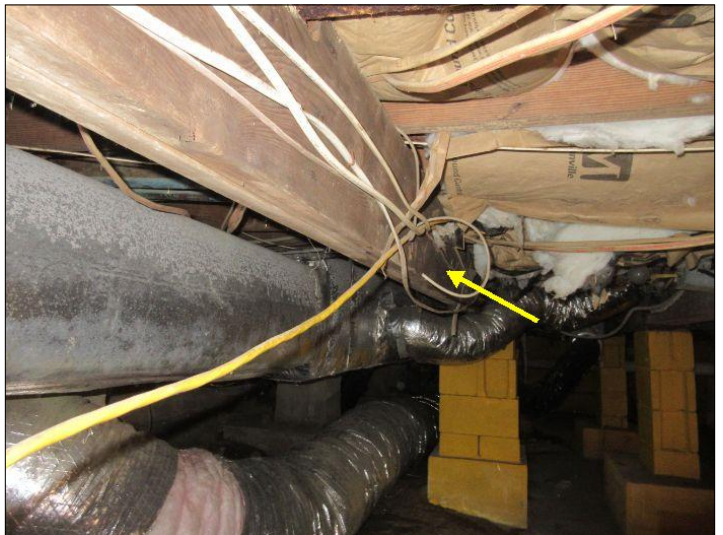
- Mid-span girder appears to be undersized
- Mid-span girder appears to be "rolling" towards the rear of the home. Recommend consultation with a structural engineer for further information and guidance.

Mid-span girder appears to be "rolling" towards the rear of the home. Recommend consultation with a structural engineer for further information and guidance.

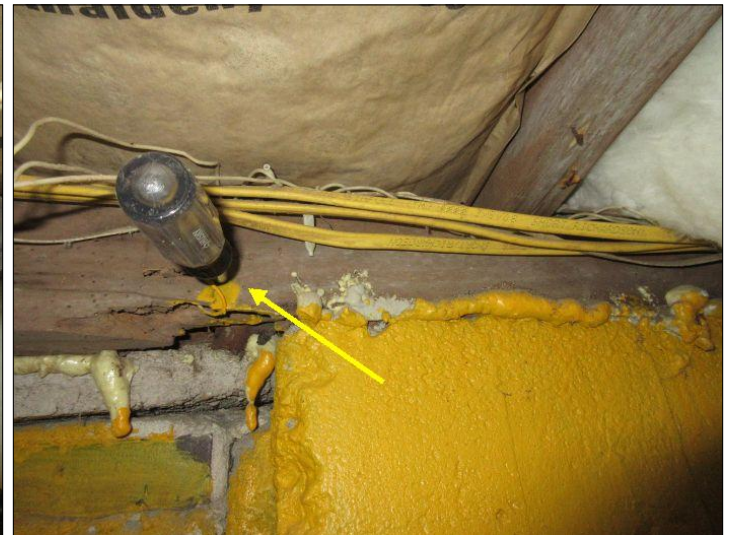
- Approximately 20' of sill plate at the rear foundation wall has been deteriorated and has failed. Structural repairs are required. Consult with licensed contractor for guidance.
- Previous repairs to floor joists noted
- Damaged sill plates has resulted in the "sinking" of the rear wall of the home, causing the 1st and 2nd floors to sag (leaning towards the rear)

WDO damaged sill plate (Rear wall)

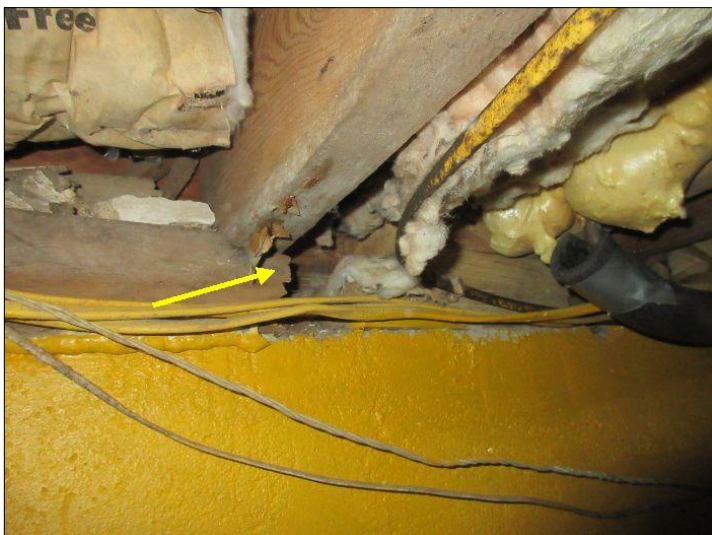
Additional damage

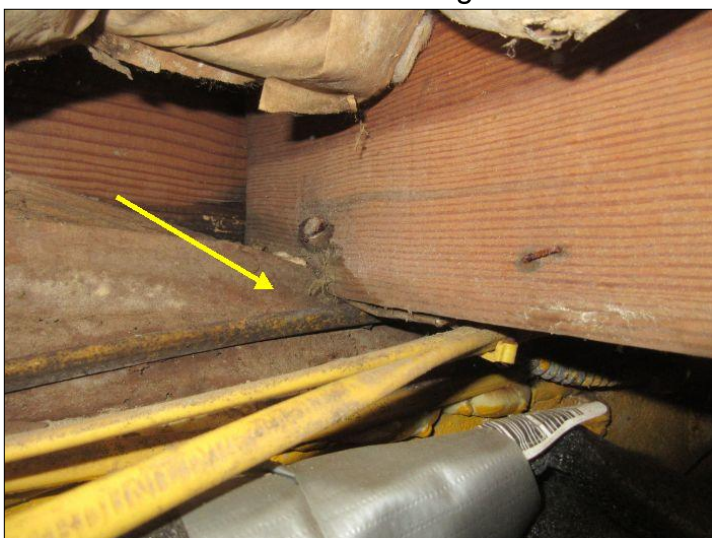
Damaged sill plate

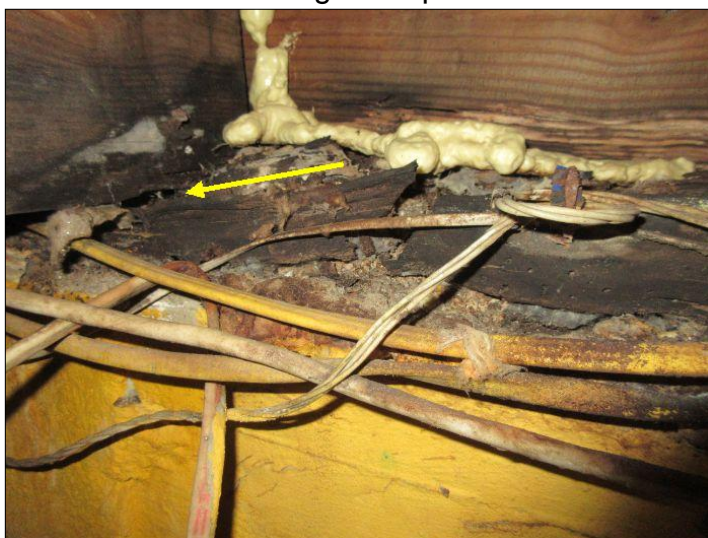
Damaged sill plate

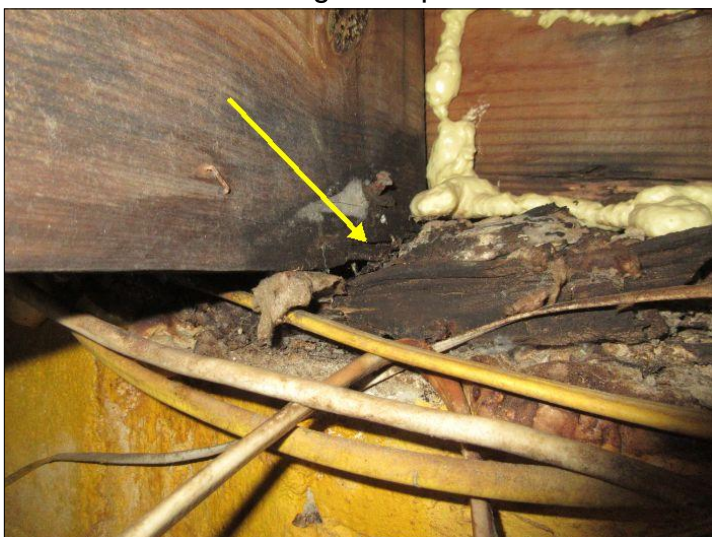
Damaged sill plate

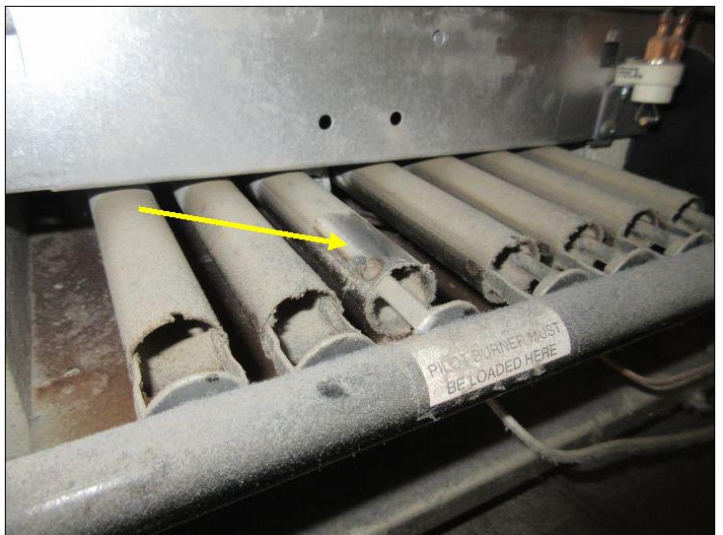
Dust buildup observed in service compartment and/or draft tubes.

Annual/Seasonal professional inspection and cleaning service contract is recommended.

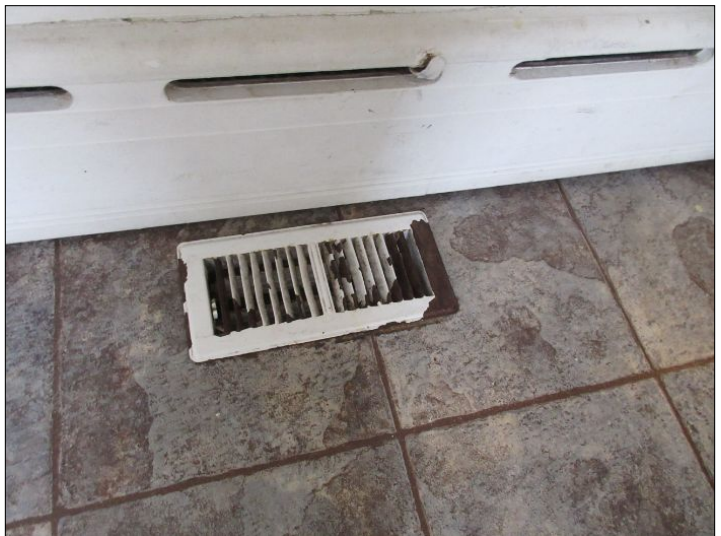
Metal ducts have been rusted / rotted resulting in the basement is a breach of the system. Conditioned air is lost to the crawlspace area, as well as moist / humid air is likely to be drawn into the home via this opening, resulting in rusting of floor register covers.

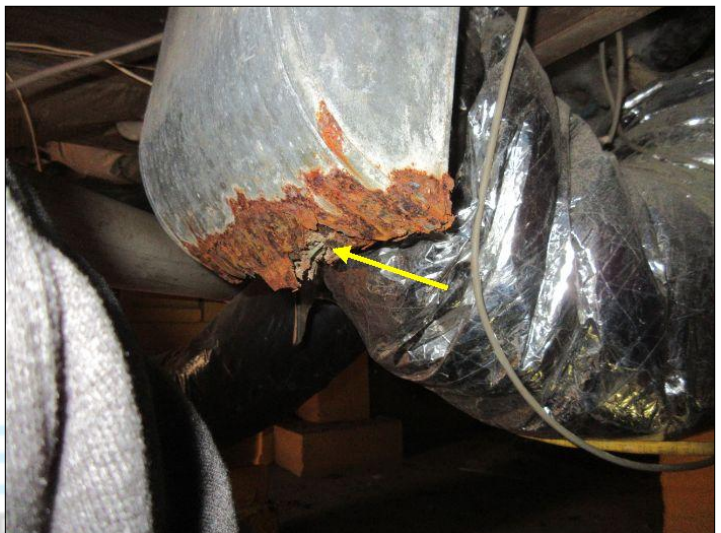
Rotted duct noted (Crawlspace)

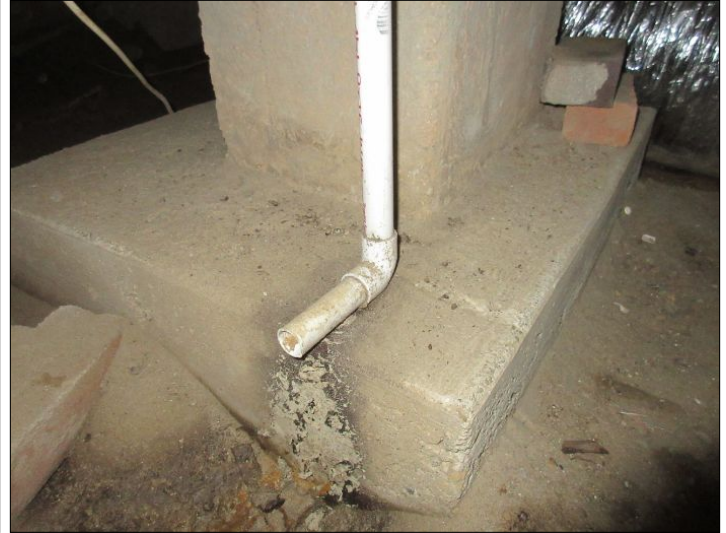
1st floor - Condensation drips into dirt floor in crawlspace, creating a more humid environment. Recommend installation of condensation pump to direct water out of home.

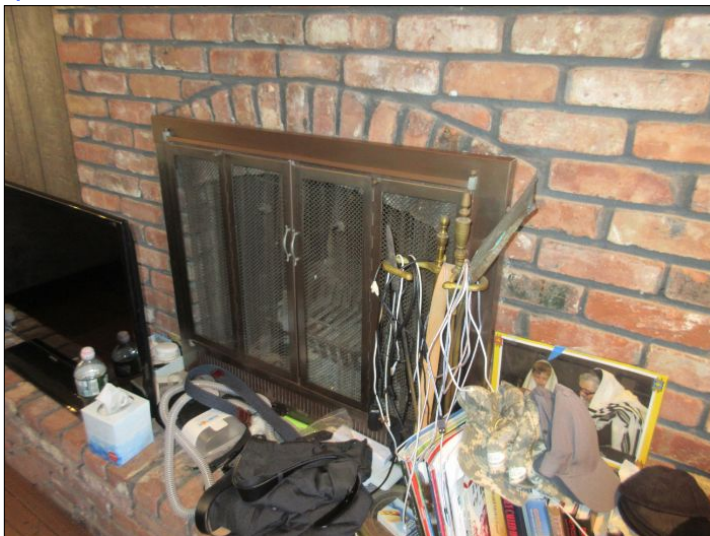
Recommend cleaning (Master Bedroom)

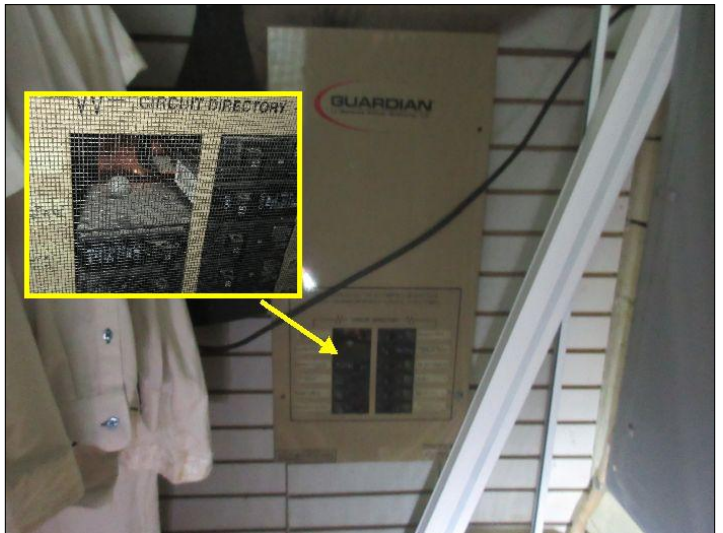
Backup Generator **Circuit** Box - Open knockouts noted, secure as needed

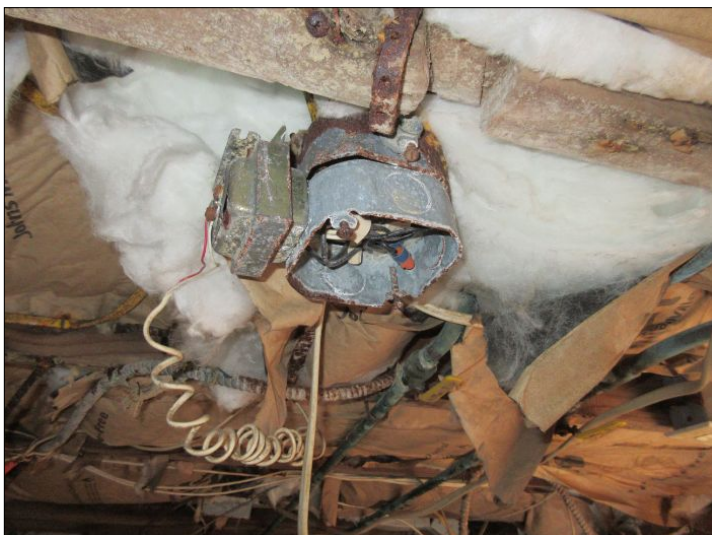
Missing junction box cover. Repair as needed.
(Crawlspace)

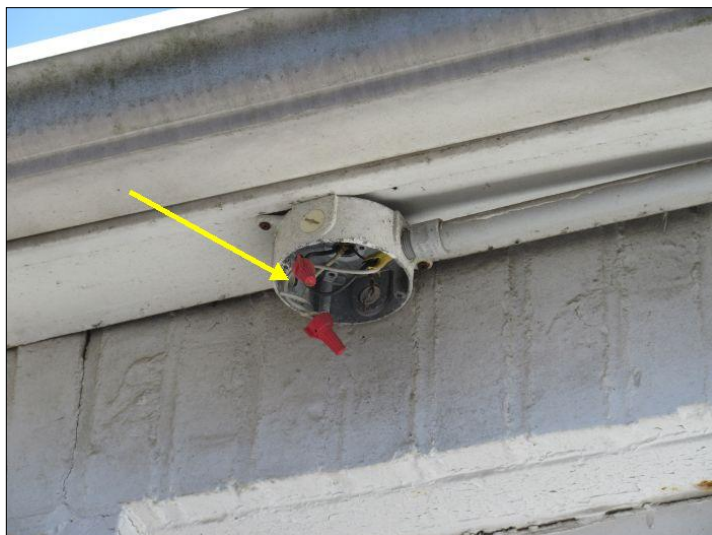
Light fixture missing. Exposed wires noted. (Left side)

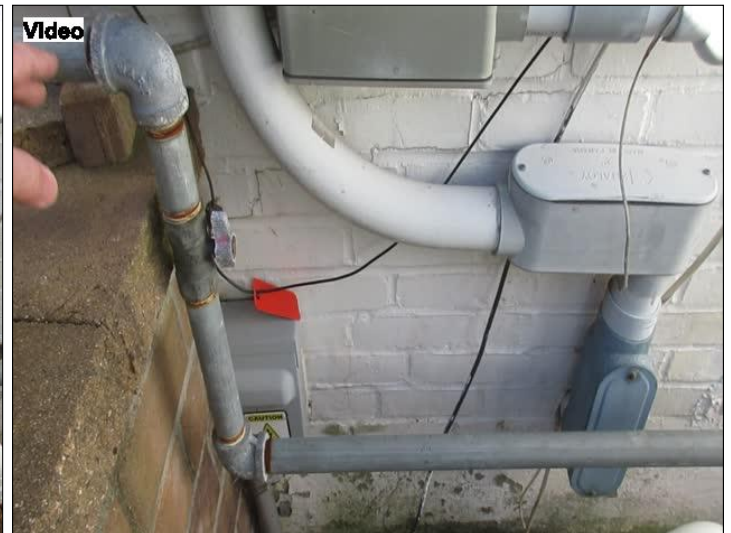
Exterior gas piping not secure

Recommend securing exposed gas pipe to prevent damage

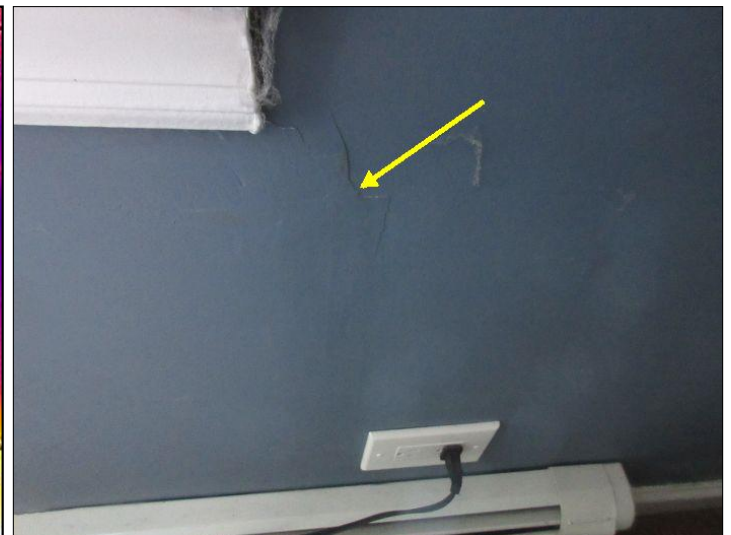
Wall repair noted - Damage from shifting foundation. Coincides w/ cracks at front brick veneer (Bedroom #5)

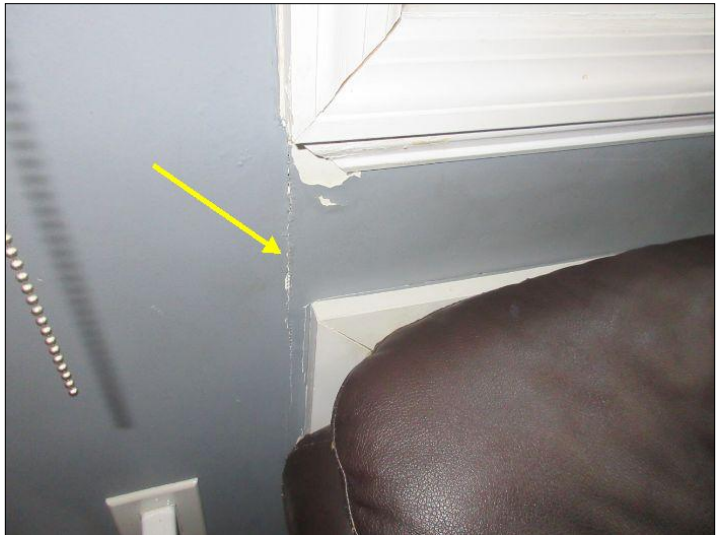
Damaged drywall noted (Bedroom #6)

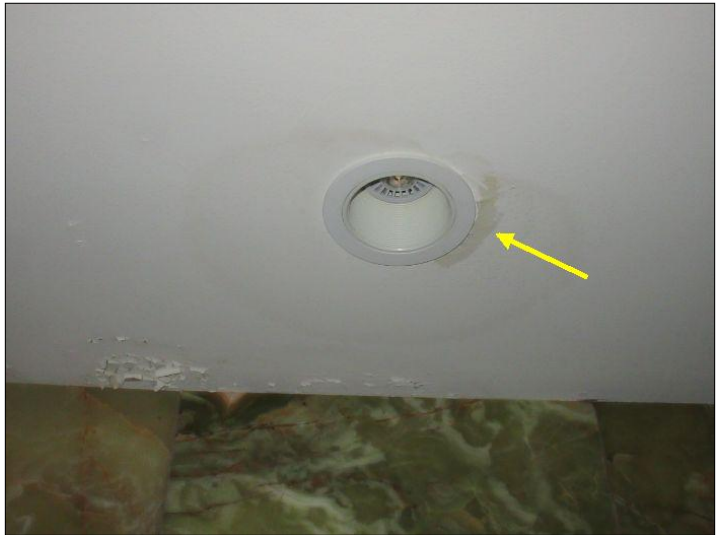
Evidence of active leak noted, likely from missing step flashing (Bathroom #1)

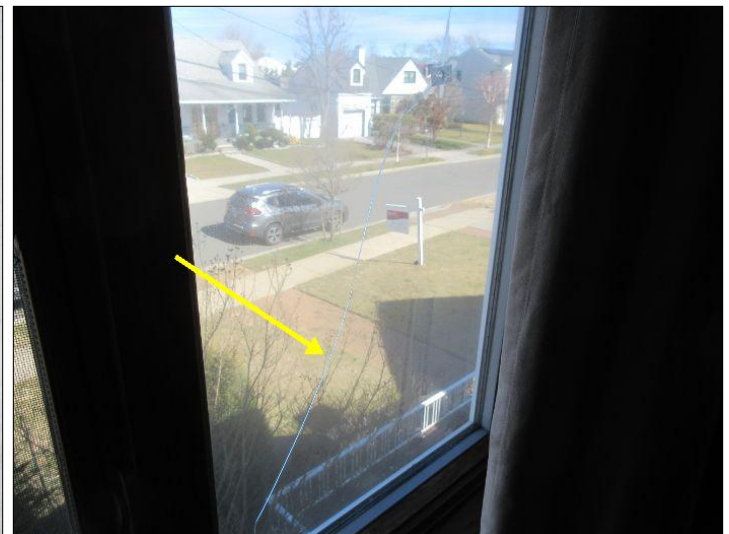
Broken glass (Master Bedroom)

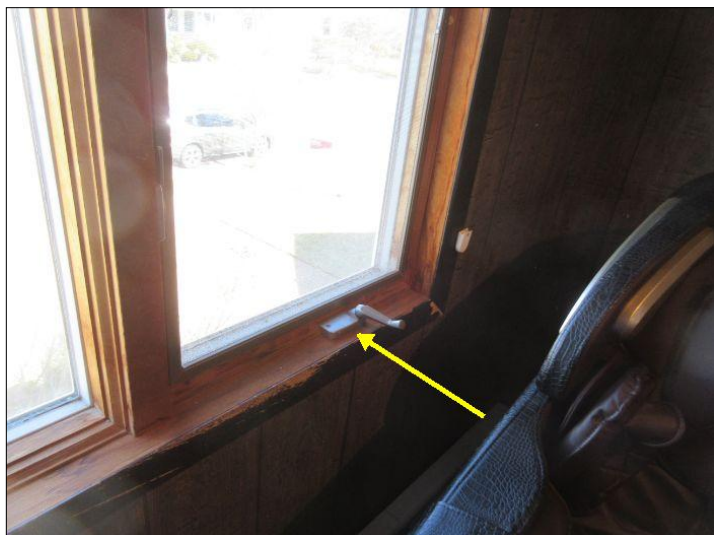
Damaged hardware noted (Master Bedroom)

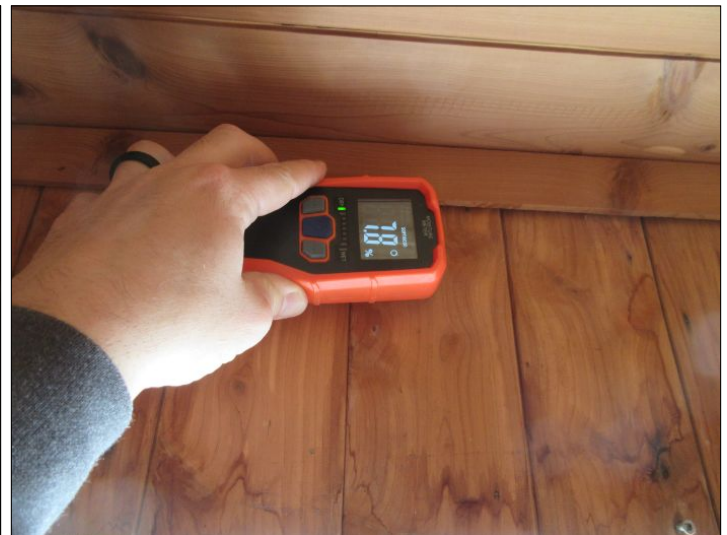
Water damage noted in cedar closet. Recommend consultation with roofing professional for additional evaluation.

Higher moisture content verified w/ moisture meter

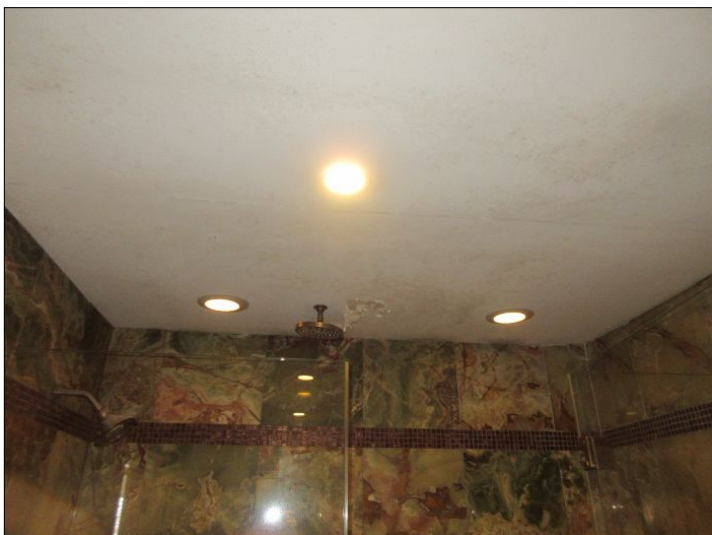
Mold like bio growth stains observed. Professional testing and evaluation is advised. Repair as needed.

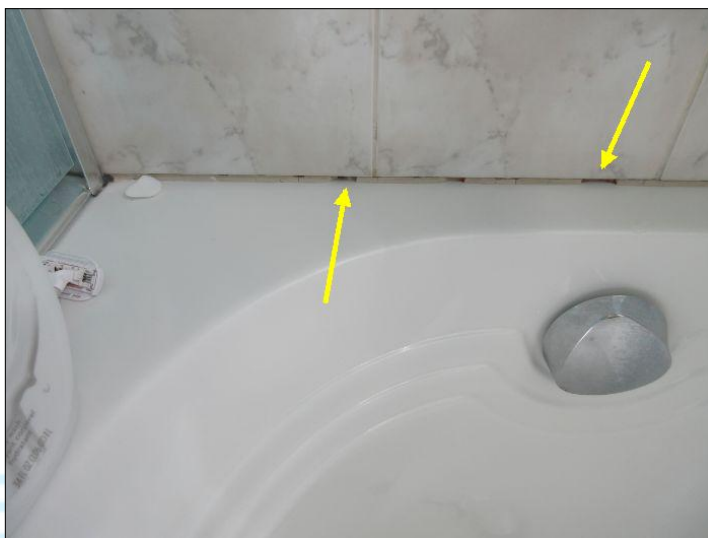
Some grout repair needed

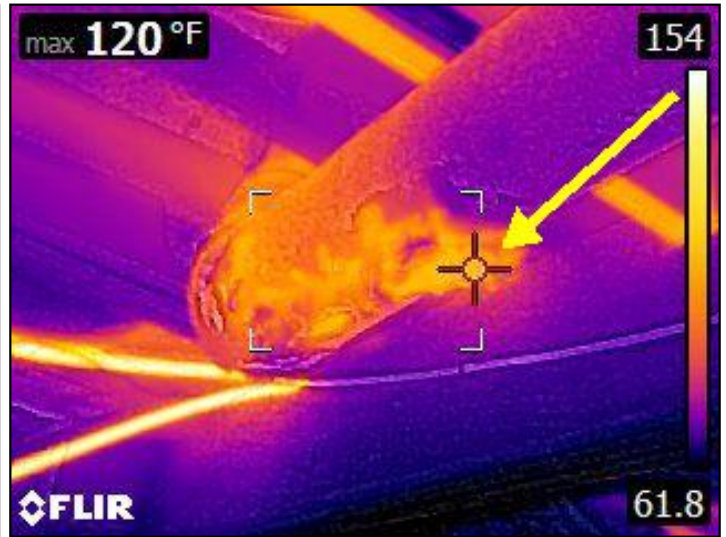
The dryer vent duct has failed and the dryer exhaust vents into the crawlspace

Dryer exhaust escaping duct at opening (Thermal View)

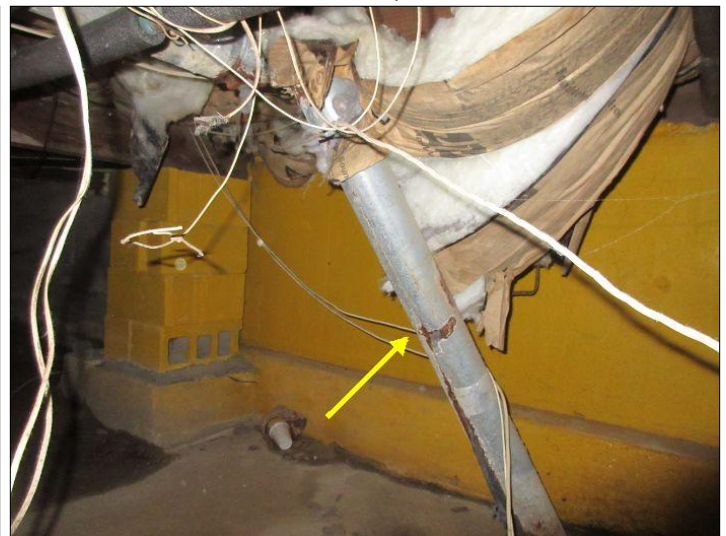
Dryer vent has failed and collapsed

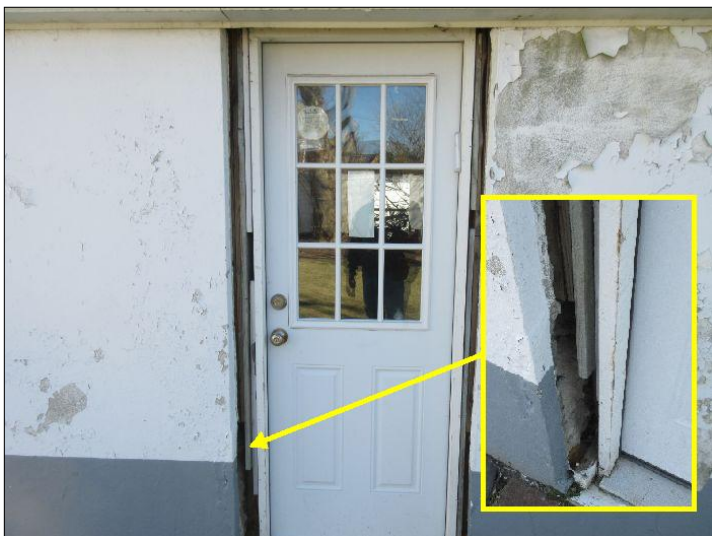
Exterior trim missing

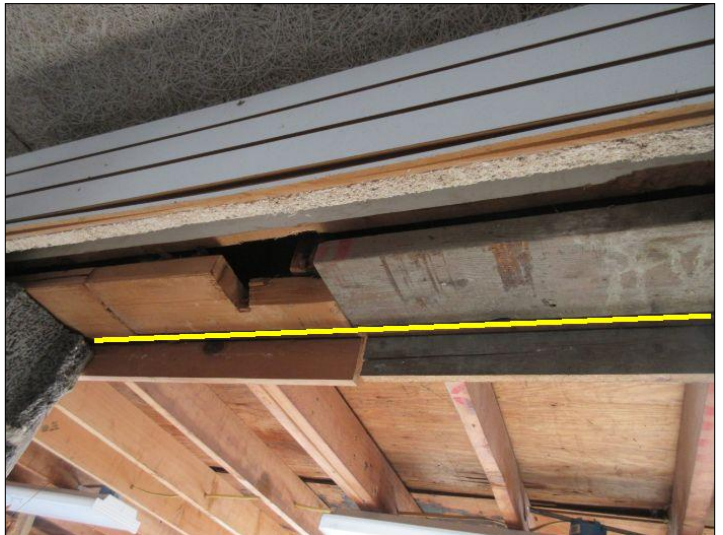
Structural - Missing header noted at opening in rear of garage

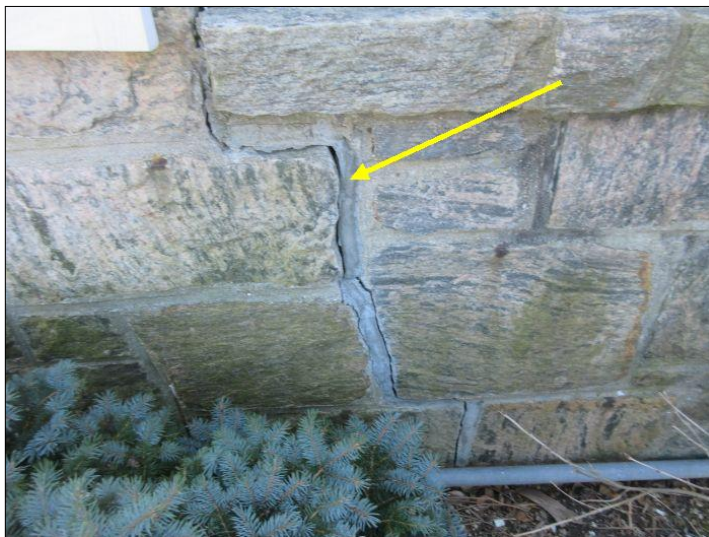
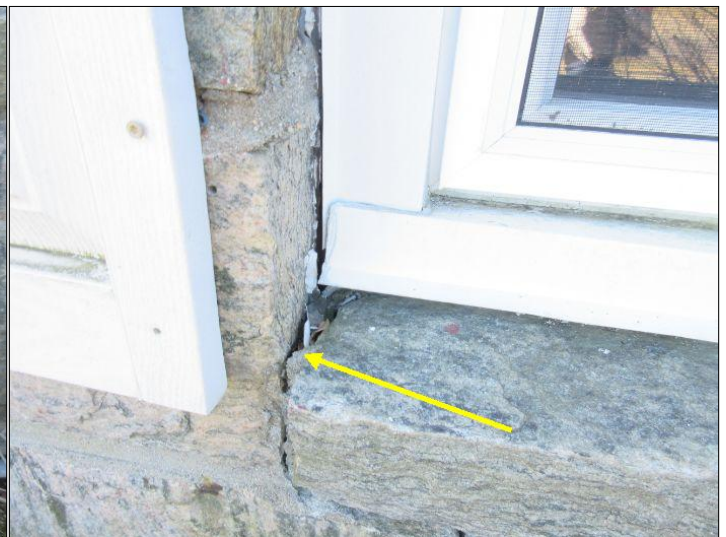
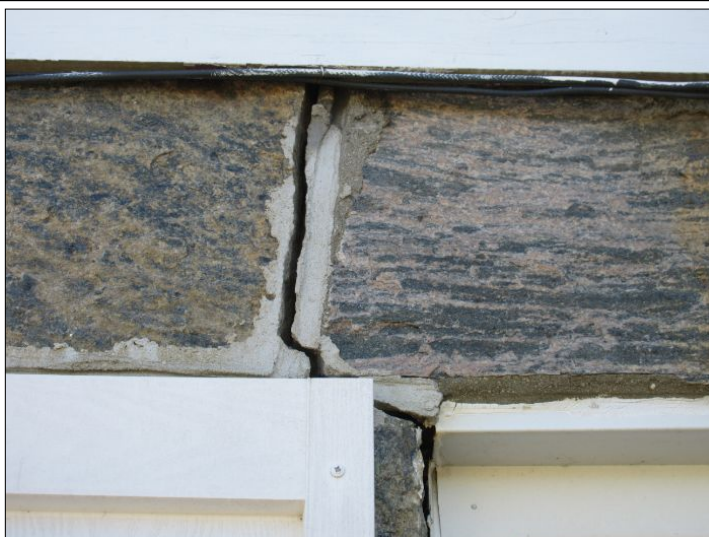
Structural crack noted at front of home. Result from undermining of foundation.

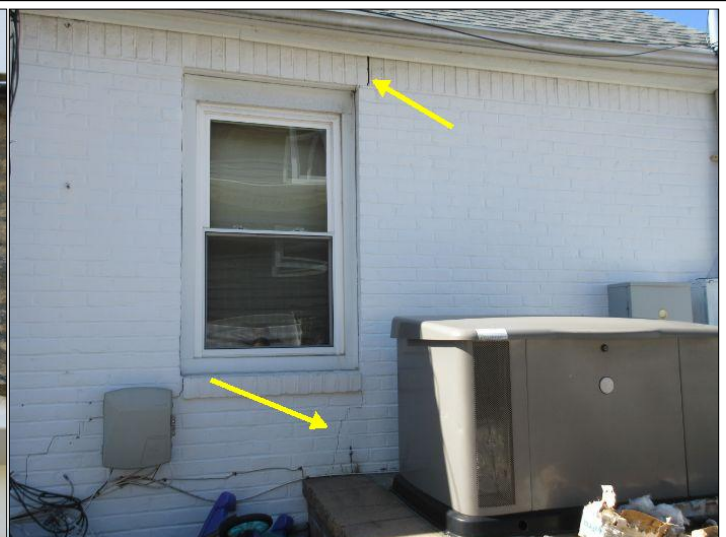
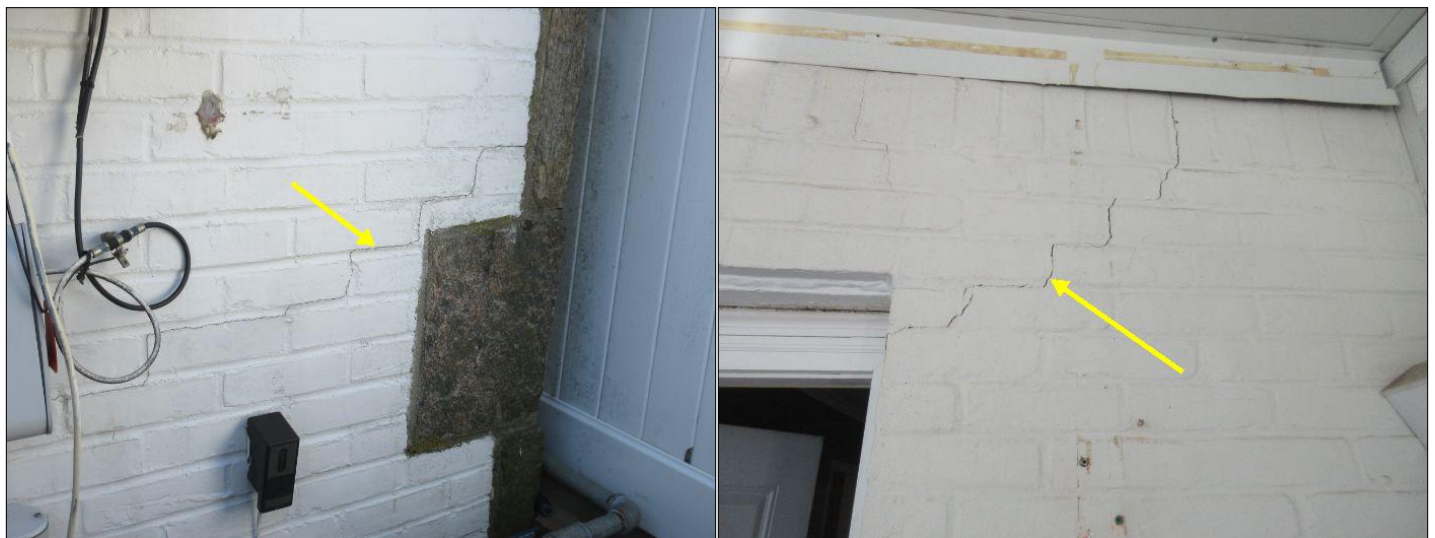
Additional cracks coinciding w/ undermined foundation

Step cracking noted - Related to damaged sill plate (Rear)

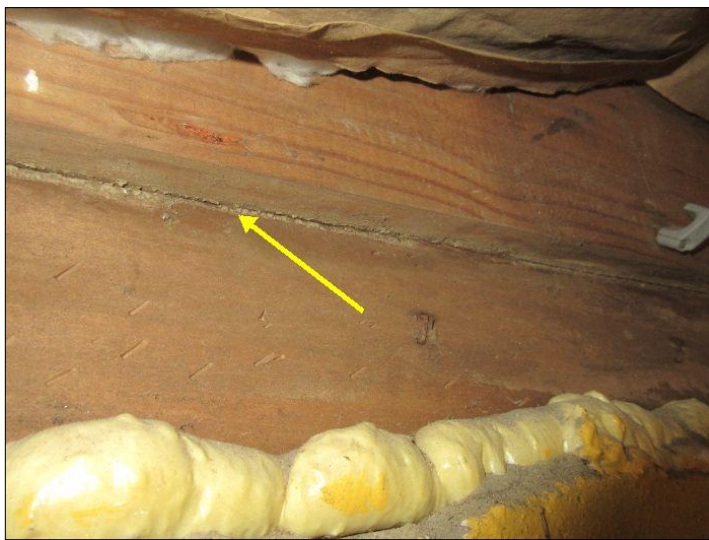
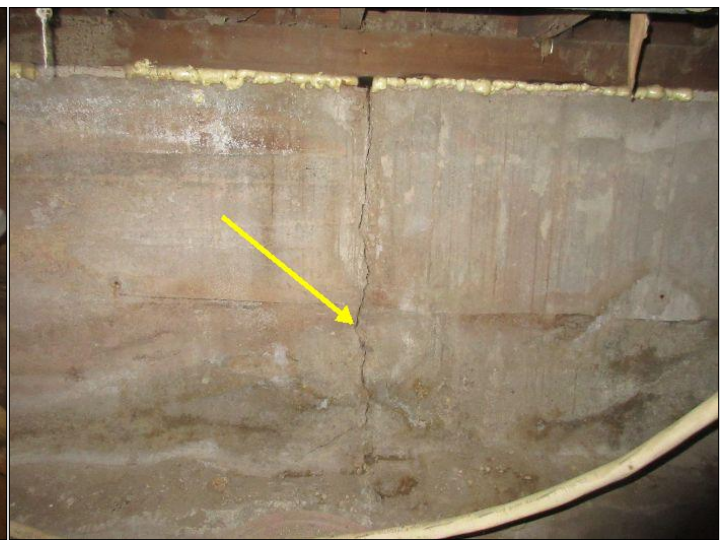
- **Undermining noted at front left corner of the home's foundation wall.**
- Numerous cracks noted at the foundation, both interior and exterior of the home. This is an indication that the structural integrity of the home has been compromised.
- Recommend consulting with a structural engineer for additional information and guidance.
- **WDC** evidence noted at **sill plates**

WDO evidence noted at sill plates

Crack at front wall extends to base of foundation

Undermining noted at front left corner of the home's foundation wall.

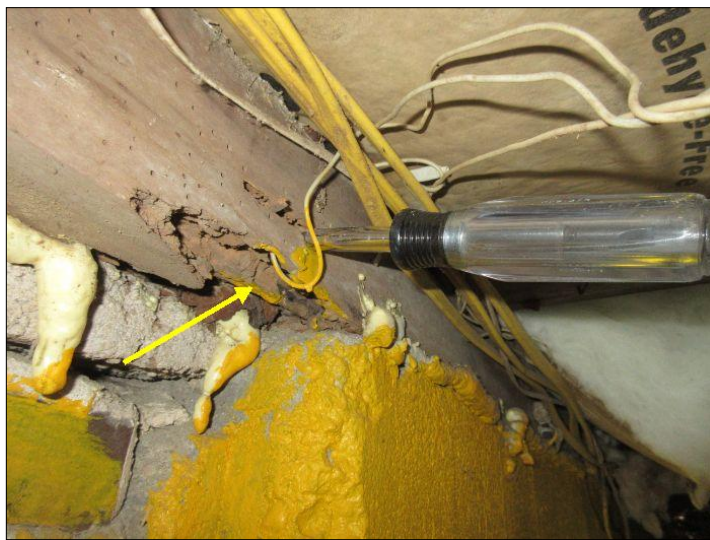
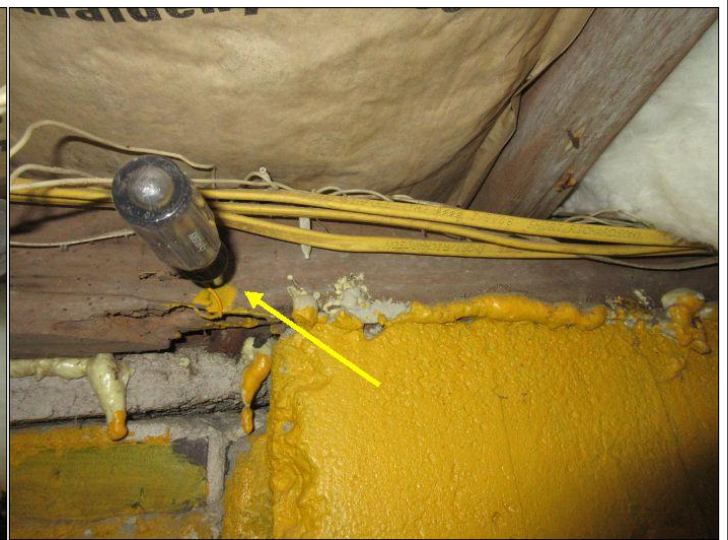
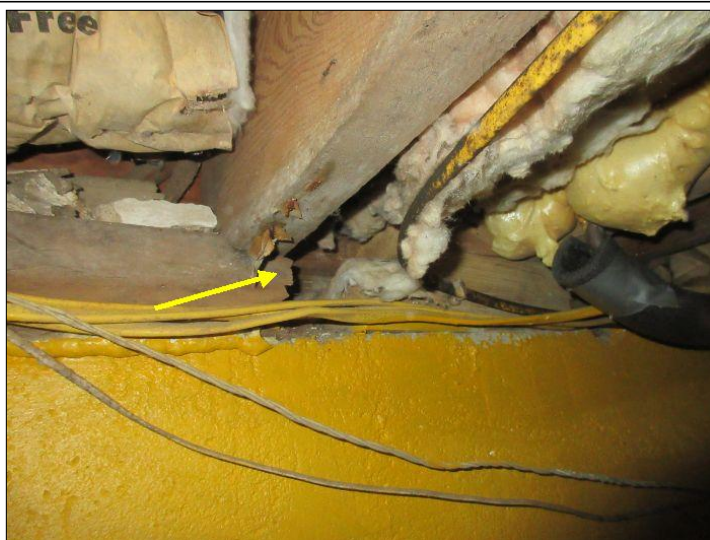
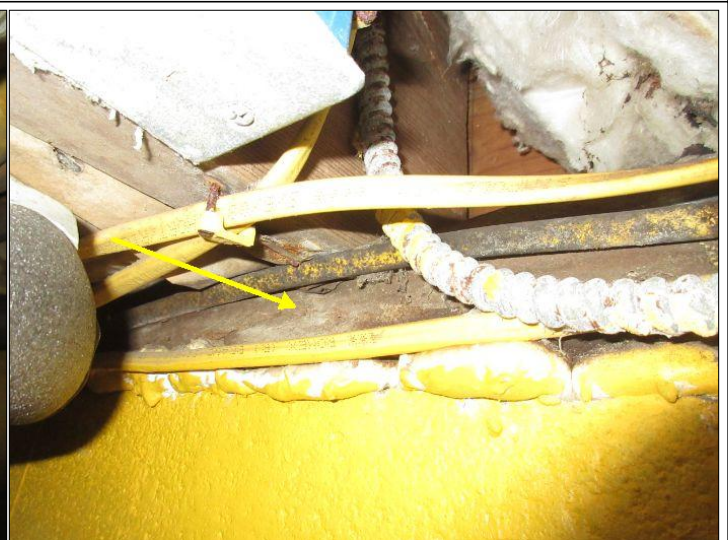
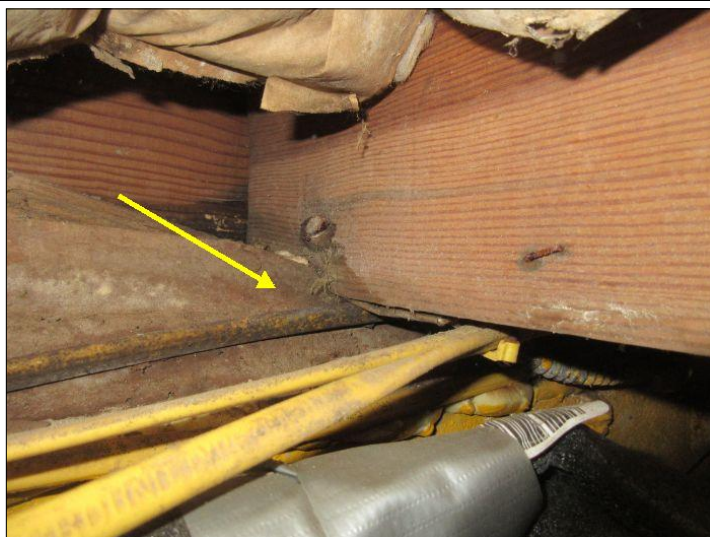
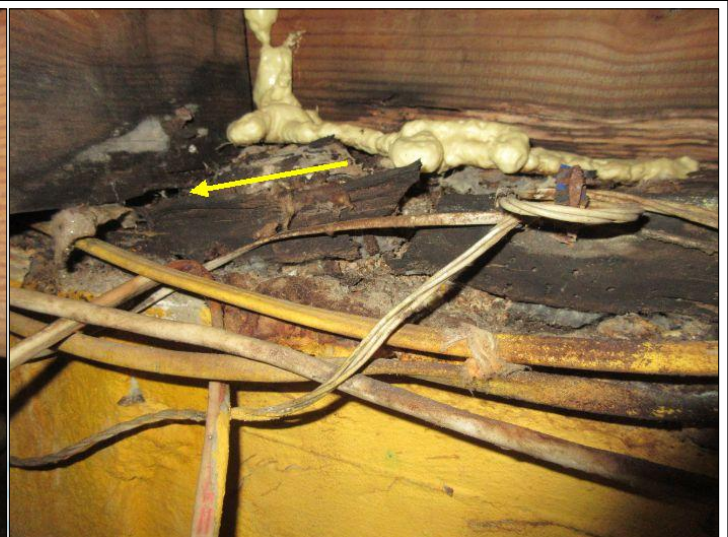
Page 24 Item: 6	Floor Structure	<ul style="list-style-type: none"> • Approximately 20' of sill plate at the rear foundation wall has been deteriorated and has failed. Structural repairs are required. Consult with licensed contractor for guidance. • Previous repairs to floor joists noted • Damaged sill plates has resulted in the "sinking" of the rear wall of the home, causing the 1st and 2nd floors to sag (leaning towards the rear)
-----------------	-----------------	---

WDO damaged sill plate (Rear wall)

Damaged sill plate
