PROPERTY INSPECTION REPORT

123 Main St, , NY 12345

DATE OF INSPECTION: 9/14/2023

Year Built: 1946

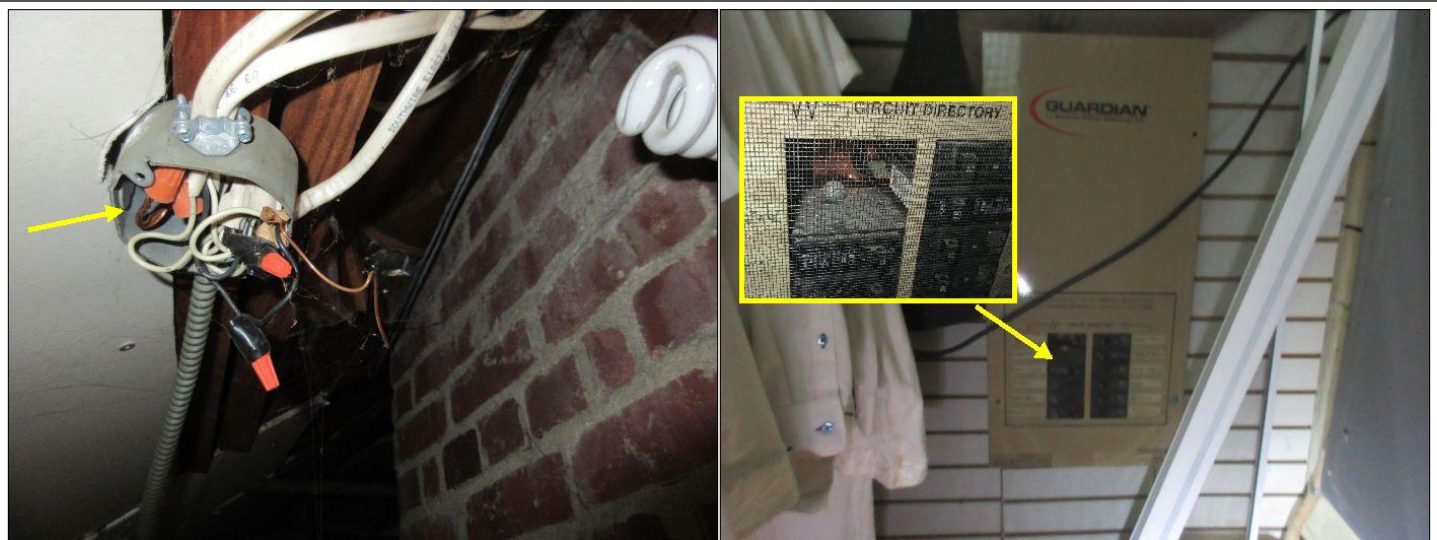
Missing junction box cover (2nd fl hallway closet) Backup Generator Circuit Box - Open knockouts noted, secure as needed

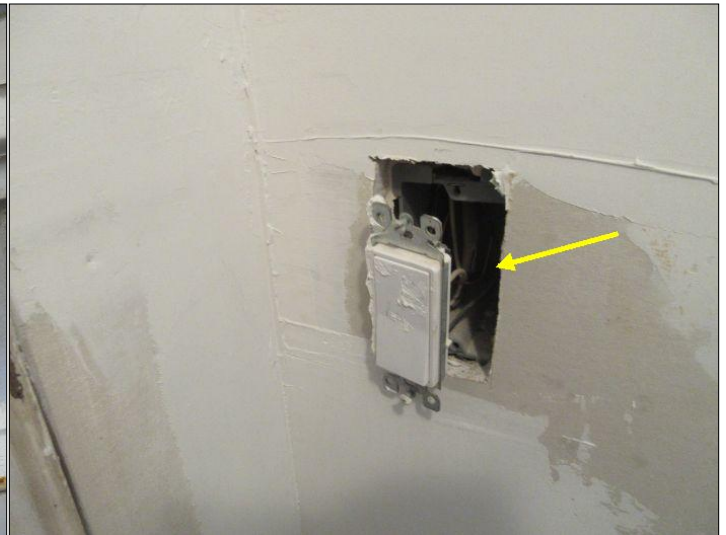
Loose switch noted, recommend correction as needed by licensed electrician (2nd fl closet)

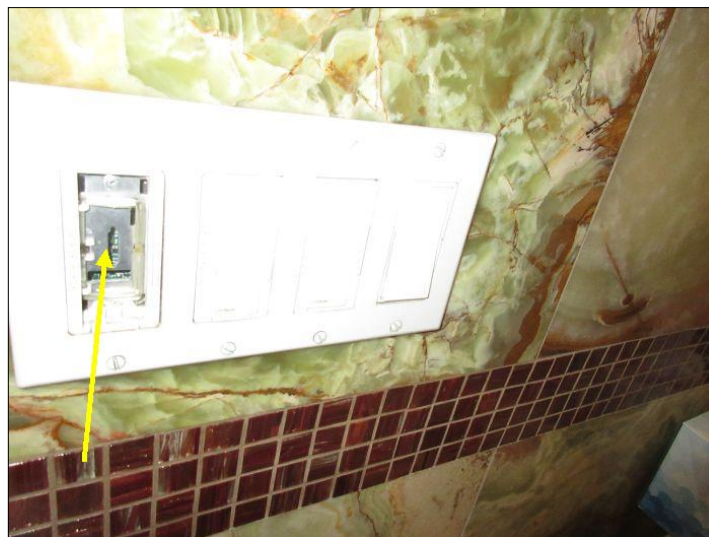
Damaged switch noted. Replace as needed (Bathroom #1)

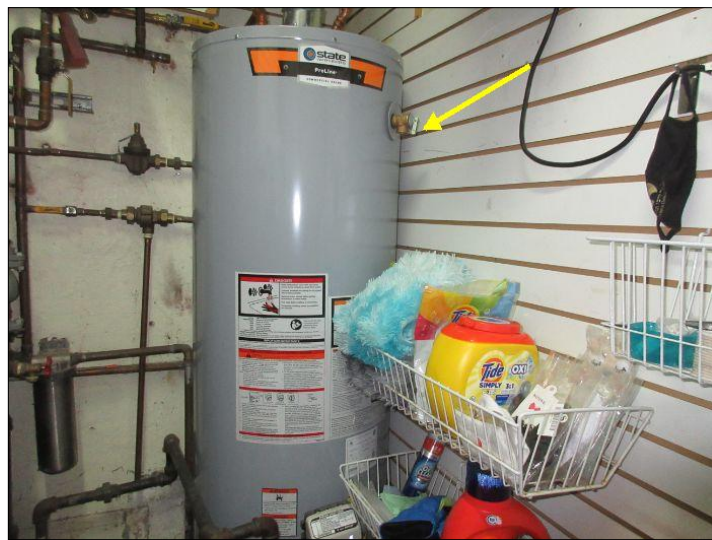
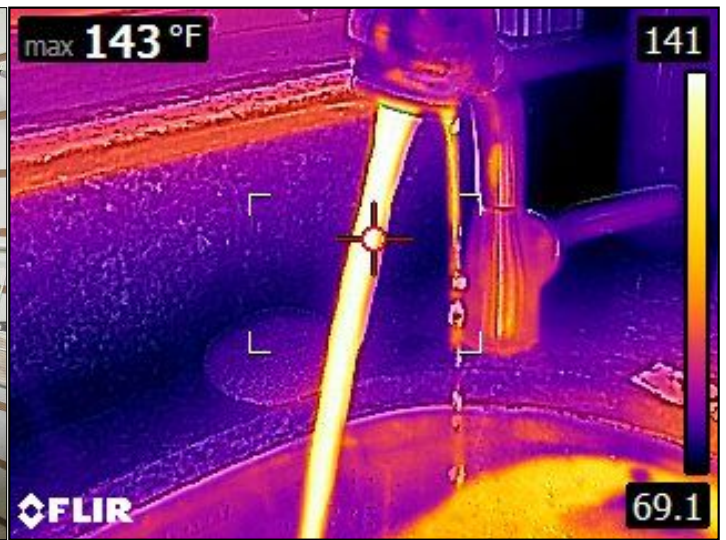
SAFETY: Temperature Pressure Relief (TPR) Valve extension pipe is missing

SAFETY: The water temperature is above the recommended temperature of 120° F

- **SAFETY:** Temperature Pressure Relief (TPR) Valve extension pipe is missing. It is recommended to install extension tube to terminate within 6" of floor to prevent burn injuries in event the water heater malfunctions.
- **SAFETY:** The water temperature is above the recommended temperature of 120° F. Recommend adjusting the temperature at the water heater to prevent burn injuries.

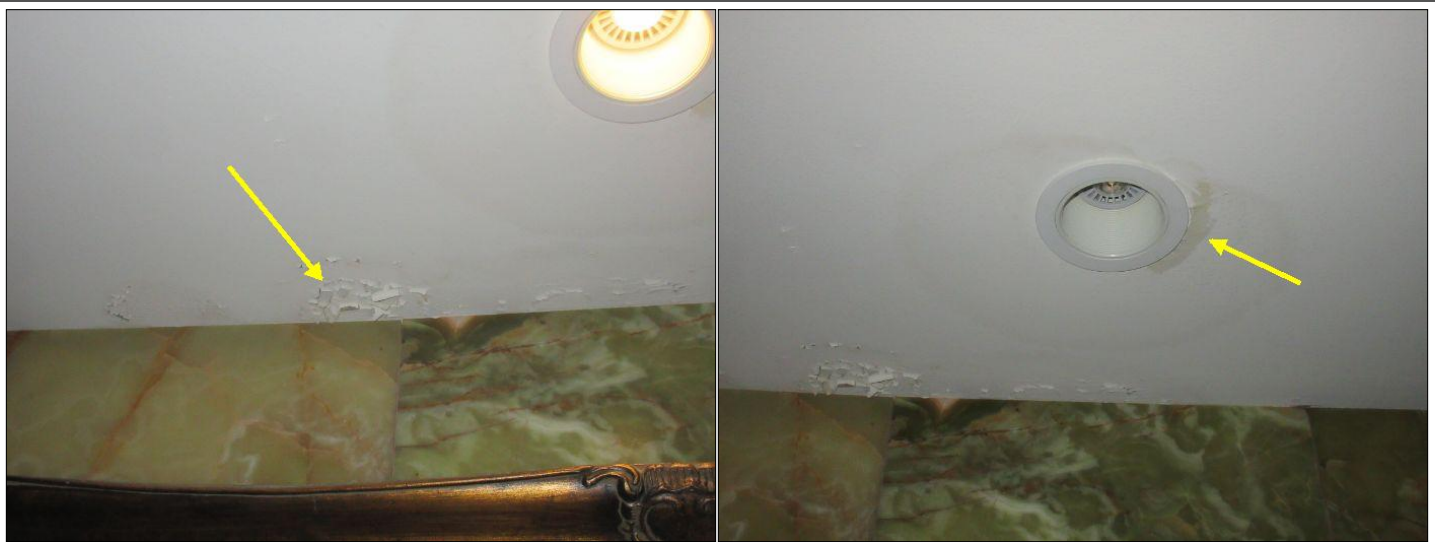
Evidence of active leak noted, likely from missing step flashing (Bathroom #1)

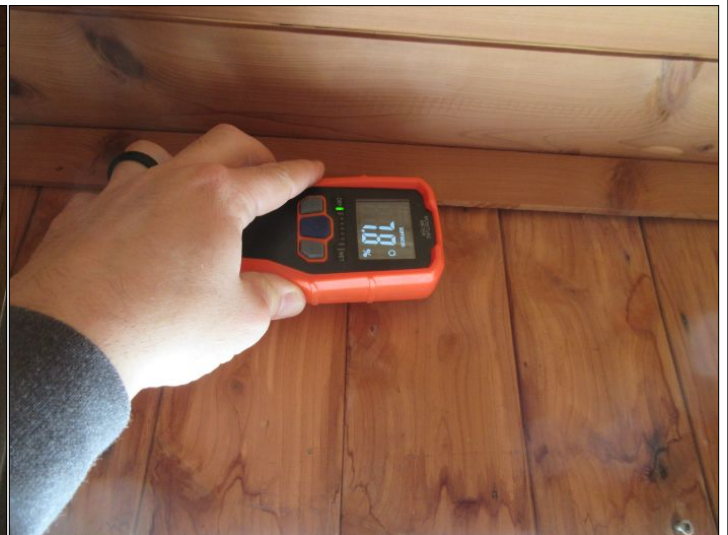
Water damage noted in cedar closet. Recommend consultation with roofing professional for additional evaluation.

Higher moisture content verified w/ moisture meter
