PROPERTY INSPECTION REPORT

456 Sample St, Anytown, NY 12345

DATE OF INSPECTION: 8/11/2022

SQUARED AWAY
HOME INSPECTIONS

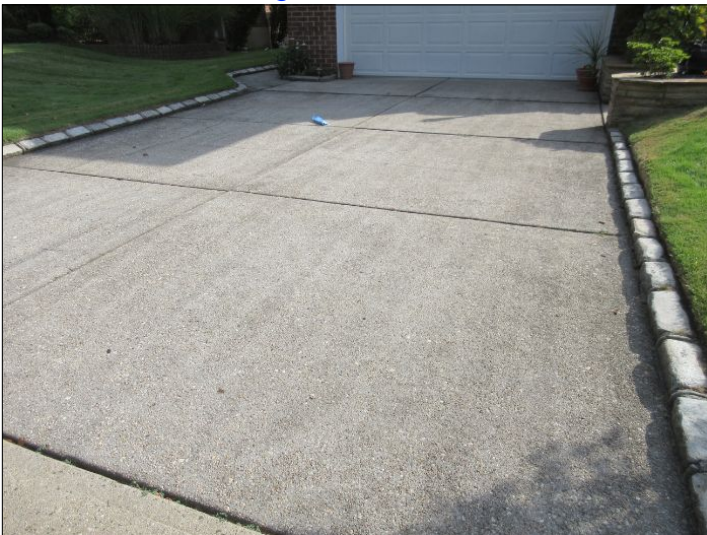
- Driveway in good shape for age and wear.
- Common cracking noted

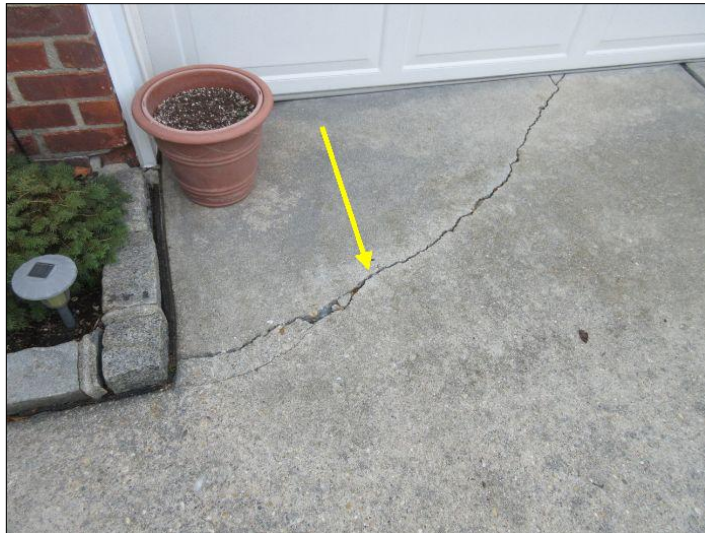
Common cracking noted

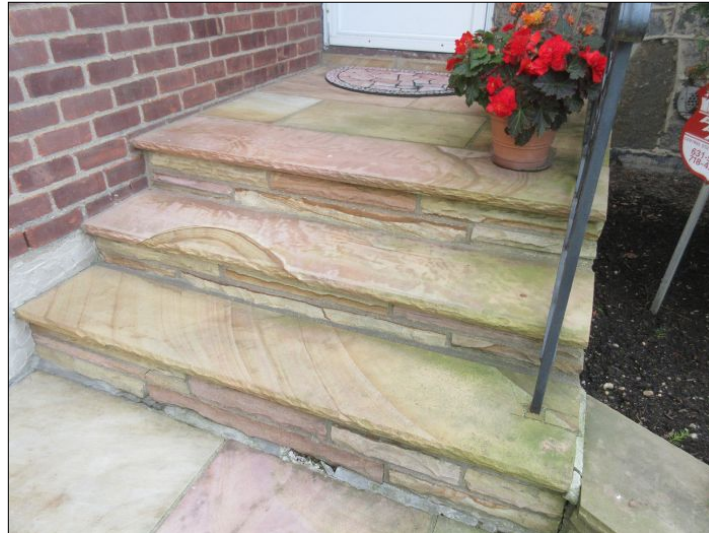
Some mortar joints require repair

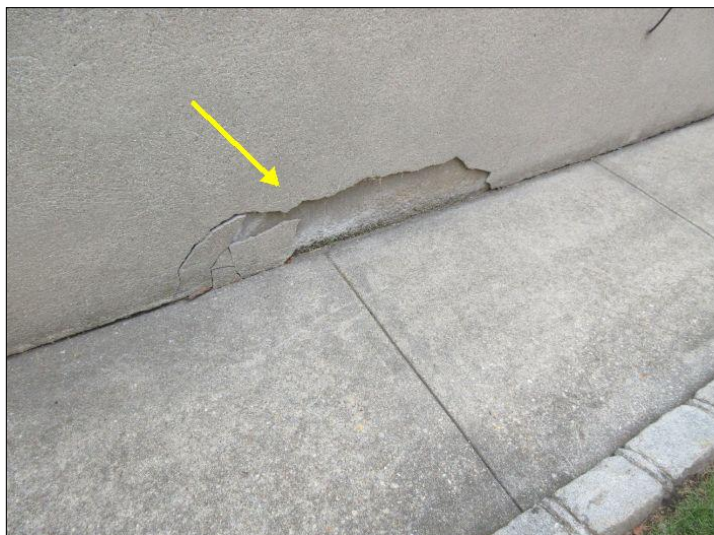
Damaged parking noted

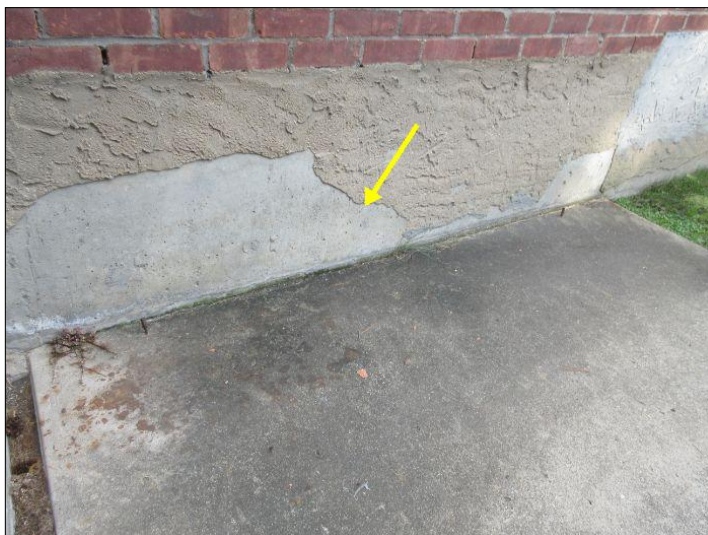
Damaged parking noted

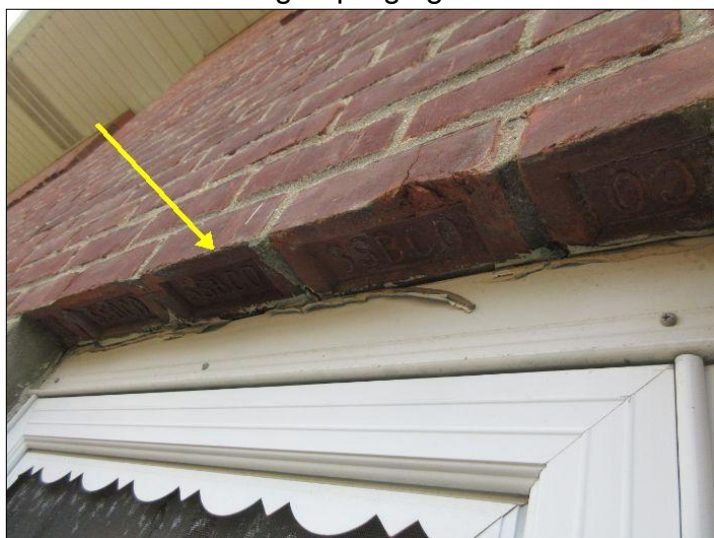
- Exterior siding appeared in serviceable condition. No deficiencies, unless otherwise noted:
- Missing lintel noted at doorway opening. Lintels hold up bricks over voids (ie door and window openings). Consult with qualified mason for correction.

Missing lintel noted at doorway opening (Garage)

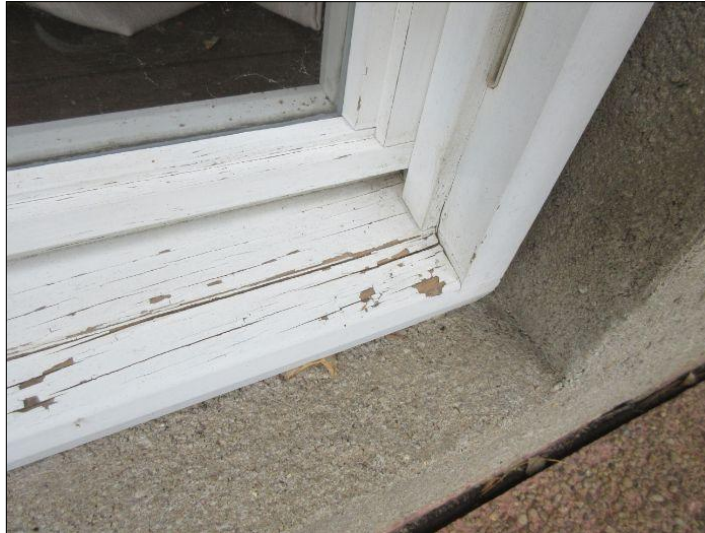
Exposed wood surfaces observed. Wood rot & deterioration can occur. Prep, prime and paint wood trim surface where paint is peeling or missing.

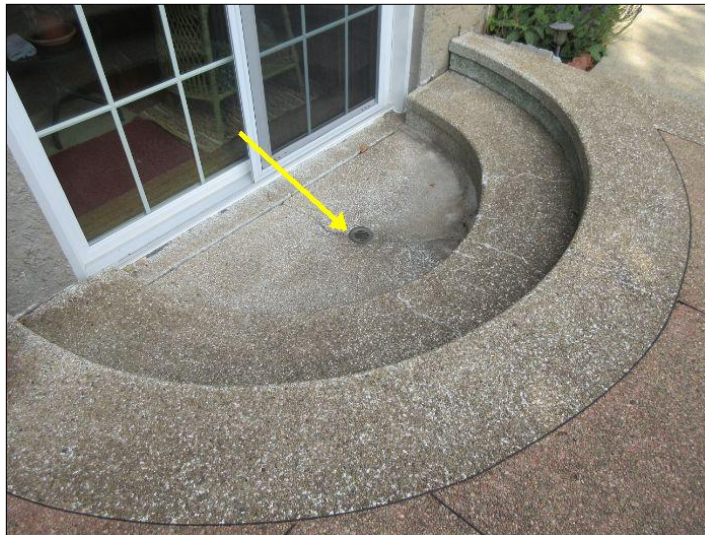
- No major deficiencies noted.
- **MAINTENANCE:** Exterior surface floor drain at the base of rear entry walkout must be routinely monitored to ensure that it is kept clear of leaves/debris and not blocked/clogged. If this drain is allowed to become clogged, the basement may flood or damage may occur to the basement door as water accumulates there during rains.

Maintain area free of debris to prevent clogging / flooding

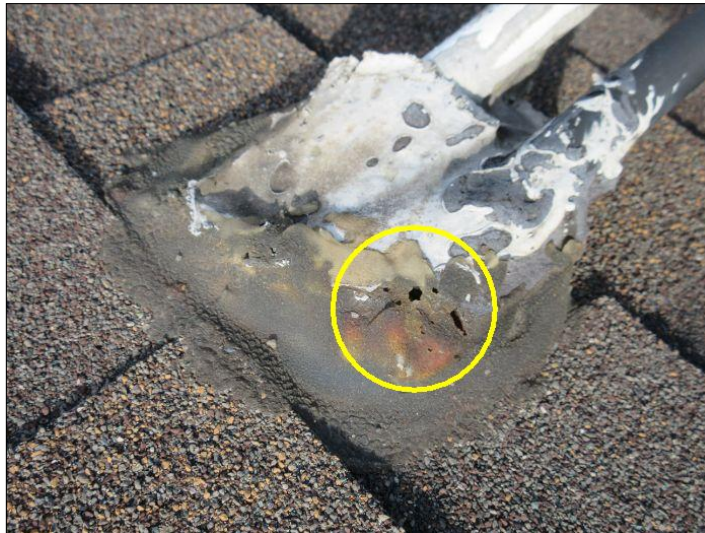
Recommend sealing as needed (Condensate drain)

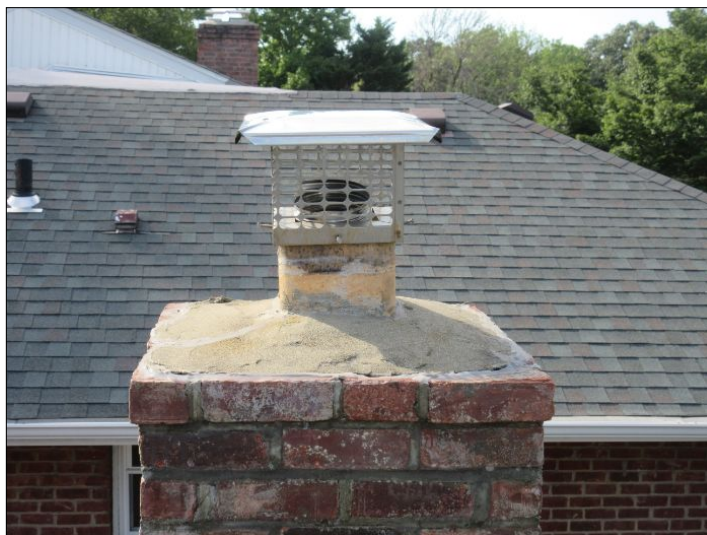
The metal chimney liner vent flue pipe was not inspected or visible from end to end. Recommend a certified chimney sweep inspect for your safety.

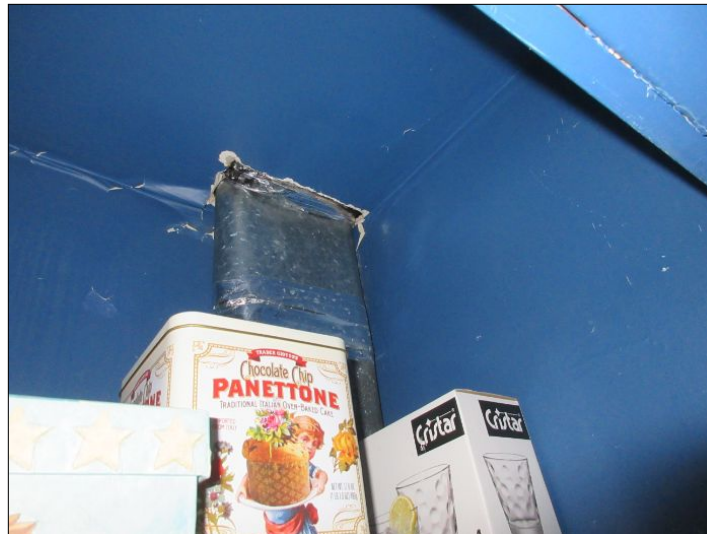
Exposed duct noted (Bedroom #3 closet)

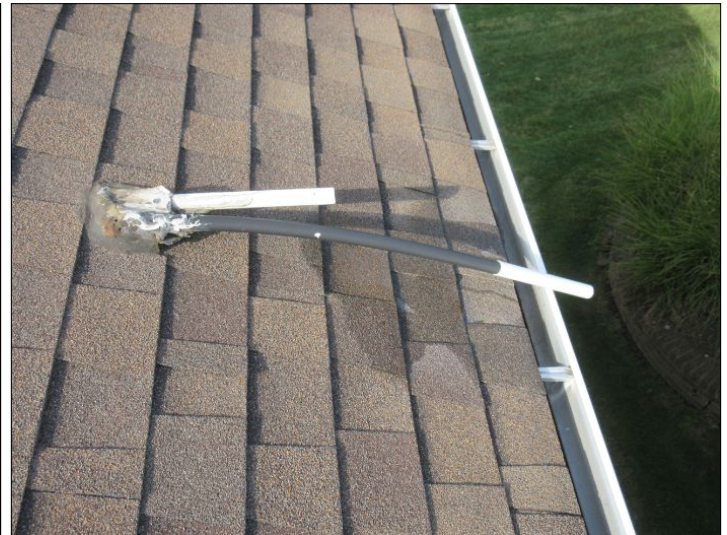
Irregular installation noted. Condensate drain pipes typically exit the home through the fascia into the gutter system. This condensate removal pipes penetrate the roof covering. Recommend having area evaluated and resealed as needed.

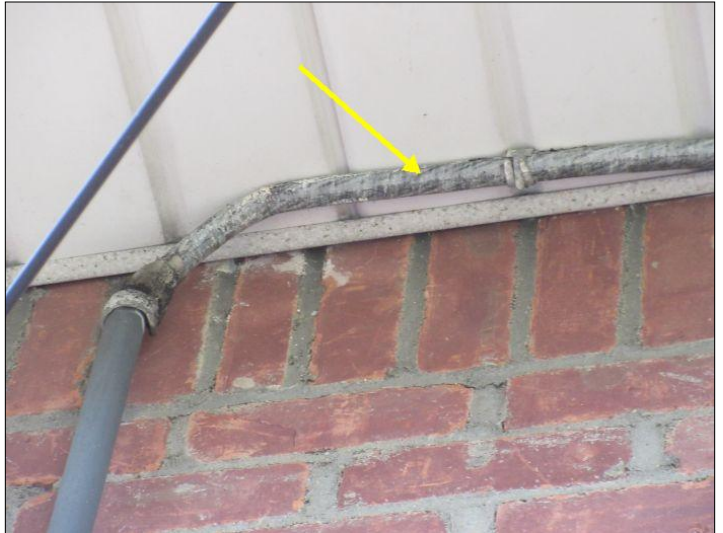
Sheathing on service entrance wires is in deteriorated condition. Recommend budgeting for upgrades to electrical service.

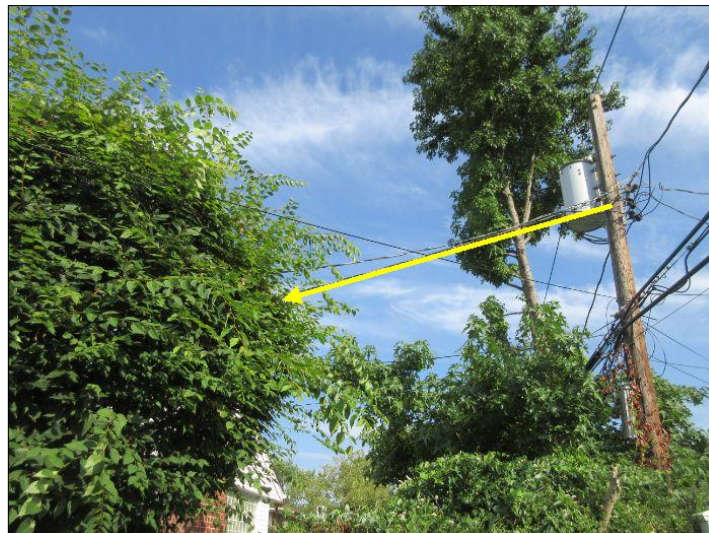
- Wires are touching trees, recommend review by the local Utility Company for trimming as necessary.

Wires are touching trees, recommend review by the local Utility Company for trimming as necessary.

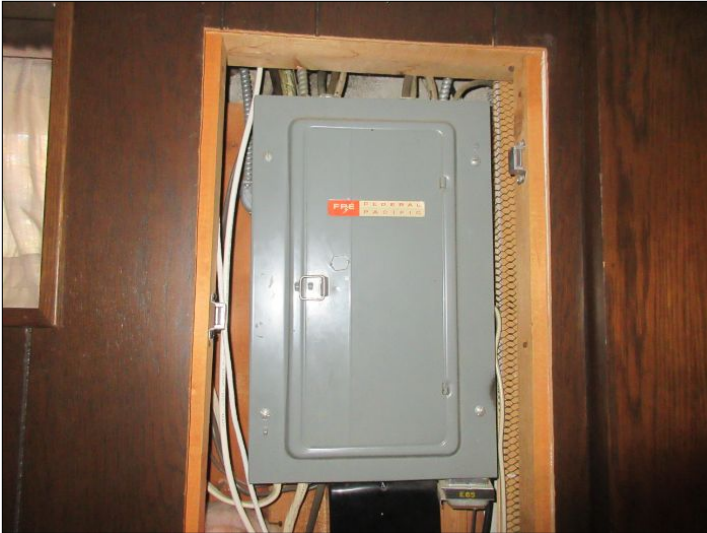
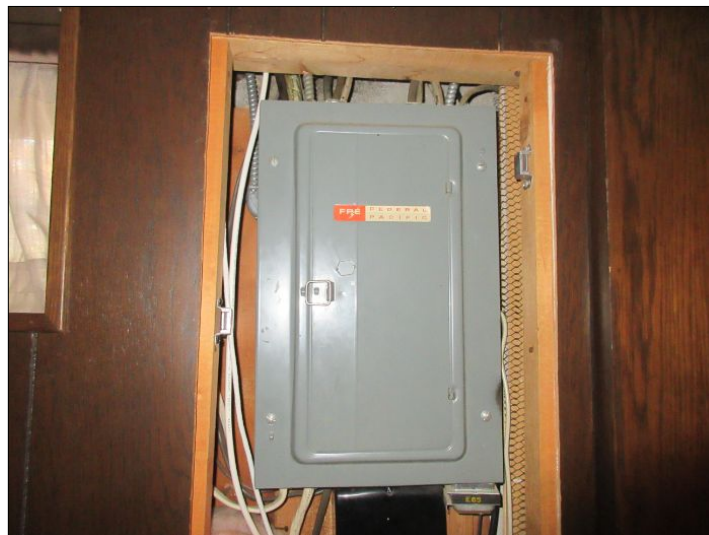
- The Main Service Panel is a Federal-Pacific brand which is legal, but there is a possibility that the **CIRCUIT** breakers may not trip when shorted possibly causing an electrical hazard. Opinions by licensed electricians on this panel varies between safe and unsafe. Recommend you consult a licensed electrician for a further evaluation and correct if necessary.
- **IMPROVE:** Main service panel is undersized. Recommend consulting with licensed electrician for upgrade.

Page 29 Item: 2	Main Service Panel(s)	<ul style="list-style-type: none"> • The Main Service Panel is a Federal-Pacific brand which is legal, but there is a possibility that the circuit breakers may not trip when shorted possibly causing an electrical hazard. Opinions by licensed electricians on this panel varies between safe and unsafe. Recommend you consult a licensed electrician for a further evaluation and correct if necessary. • IMPROVE: Main service panel is undersized. Recommend consulting with licensed electrician for upgrade.
-----------------	-----------------------	---

Recommend replacement during future renovations

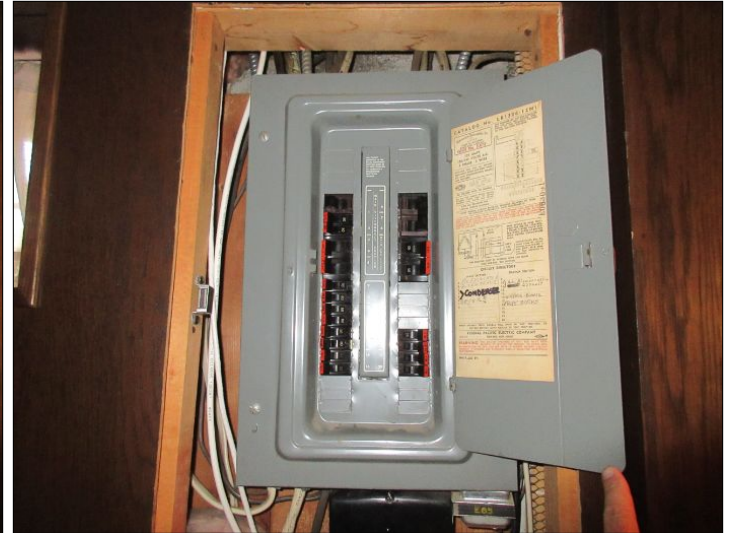
See comments above

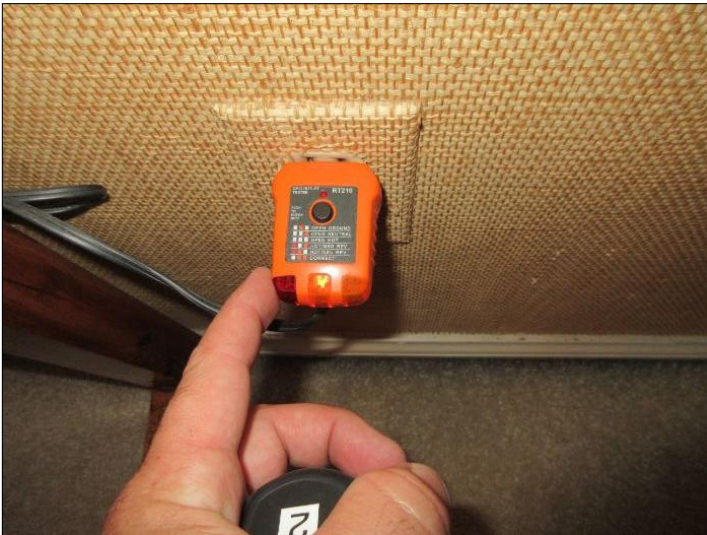
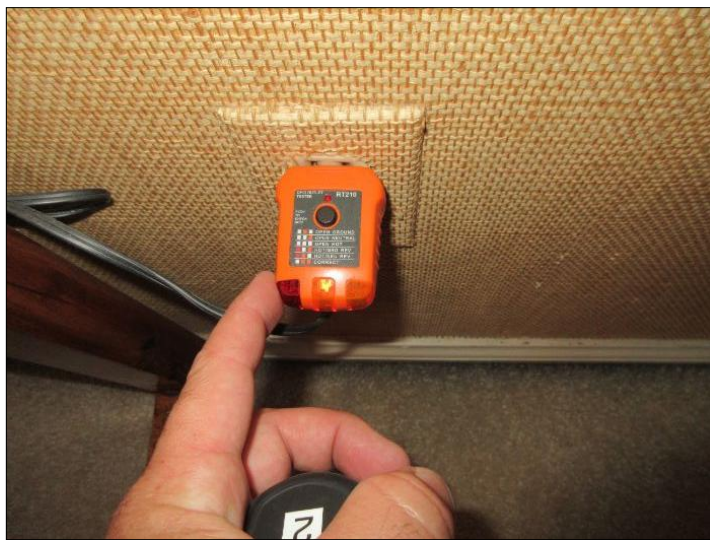
- A **representative number** of receptacles, switches and lights were tested and are generally serviceable, unless otherwise noted.
- **SAFETY CONCERN:** One/Several receptacle(s) have "open ground" fault. This is an electrical shock hazard. A qualified individual or company should correct/repair as needed.

Open ground noted

Page 29 Item: 4	Lighting, Fixtures, Switches, Outlets	<ul style="list-style-type: none"> • SAFETY CONCERN: One/Several receptacle(s) have "open ground" fault. This is an electrical shock hazard. A qualified individual or company should correct/repair as needed.
-----------------	---------------------------------------	---

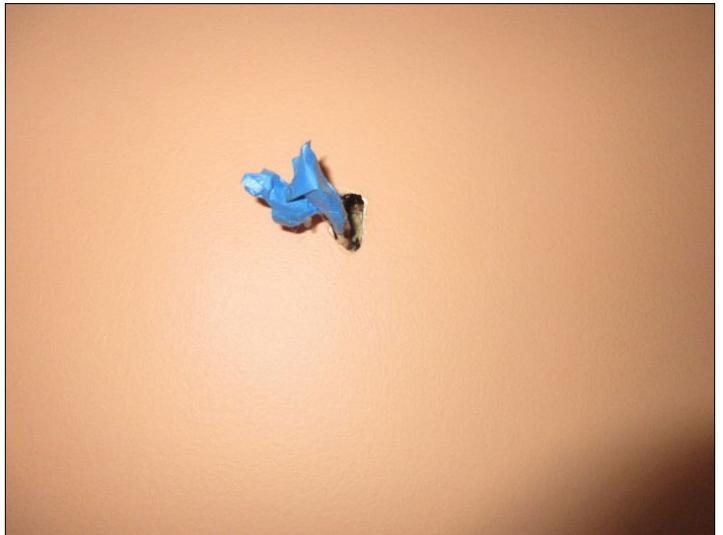
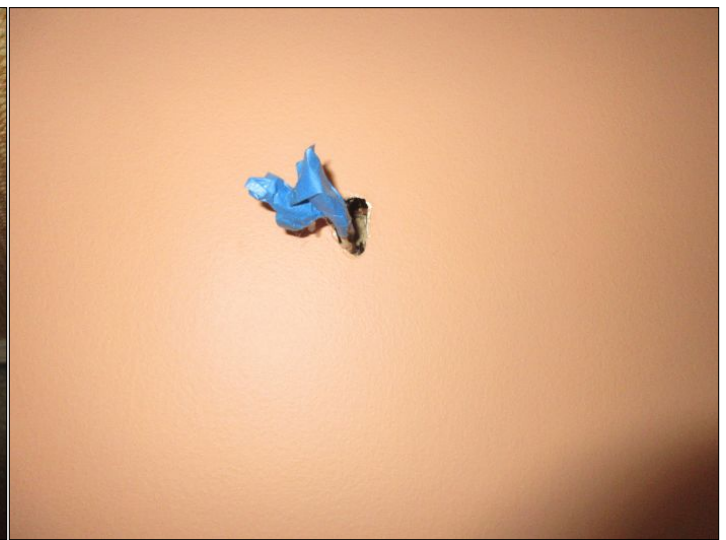
Exposed wiring noted from removed wall sconce. Recommend securing by licensed electrician (Living Room)

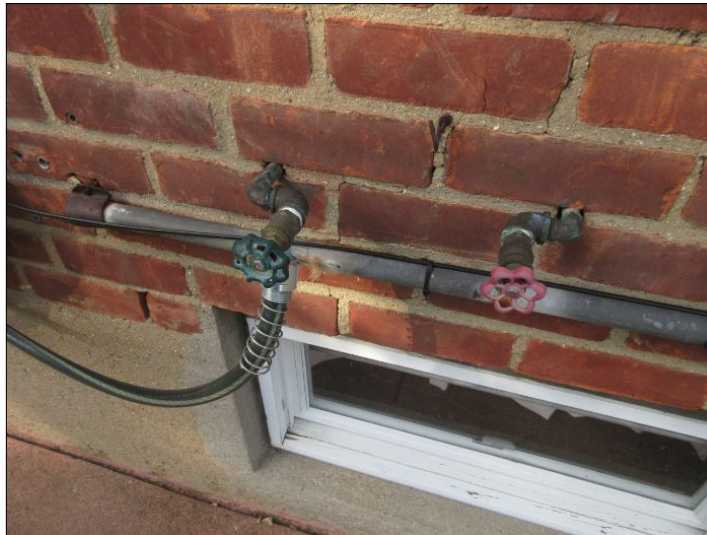
IMPROVE: Install the frost-free type faucet to reduce the risks of a bursted/frozen pipe or faucet.

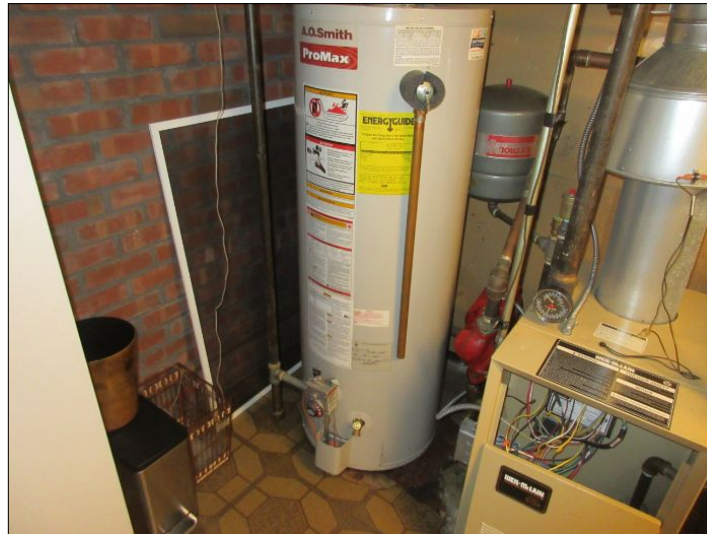
IMPROVE: Water heater is past the end of its typical service life. Recommend budget for replacement.

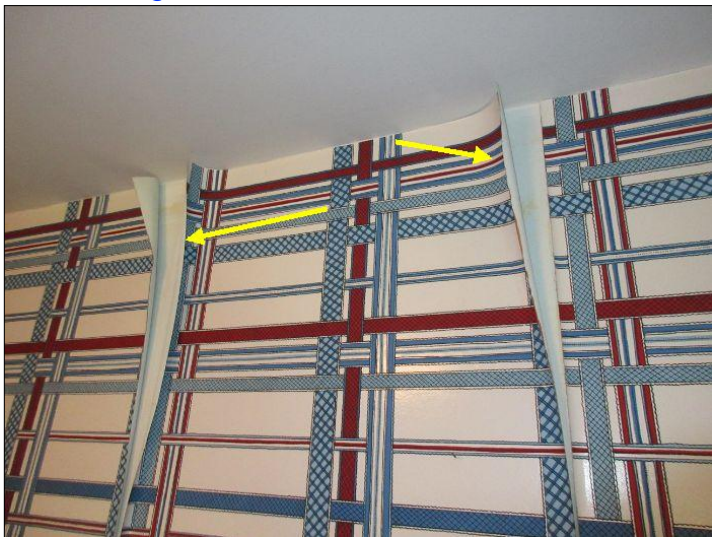
Peeling wallpaper noted

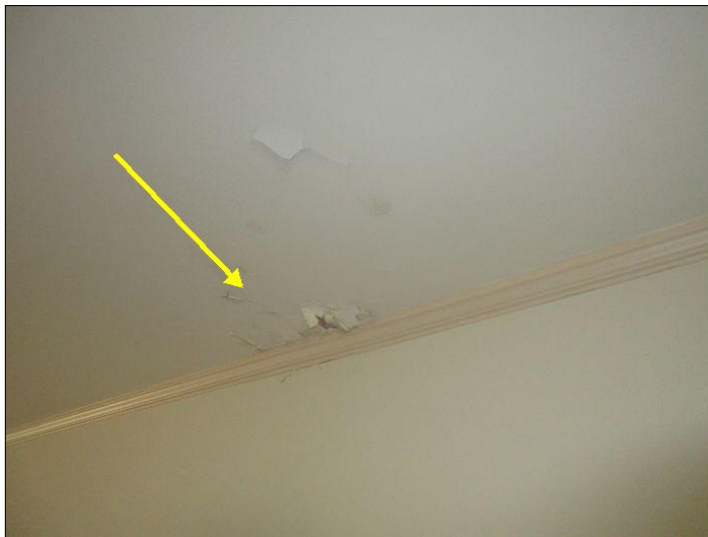
Blistering noted - Area did not appear wet when tested with moisture meter - Recommend monitoring (Living Room)

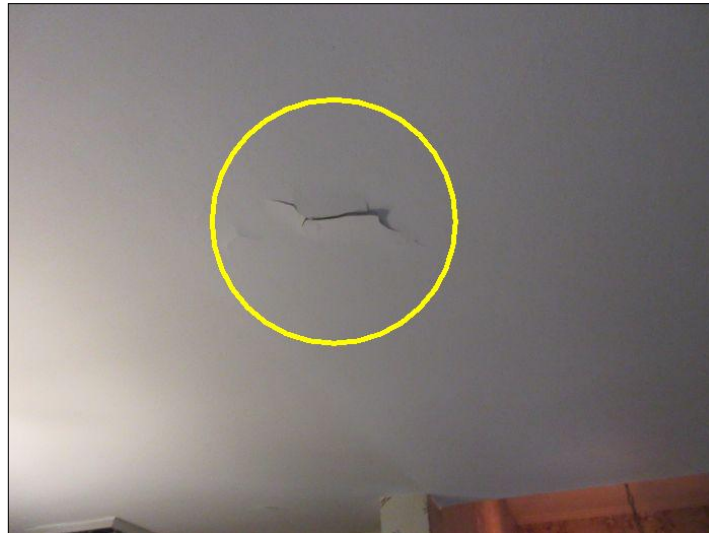
Peeling wallpaper noted (Kitchen)

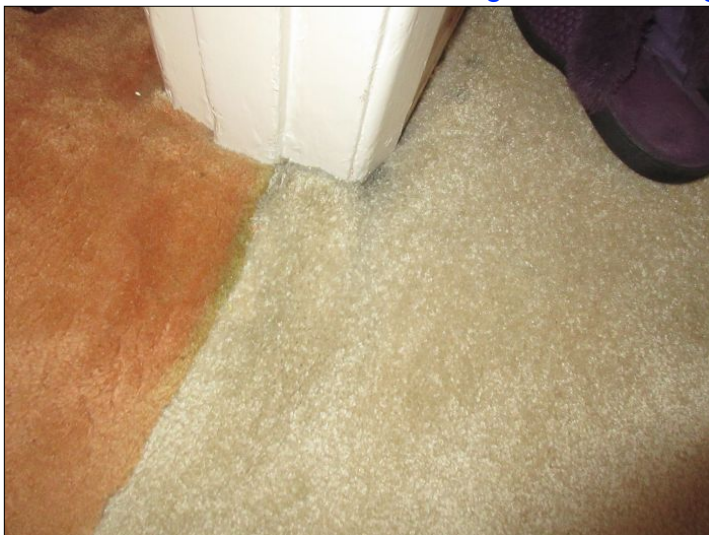
Carpet loose in areas

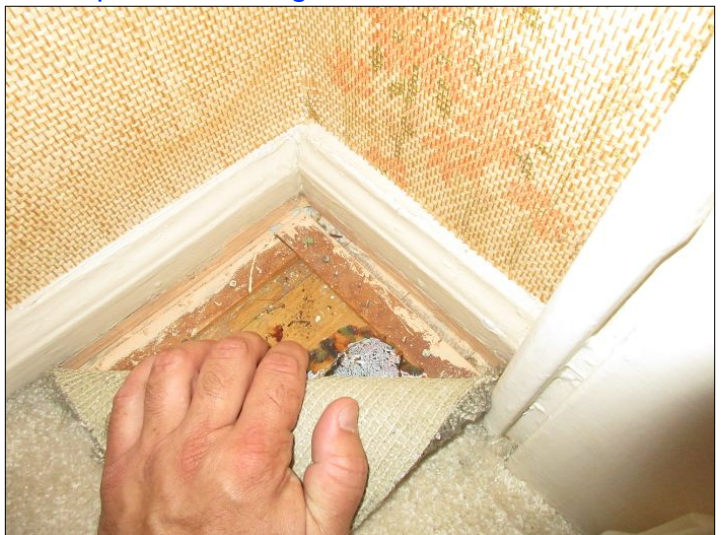
There are areas of hardwood flooring under carpet. Unable to fully evaluate.

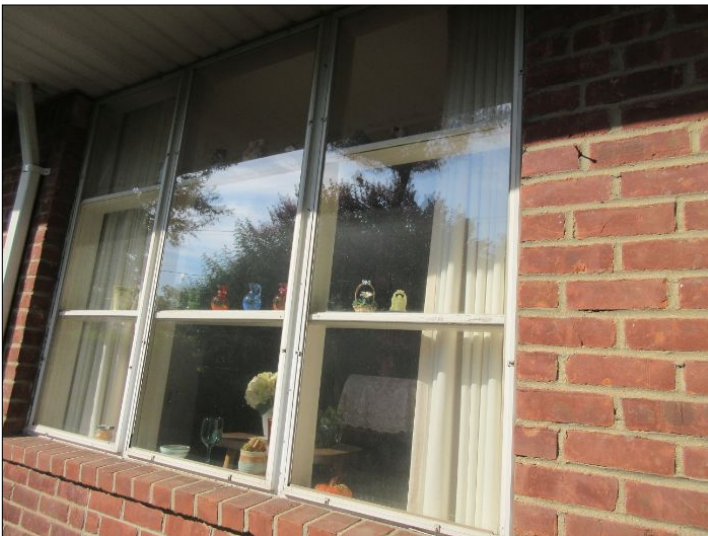
Recommend replacement

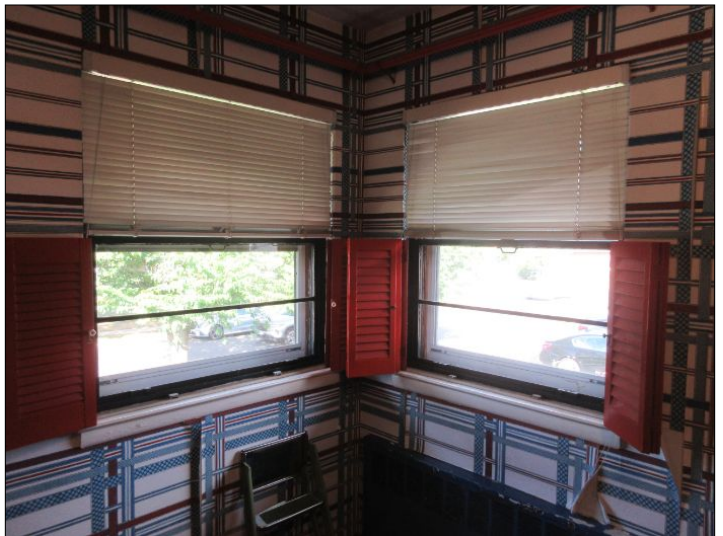
DEFERRED COST: Windows are original. Consider upgrading to double pane, thermally insulated, more efficient type.

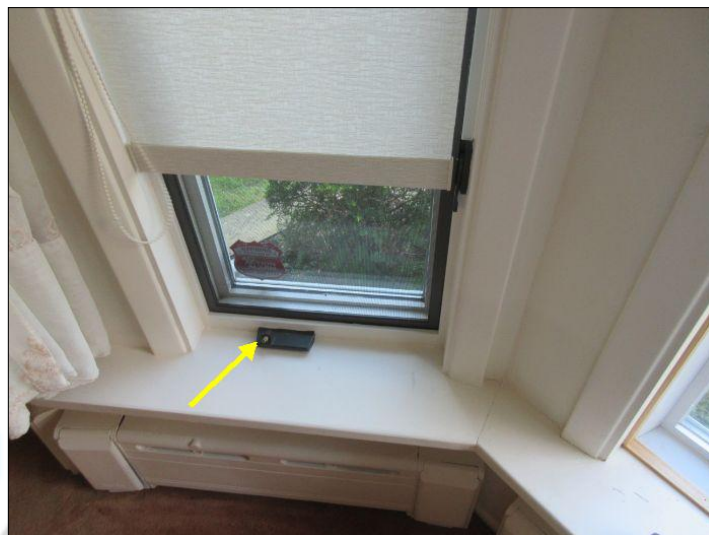
Missing handle noted

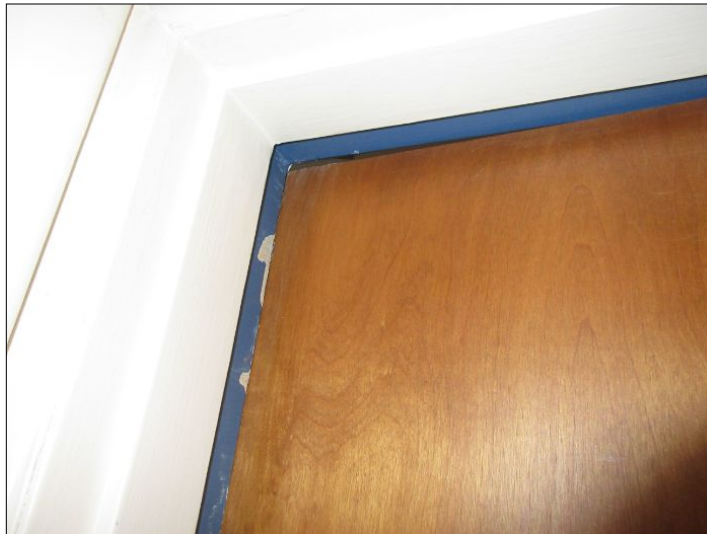
Door sticks, does not close, needs adjustment (Bedroom #3)

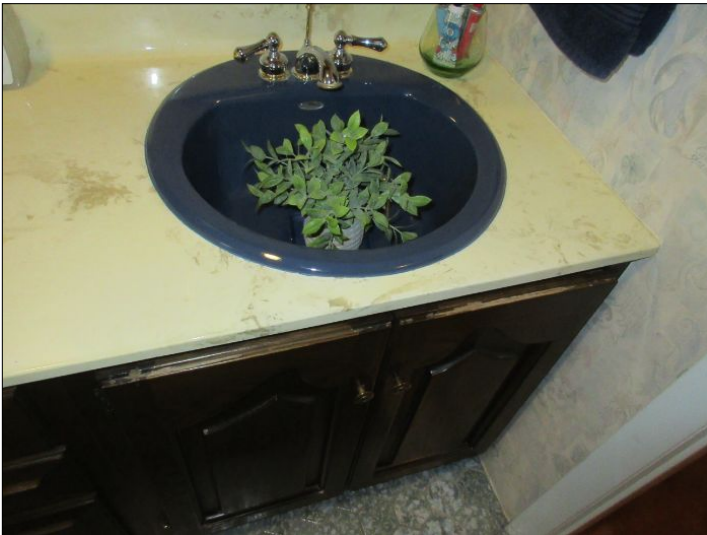
Owner stated right sink does not operate - Not tested
