PROPERTY INSPECTION REPORT

456 Sample St, Anytown, NY 12345

DATE OF INSPECTION: 8/11/2022

SQUARED AWAY
HOME INSPECTIONS

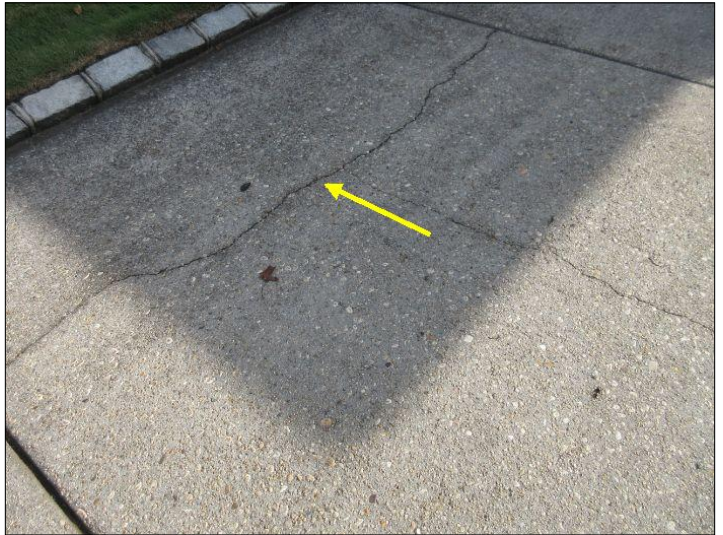
Common cracking noted

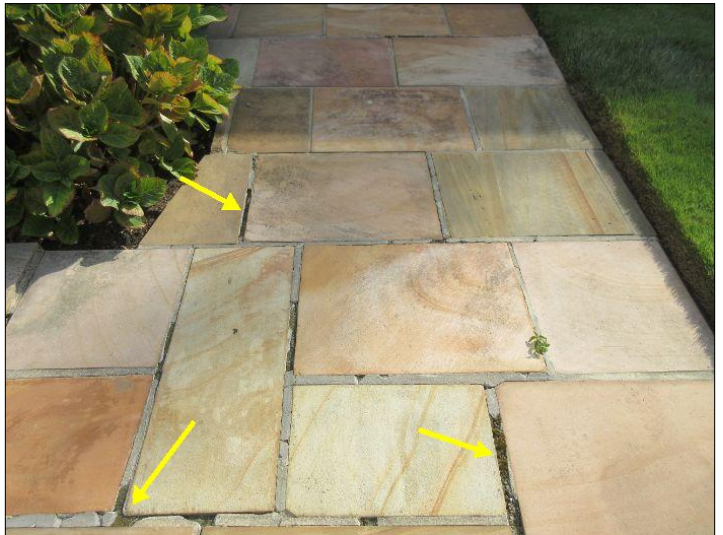
Some mortar joints require repair

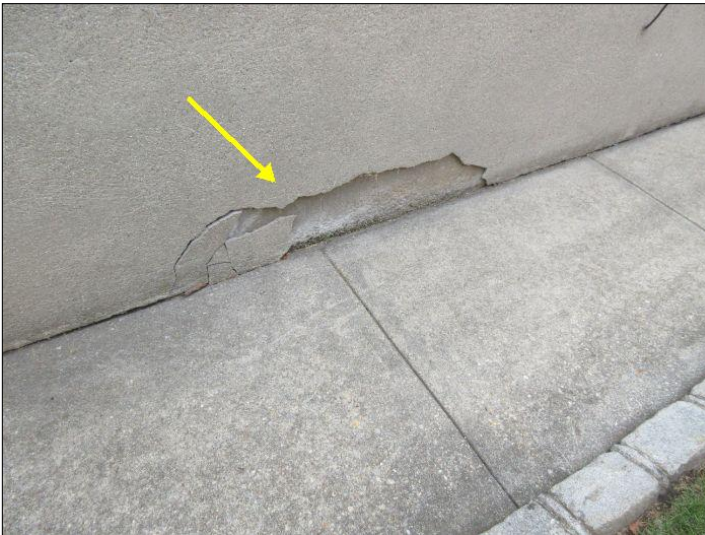
Damaged parging noted

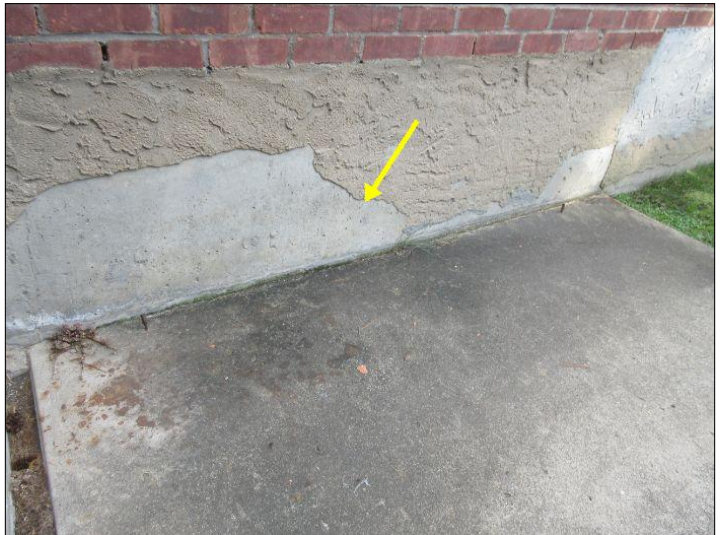
Damaged parging noted

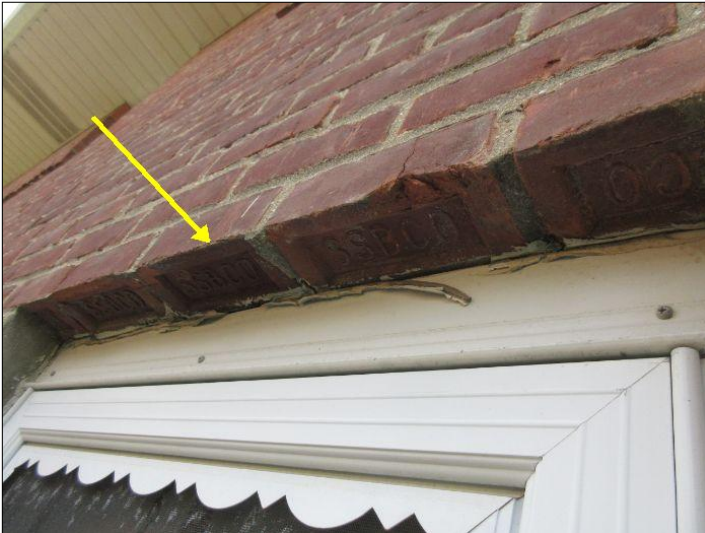
- Exterior siding appeared in serviceable condition. No deficiencies, unless otherwise noted:
- Missing lintel noted at doorway opening. Lintels hold up bricks over voids (ie door and window openings). Consult with qualified mason for correction.

Missing lintel noted at doorway opening (Garage)

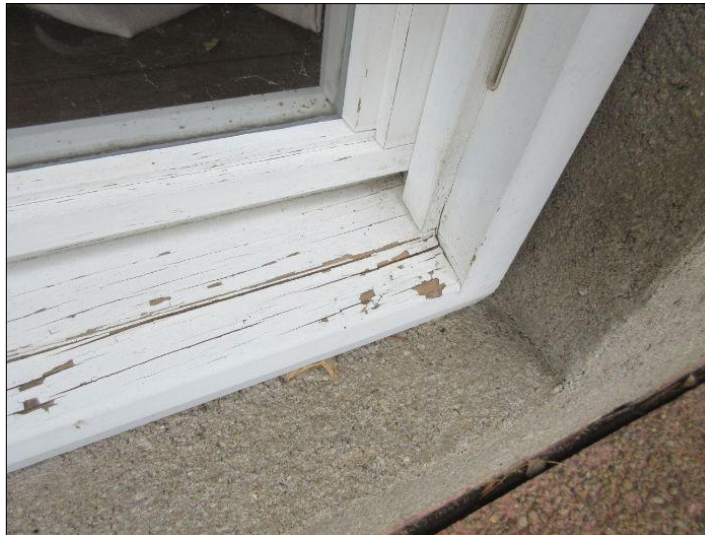
Exposed wood surfaces observed. Wood rot & deterioration can occur. Prep, prime and paint wood trim surface where paint is peeling or missing.

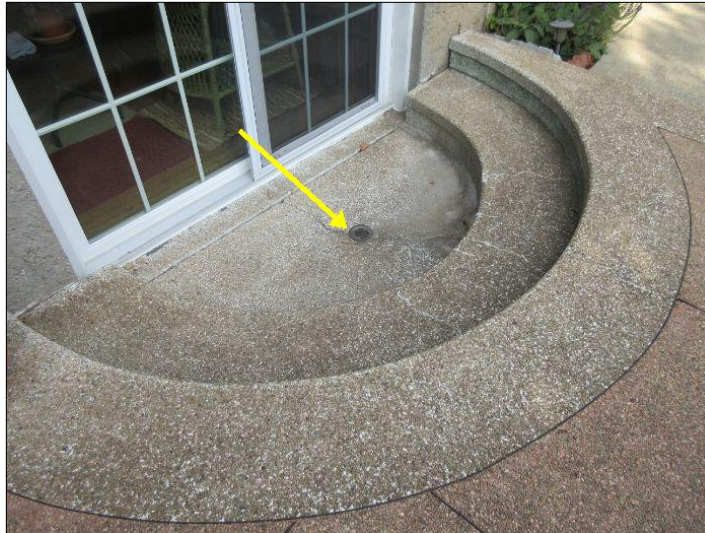
- No major deficiencies noted.
- **MAINTENANCE:** Exterior surface floor drain at the base of rear entry walkout must be routinely monitored to ensure that it is kept clear of leaves/debris and not blocked/clogged. If this drain is allowed to become clogged, the basement may flood or damage may occur to the basement door as water accumulates there during rains.

Maintain area free of debris to prevent clogging / flooding

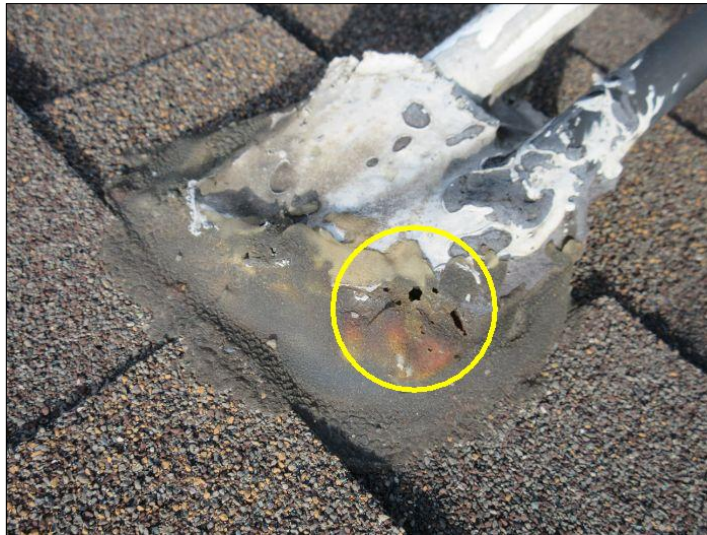
Recommend sealing as needed (Condensate drain)

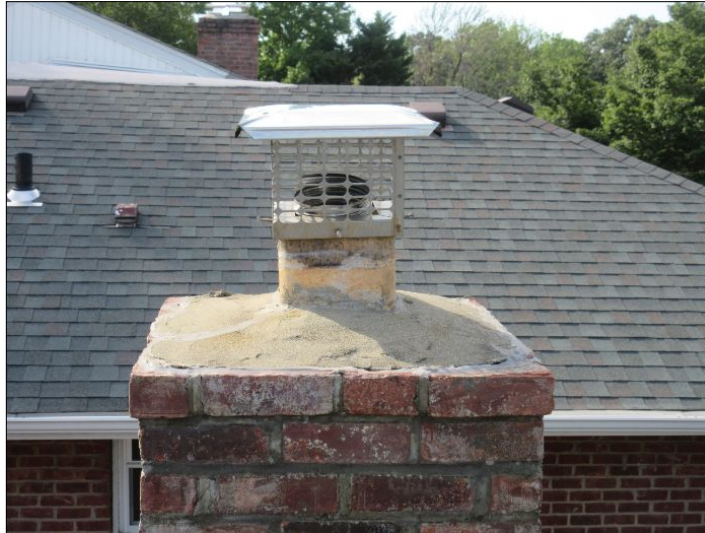
The metal chimney liner vent flue pipe was not inspected or visible from end to end. Recommend a certified chimney sweep inspect for your safety.

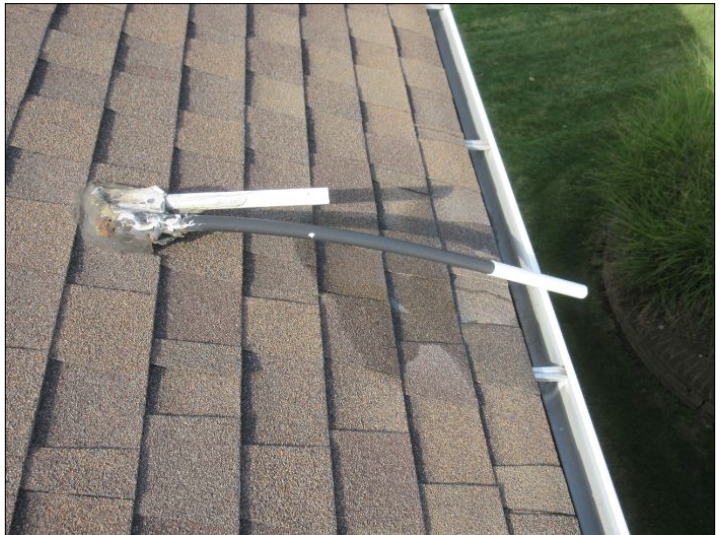
Irregular installation noted. Condensate drain pipes typically exit the home through the fascia into the gutter system. This condensate removal pipes penetrate the roof covering. Recommend having area evaluated and resealed as needed.

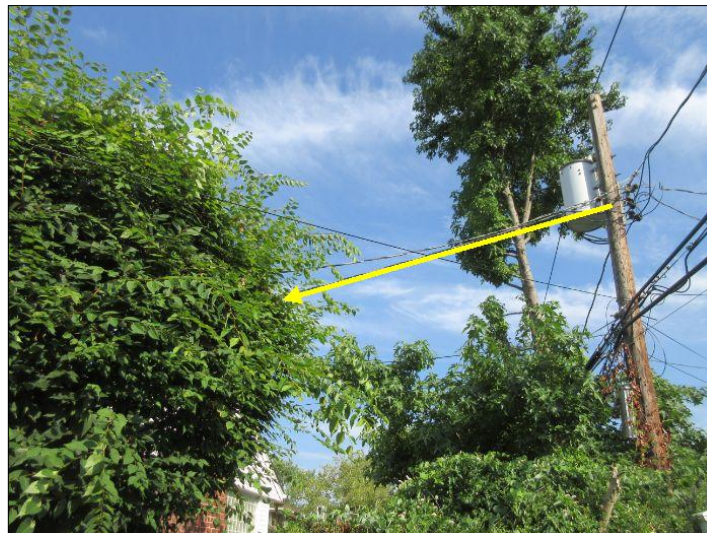
Wires are touching trees, recommend review by the local Utility Company for trimming as necessary.

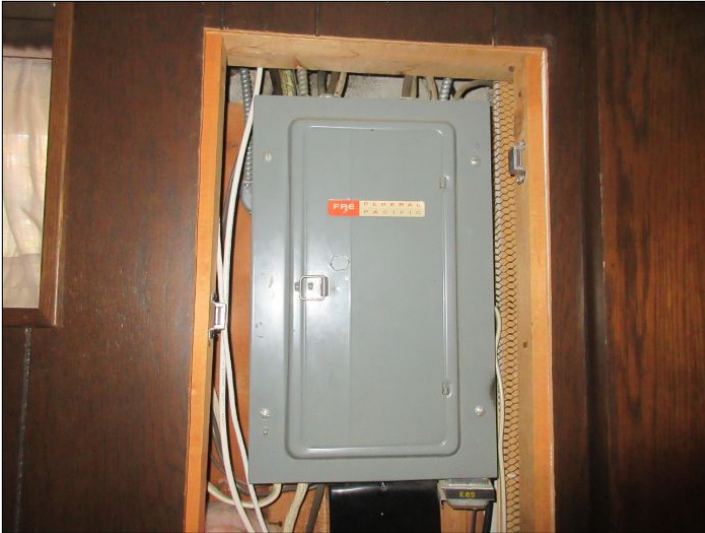
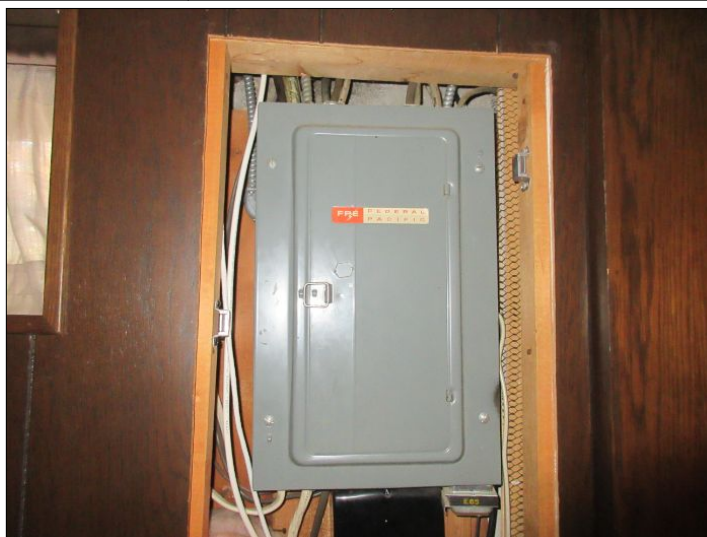
- The Main Service Panel is a Federal-Pacific brand which is legal, but there is a possibility that the **circuit** breakers may not trip when shorted possibly causing an electrical hazard. Opinions by licensed electricians on this panel varies between safe and unsafe. Recommend you consult a licensed electrician for a further evaluation and correct if necessary.
- **IMPROVE:** Main service panel is undersized. Recommend consulting with licensed electrician for upgrade.

Recommend replacement during future renovations

Page 29 Item: 2	Main Service Panel(s)	<ul style="list-style-type: none"> • The Main Service Panel is a Federal-Pacific brand which is legal, but there is a possibility that the circuit breakers may not trip when shorted possibly causing an electrical hazard. Opinions by licensed electricians on this panel varies between safe and unsafe. Recommend you consult a licensed electrician for a further evaluation and correct if necessary. • IMPROVE: Main service panel is undersized. Recommend consulting with licensed electrician for upgrade.
-----------------	-----------------------	---

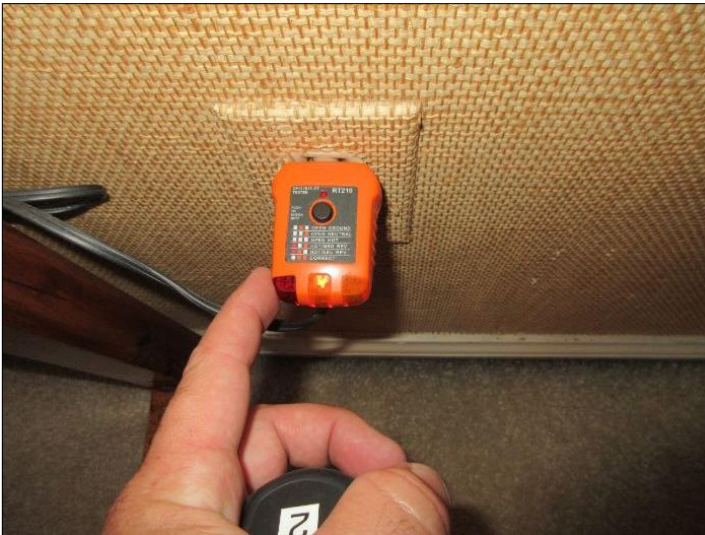
- A **representative number** of receptacles, switches and lights were tested and are generally serviceable, unless otherwise noted.
- **SAFETY CONCERN:** One/Several receptacle(s) have "open ground" fault. This is an electrical shock hazard. A qualified individual or company should correct/repair as needed.

Open ground noted

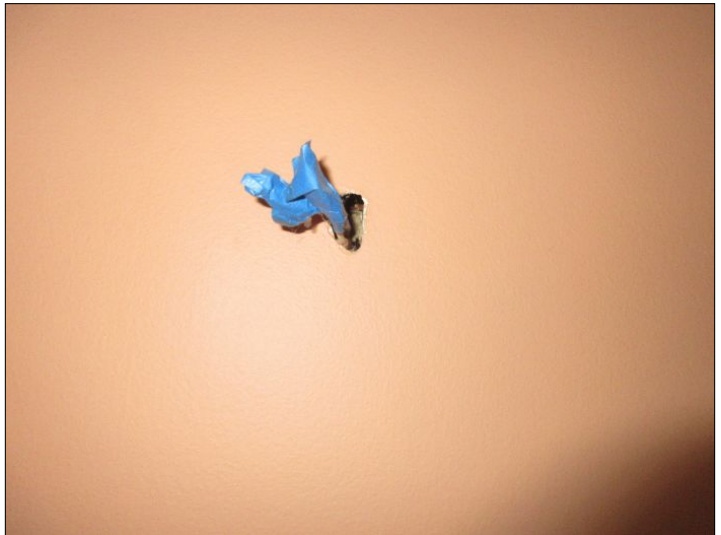
Exposed wiring noted from removed wall sconce.
Recommend securing by licensed electrician
(Living Room)

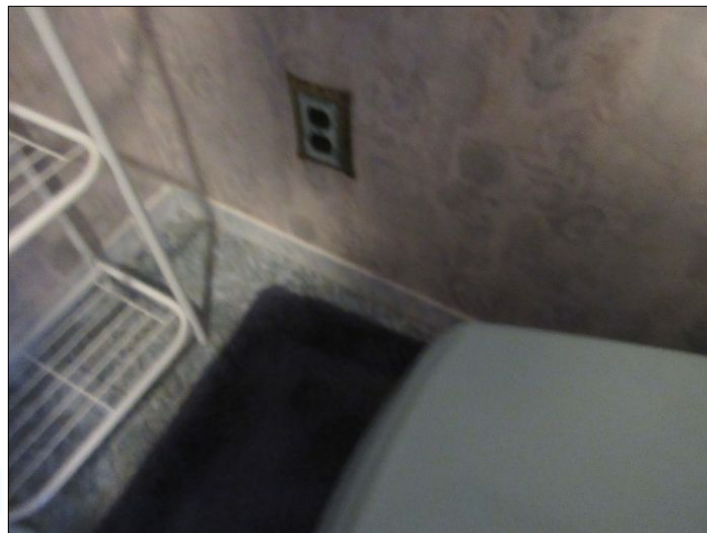
- Operated when tested, unless otherwise noted:
- **IMPROVE:** Modern safety standards require any branch circuit outlets accessible from the kitchen countertop(s), at bathrooms and at exterior to be GFCI protected. At the time this house was built, this was not required protection. Nonetheless, we strongly recommend they be added at these locations as an extra preventative safety measure. A licensed should provide an estimate on installing GFCI protection.

Recommend upgrading to GFCI protected outlet (Bathroom #2)

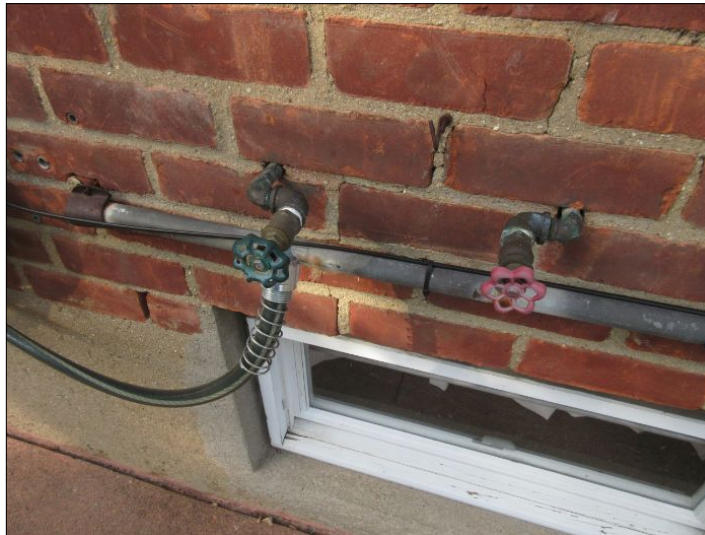
IMPROVE: Install the frost-free type faucet to reduce the risks of a bursted/frozen pipe or faucet.

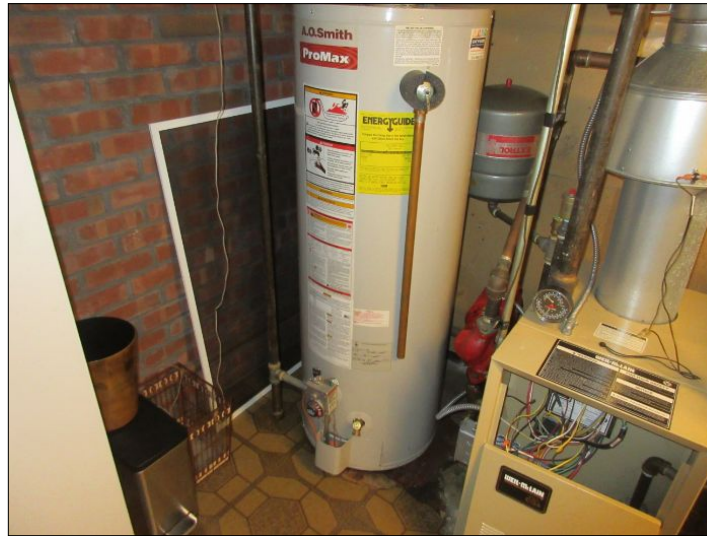
IMPROVE: Water heater is past the end of its typical service life. Recommend budget for replacement.

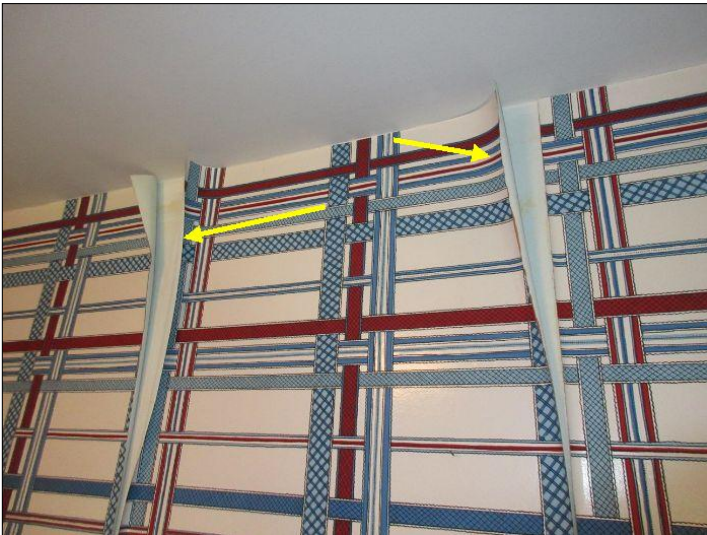
Peeling wallpaper noted

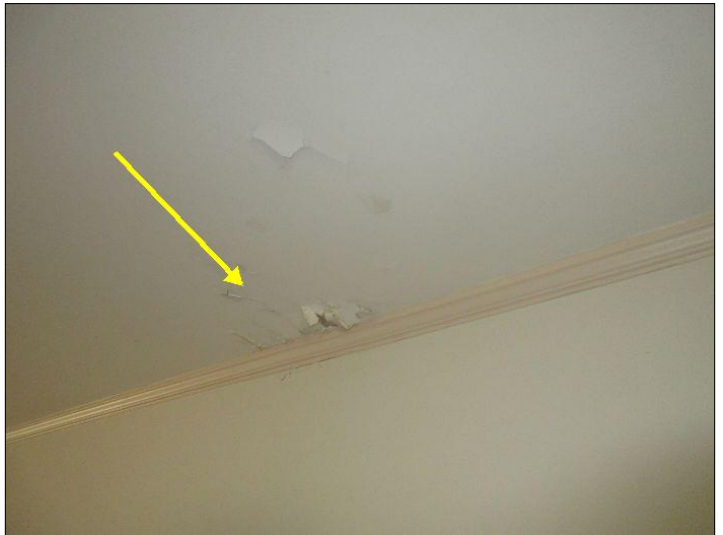
Blistering noted - Area did not appear wet when tested with moisture meter - Recommend monitoring (Living Room)

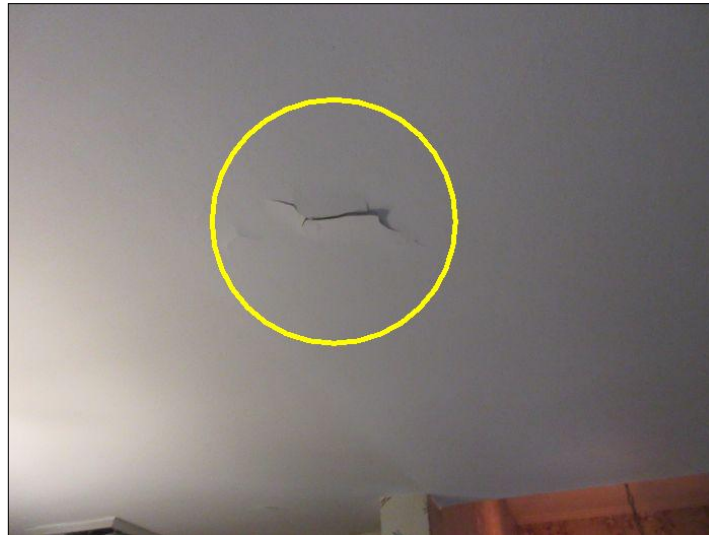
Peeling wallpaper noted (Kitchen)

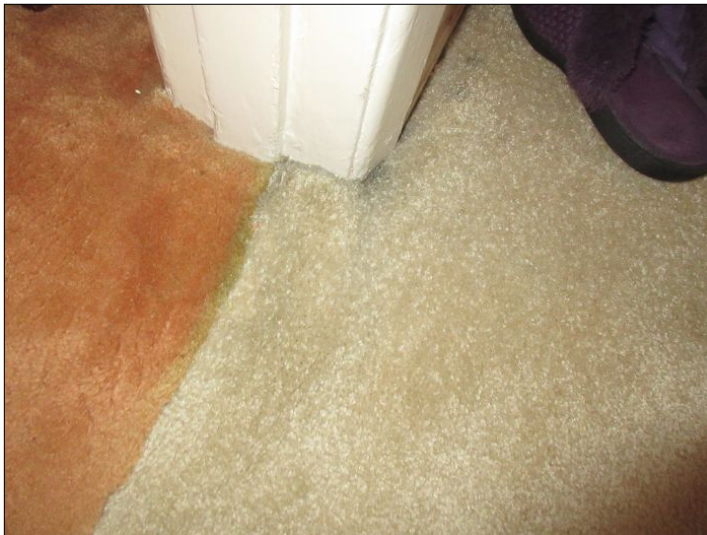
Carpet loose in areas

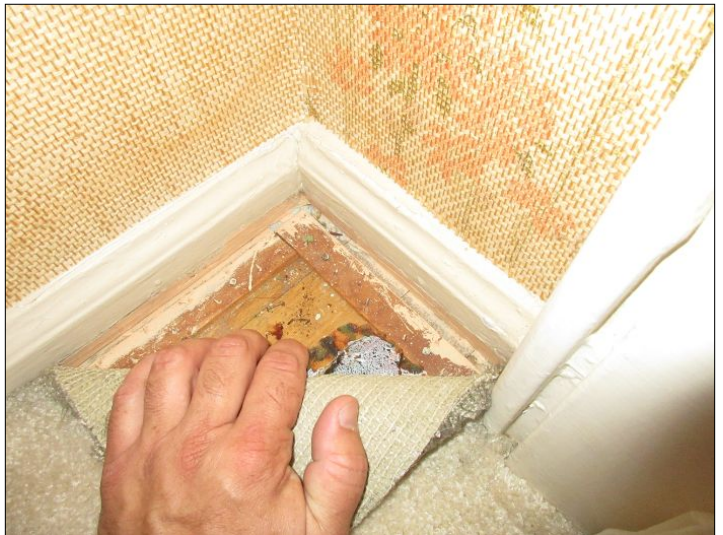
There are areas of hardwood flooring under carpet. Unable to fully evaluate.

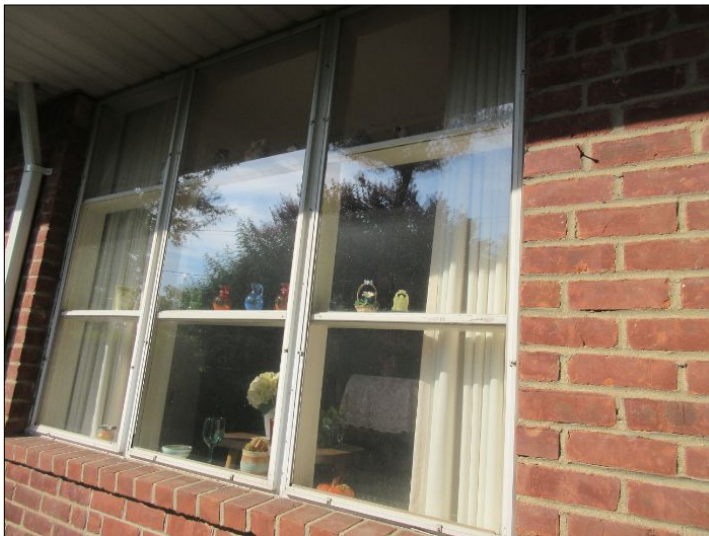
Recommend replacement

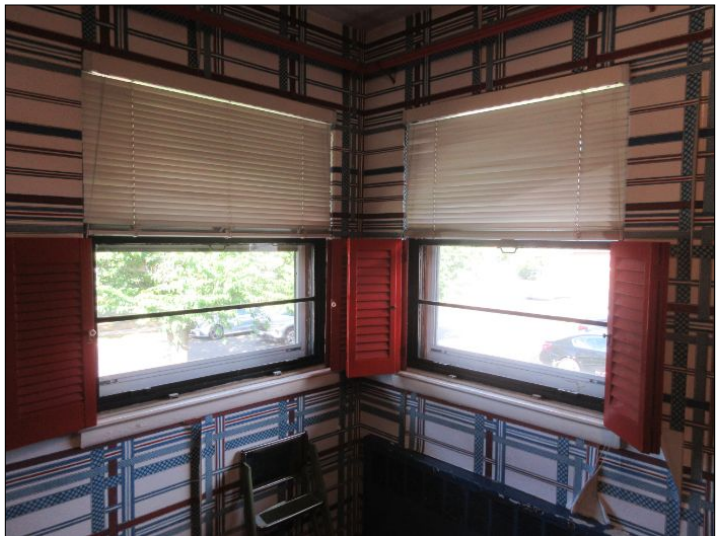
DEFERRED COST: Windows are original. Consider upgrading to double pane, thermally insulated, more efficient type.

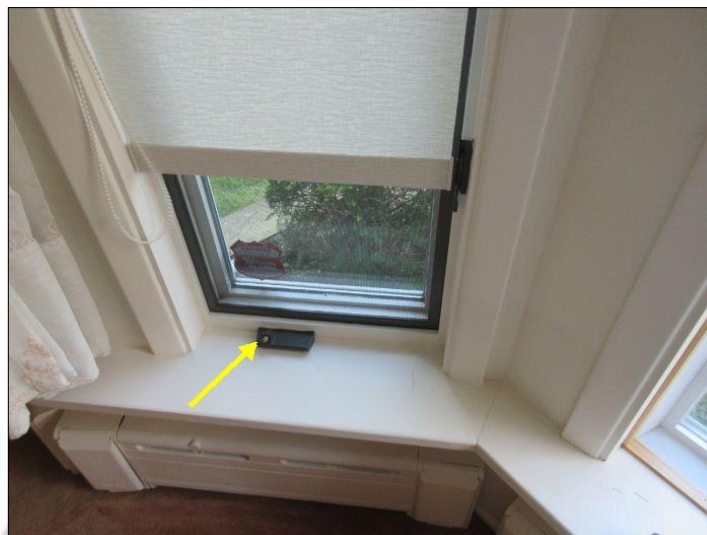
Missing handle noted

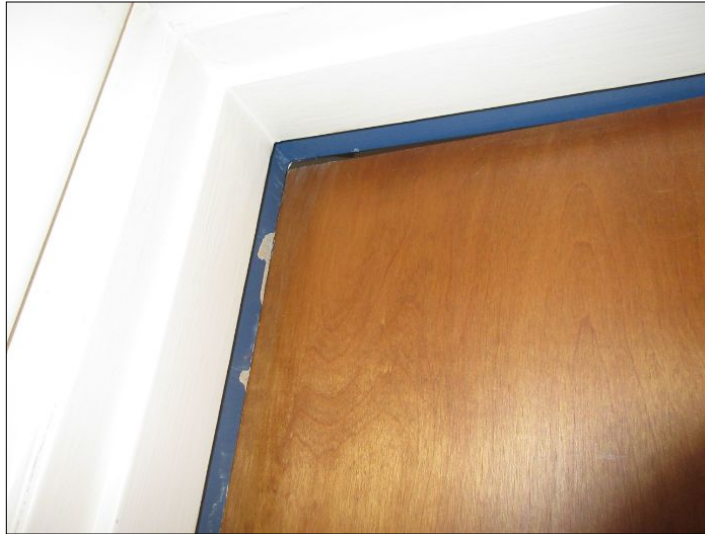
Door sticks, does not close, needs adjustment (Bedroom #3)

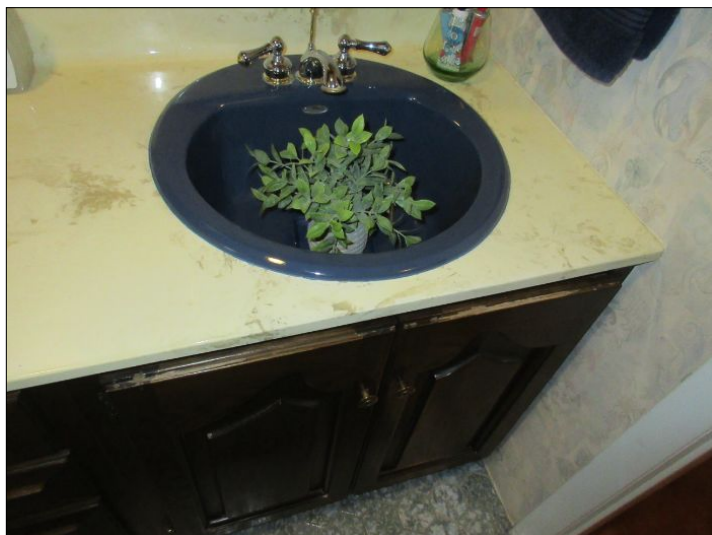
Owner stated right sink does not operate - Not tested

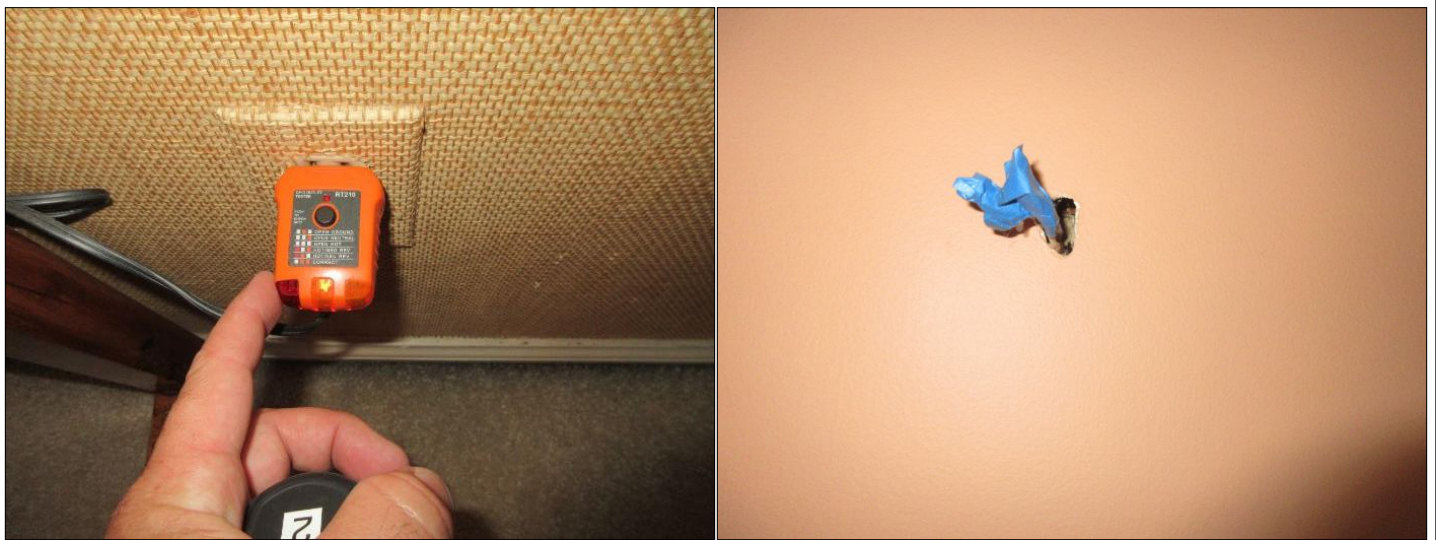
Page 29 Item: 4	Lighting, Fixtures, Switches, Outlets	<ul style="list-style-type: none"> • SAFETY CONCERN: One/Several receptacle(s) have "open ground" fault. This is an electrical shock hazard. A qualified individual or company should correct/repair as needed.
-----------------	---------------------------------------	---

Open ground noted

Exposed wiring noted from removed wall sconce.
Recommend securing by licensed electrician
(Living Room)
