PROPERTY INSPECTION REPORT

123 Main St, , NY 12345

DATE OF INSPECTION: 9/14/2023

Year Built: 1946

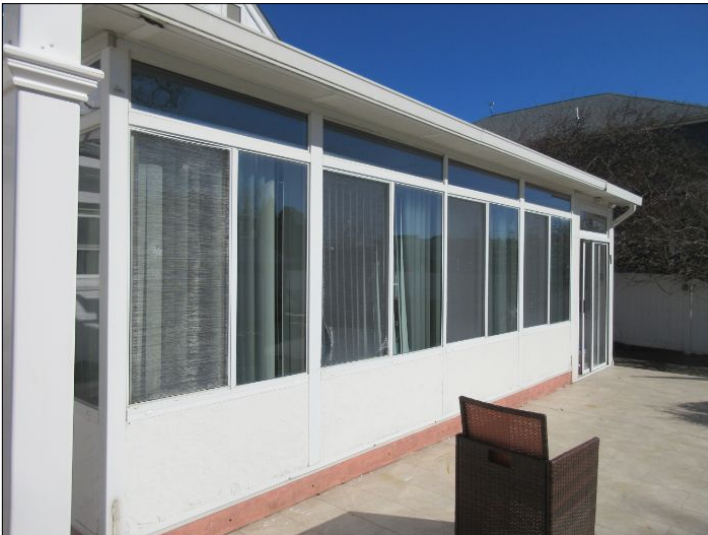
Rear sun room - Satisfactory

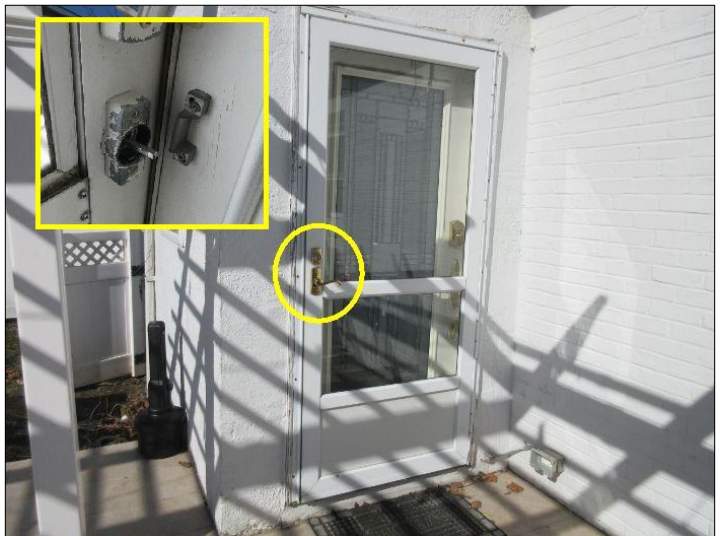
Missing hardware noted

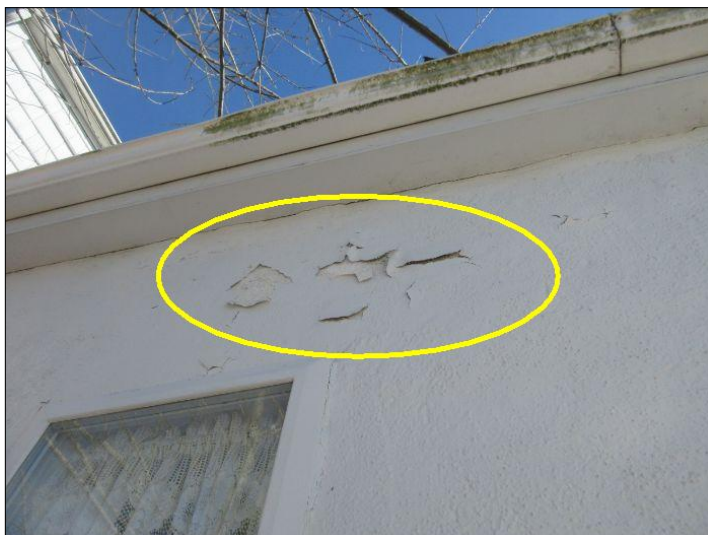
Flaking noted. Refinish as needed (Right side)

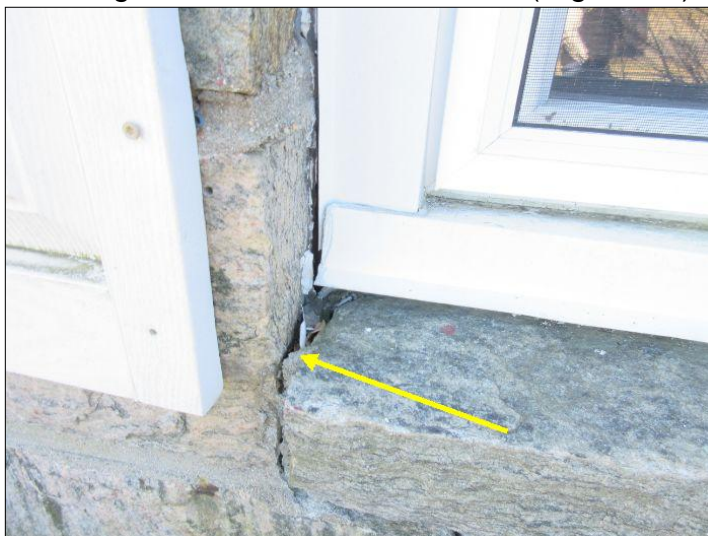
Structural crack noted at front of home. Result from undermining of foundation.

Undermining noted at front left corner of the home's foundation wall.

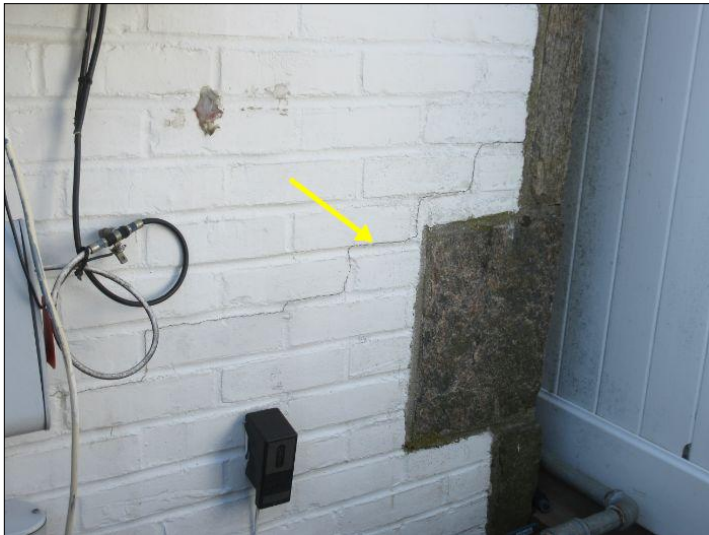
Additional cracks coinciding w/ undermined foundation

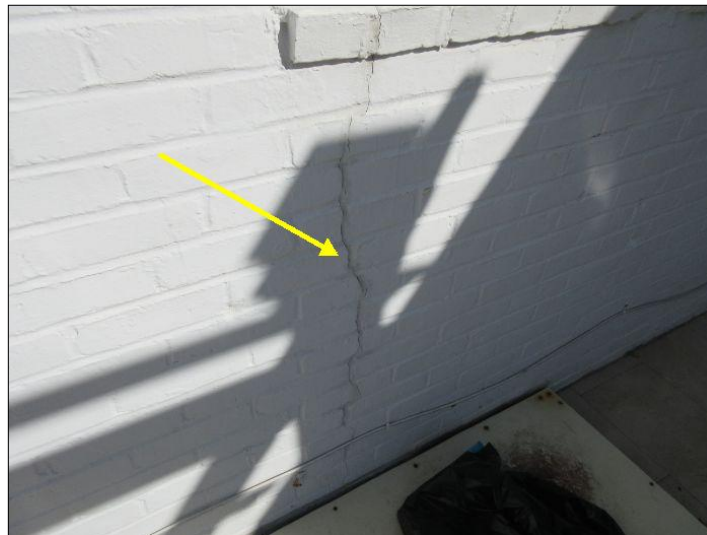
Cracking noted - Likey caused by deteriorated sill plates at rear of home

WDO evidence noted at sill plates

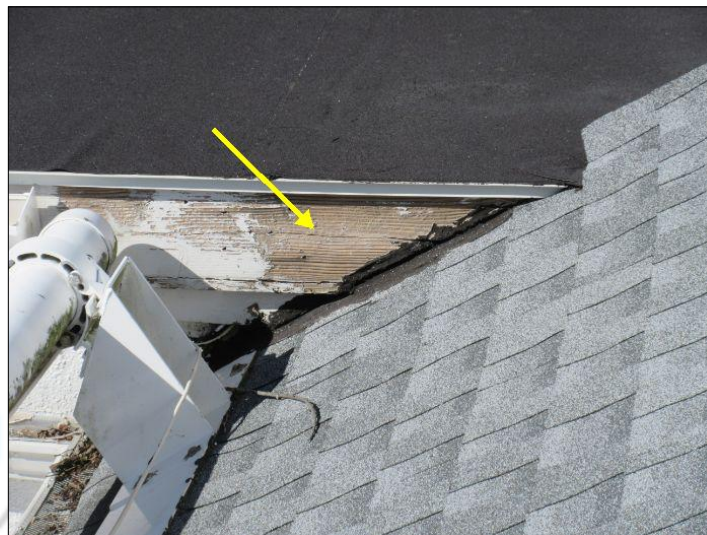
Weathered wood noted. Recommend correction as needed (Rear)

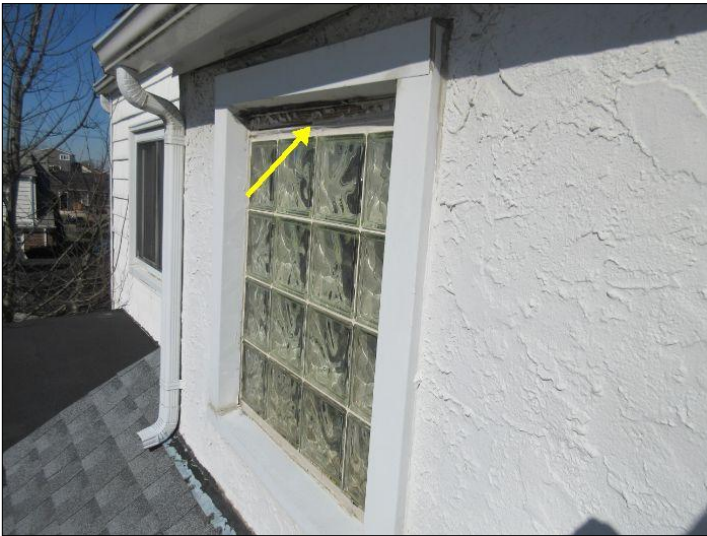
- Components appeared in satisfactory condition at time of inspection.
- Exposed wood surfaces observed. **Wood rot** & deterioration can occur. Prep, prime and paint wood trim surface where paint is peeling or missing.

Exposed wood surfaces observed. Recommend enclosing as needed.

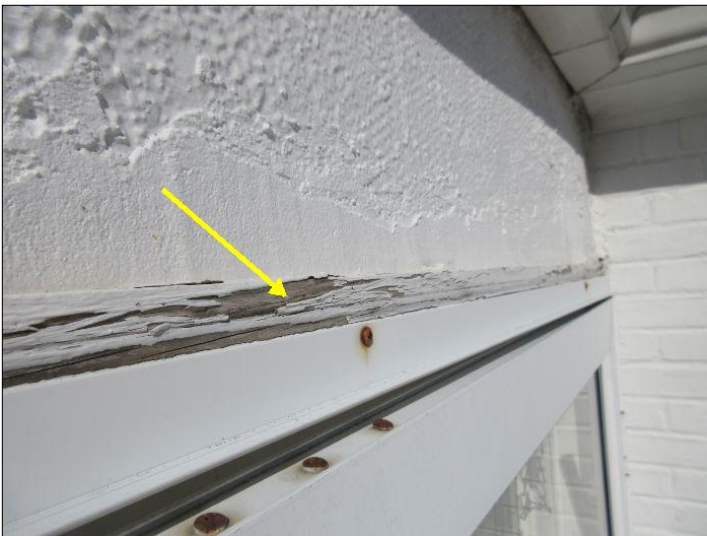
Deteriorated materials noted (Rear door)

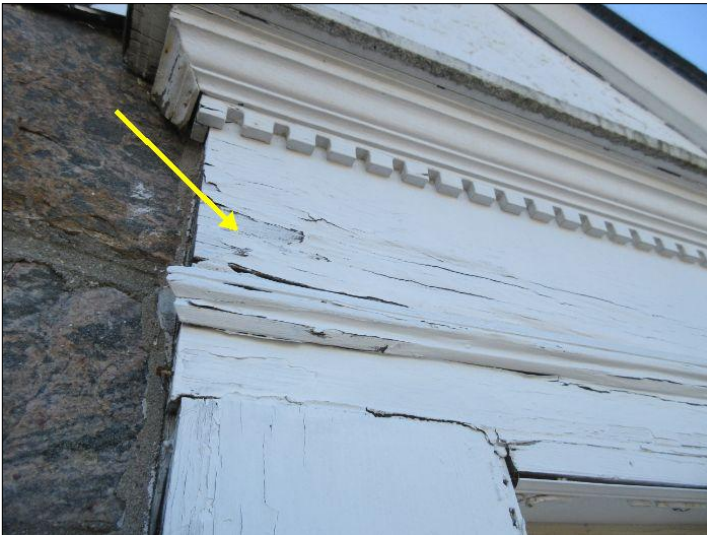
Deteriorated materials noted (Front door)

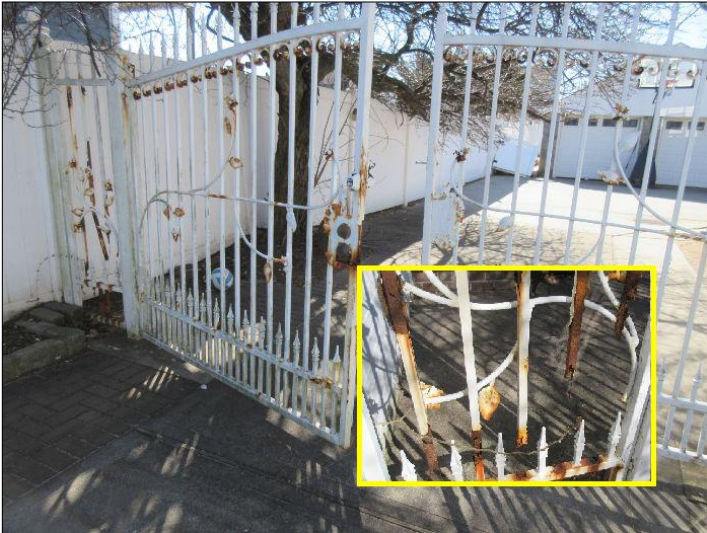
Driveway gate showing signs of deterioration.
Recommend budgeting for replacement.

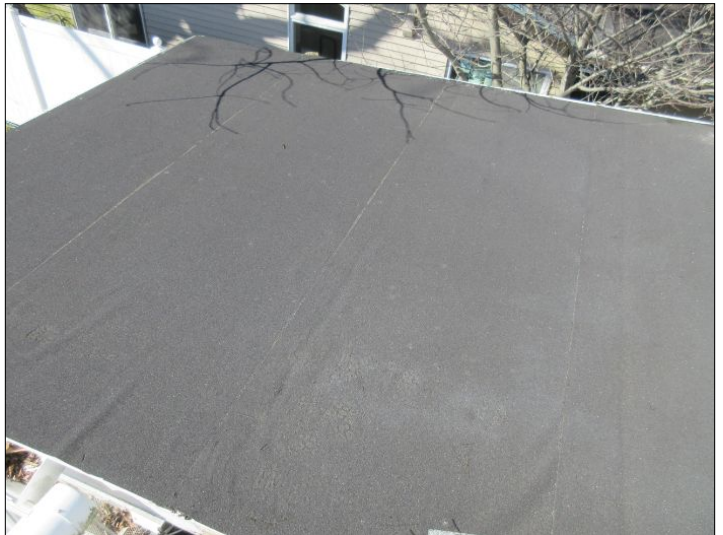
Roof appeared serviceable condition at time of inspection

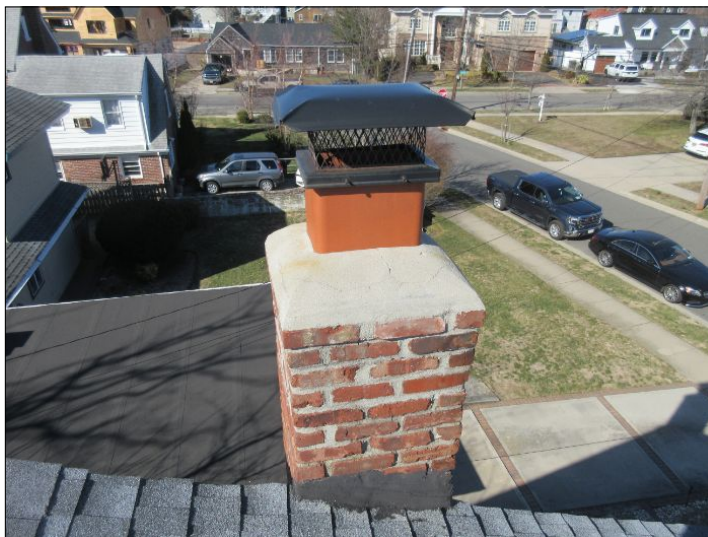
Appeared functional at time of inspection (Bedroom Fireplace)

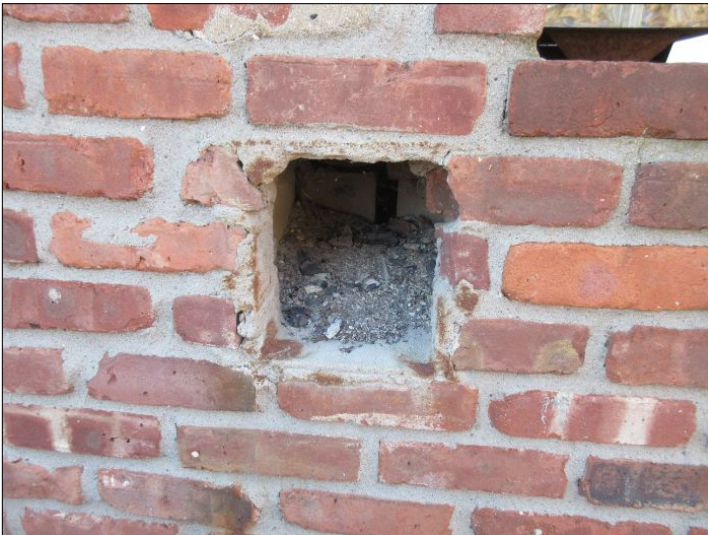
Cleanout cover missing (Right side)

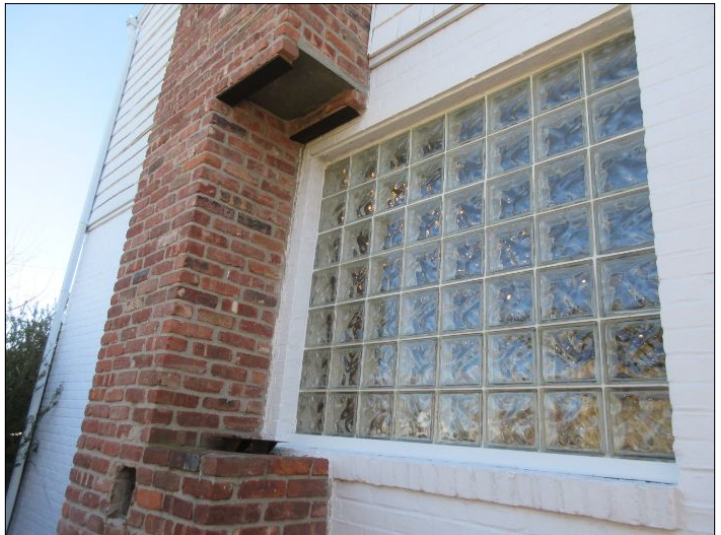
Appeared functional at time of inspection (Right side)

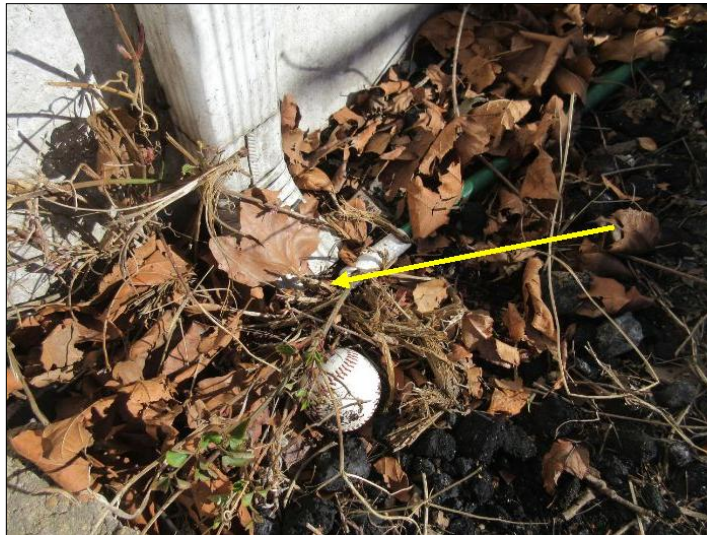
Discharge blocked. Clear as needed (Rear)

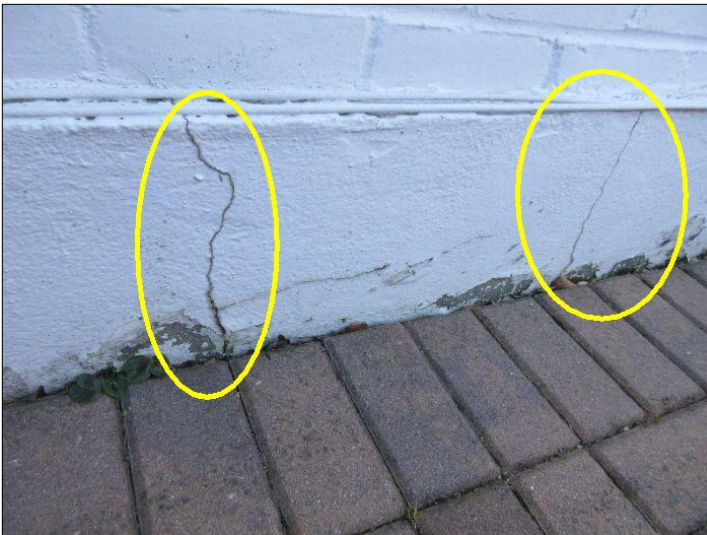
- Undermining noted at front left corner of the home's **foundation wall**.
- Numerous cracks noted at the foundation, both interior and exterior of the home. This is an indication that the structural integrity of the home has been compromised.
- Recommend consulting with a structural engineer for additional information and guidance.
- **WDO** evidence noted at sill plates

Minor cracking noted (Right side)

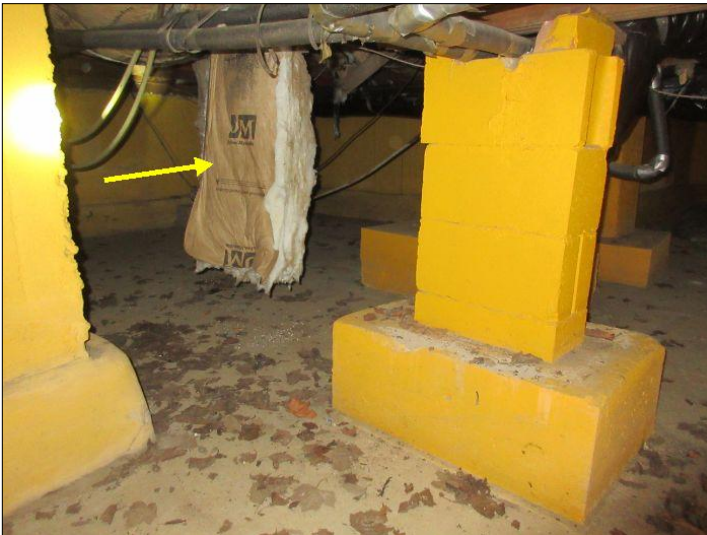
Insulation loose in area(s)

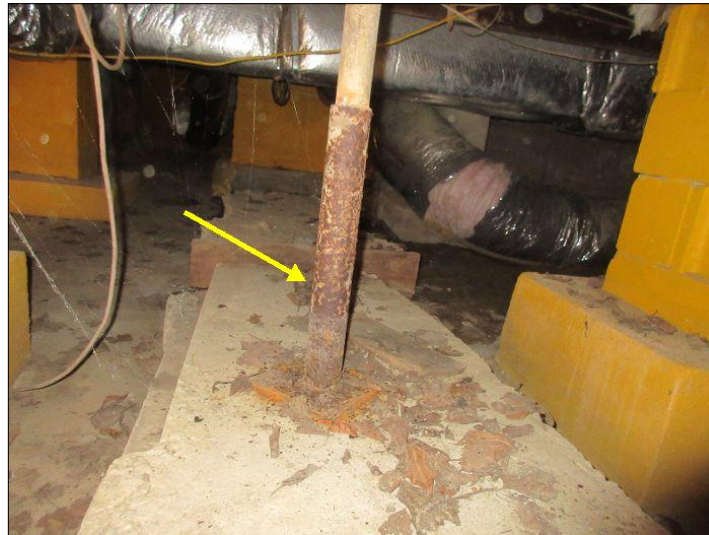
- Mid-span girder appears to be undersized
- Mid-span girder appears to be "rolling" towards the rear of the home. Recommend consultation with a structural engineer for further information and guidance.

Temporary support column noted

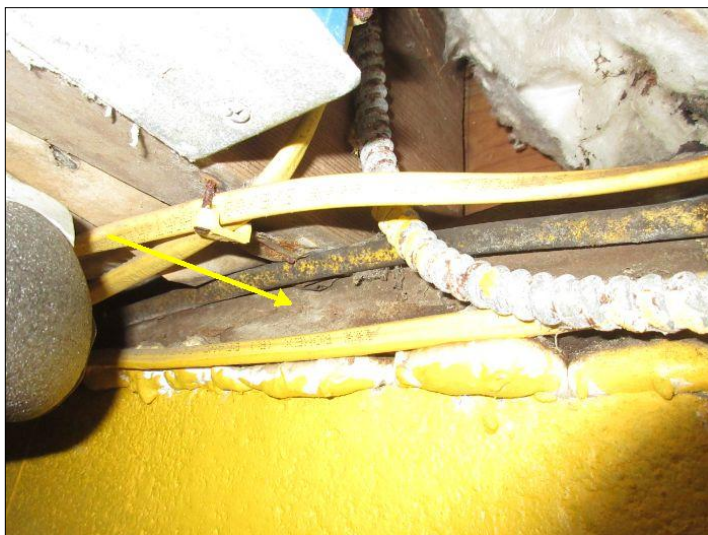
- Approximately 20' of sill plate at the rear foundation wall has been deteriorated and has failed. Structural repairs are required. Consult with licensed contractor for guidance.
- Previous repairs to floor joists noted
- Damaged sill plates has resulted in the "sinking" of the rear wall of the home, causing the 1st and 2nd floors to sag (leaning towards the rear)

Damaged sill plate

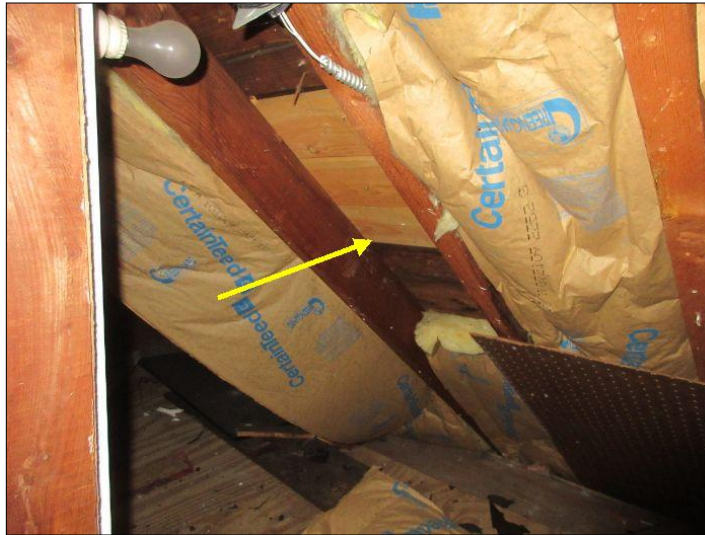
Loose insulation noted in attic area

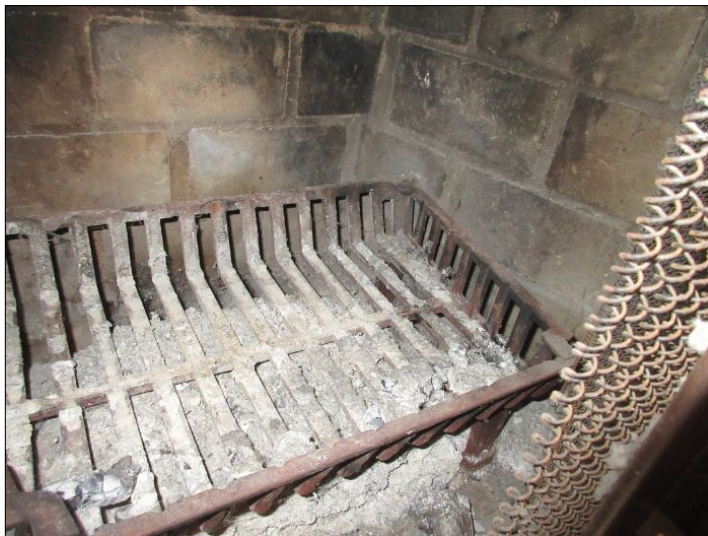
Recommend cleaning (Master Bedroom)

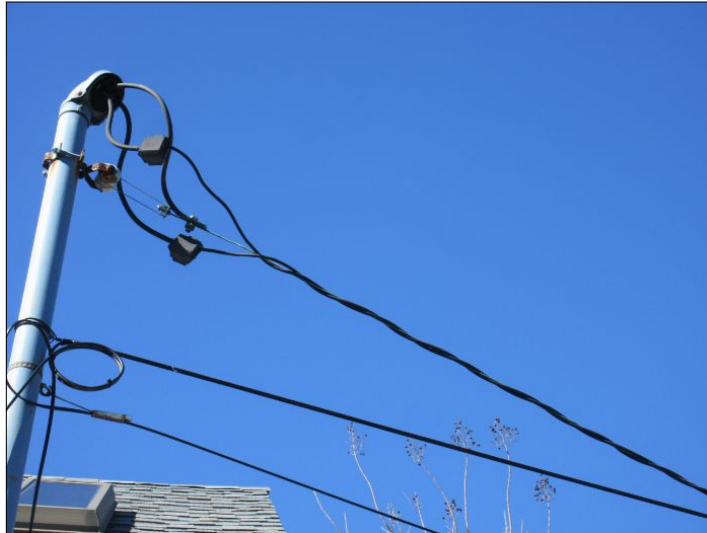
Electrical service mast

- The exterior meter is rusted. Have a qualified professional evaluate.

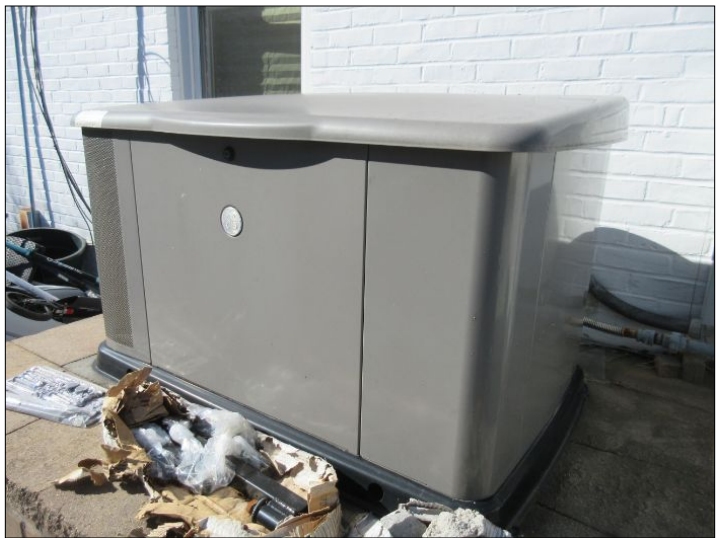
Backup generator - Locked, unable to test

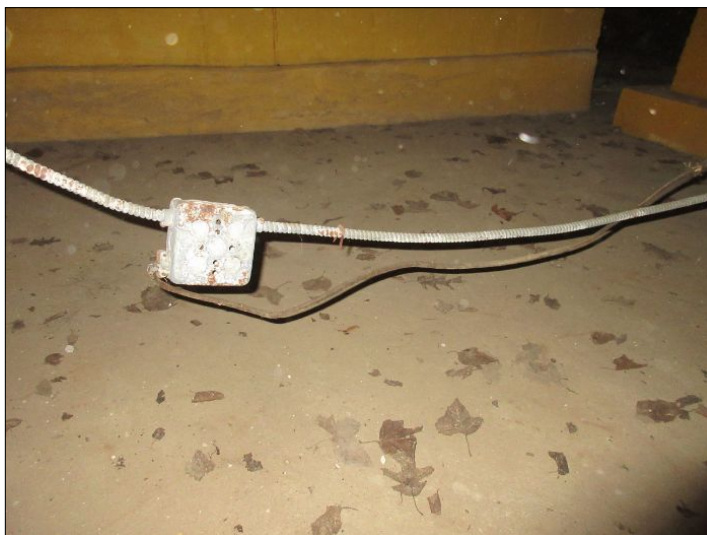
Recommend securing wires as needed
(Crawlspace)

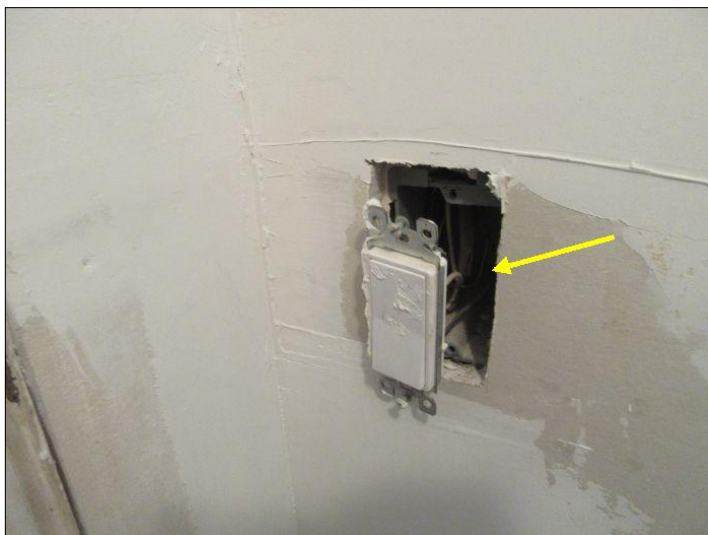
Loose switch noted, recommend correction as needed by licensed electrician (2nd fl closet)

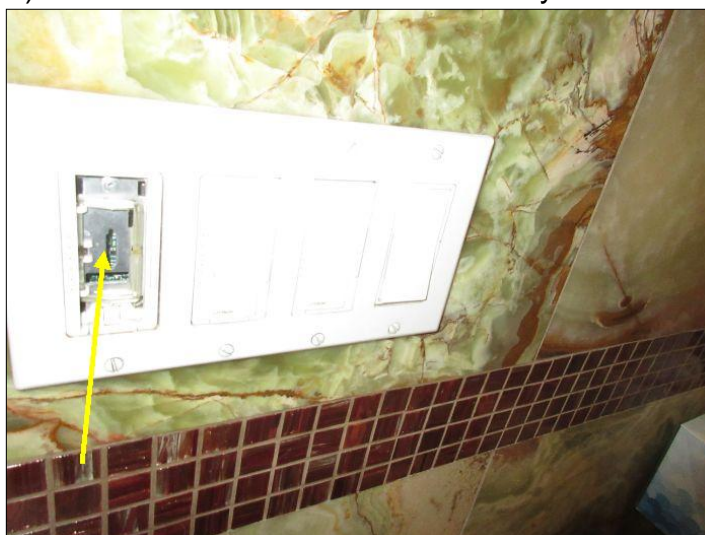
Damaged switch noted. Replace as needed (Bathroom #1)

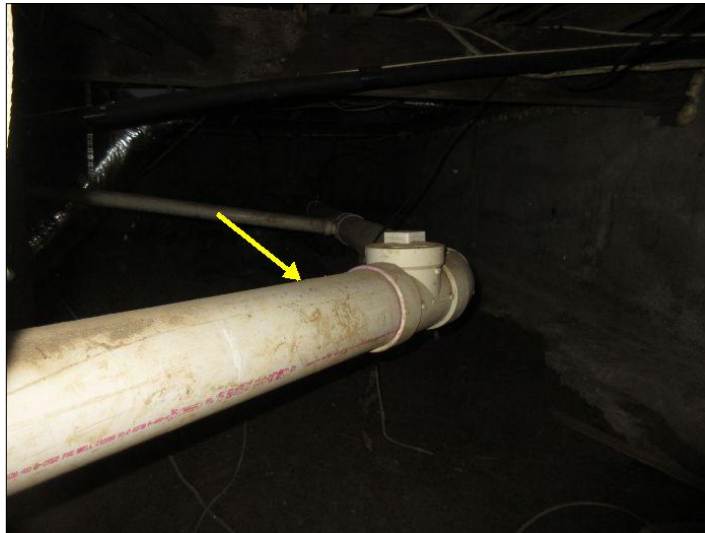
Recommend additional supports as needed

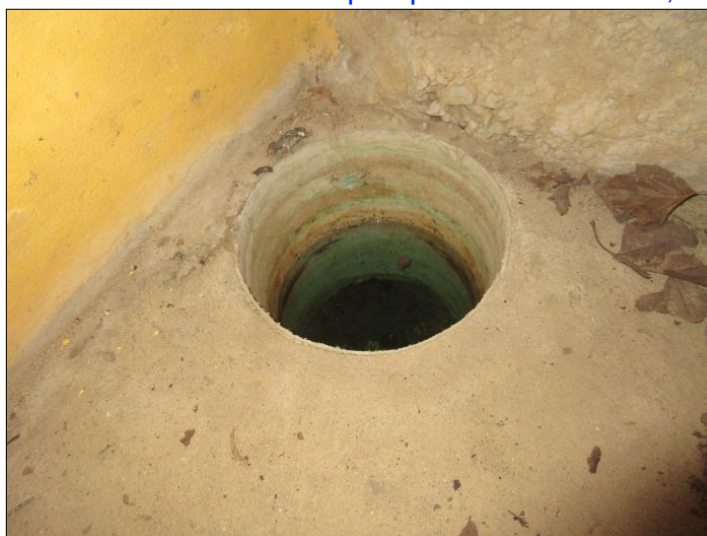
Catch basin noted. Recommend installation of pump to remove water, as needed.

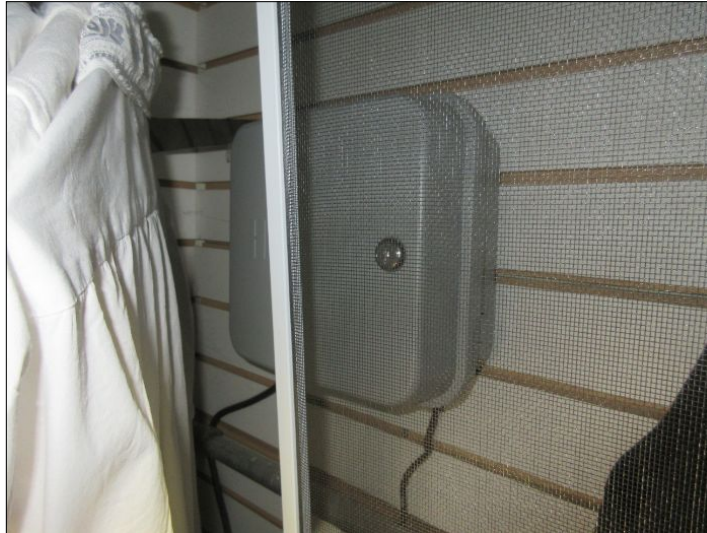
- Sprinkler System **backflow preventer** PRESENT. Sprinkler systems are beyond the scope the house inspection. Recommend qualified contractor to inspect sprinkler system.
- Not tested.

Sprinkler system timer (Utility Room)

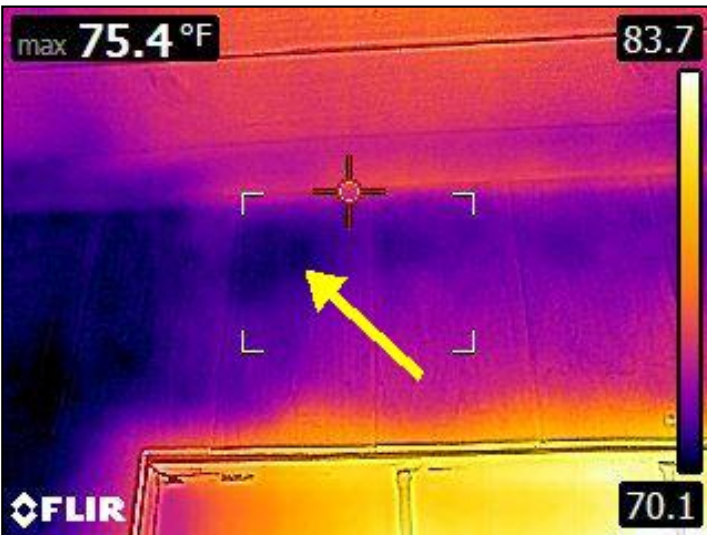
Indications of water penetration in cedar closet (Thermal View)

- Water damage noted in cedar closet. Recommend consultation with roofing professional for additional evaluation.

Higher moisture content verified w/ moisture meter

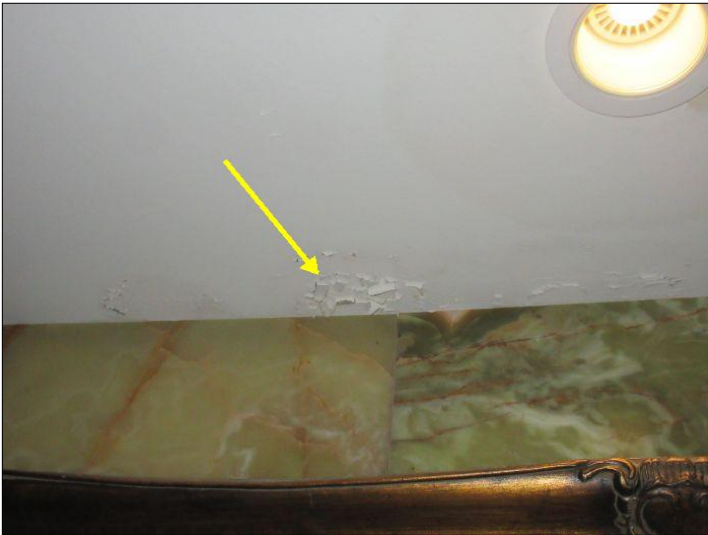
Evidence of active leak noted, likely from missing step flashing (Bathroom #1)

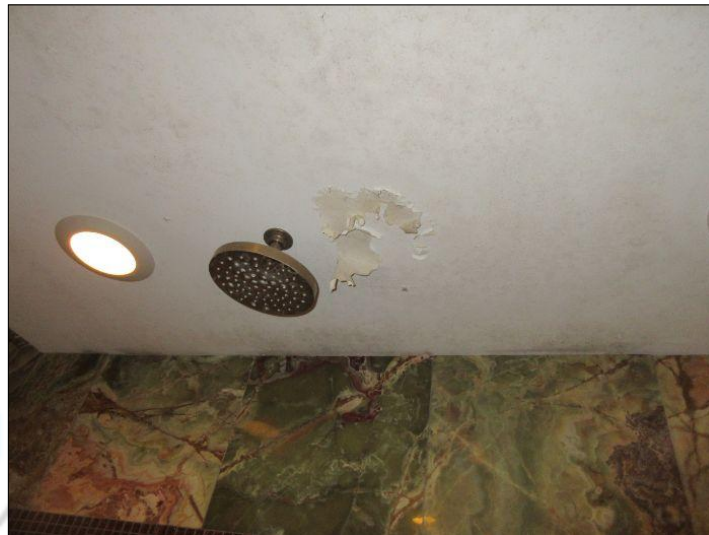
Mold-like bio growth observed. Professional testing & evaluation advised (Bathroom #1)

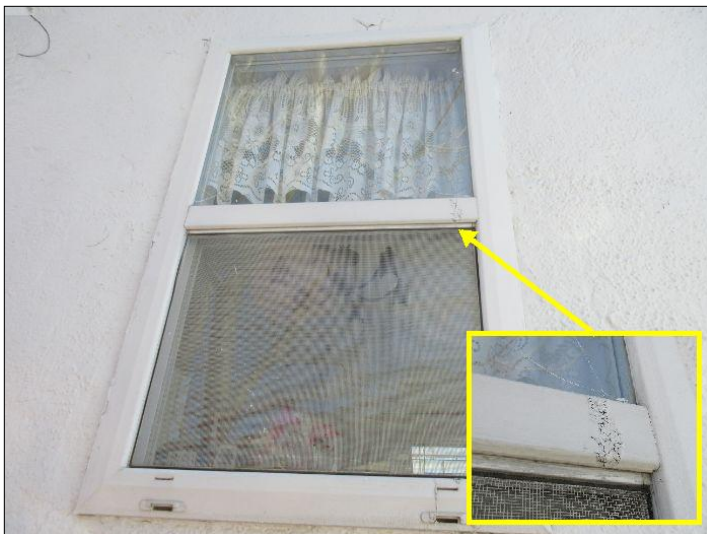
Deteriorated exterior finish noted (Right side)

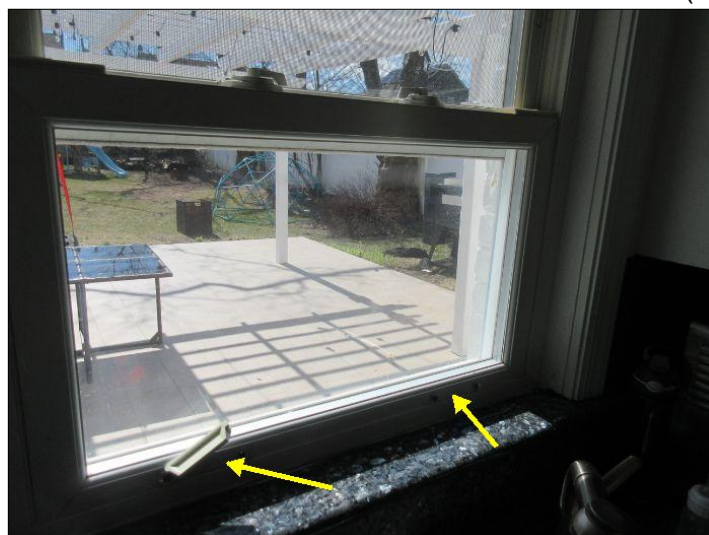
Damaged hardware noted (Kitchen)

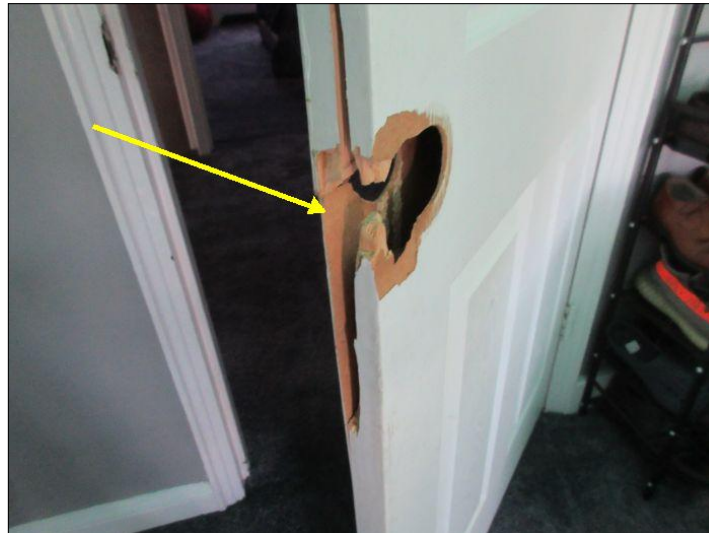
Damaged door, replacement required (Bedroom #3)

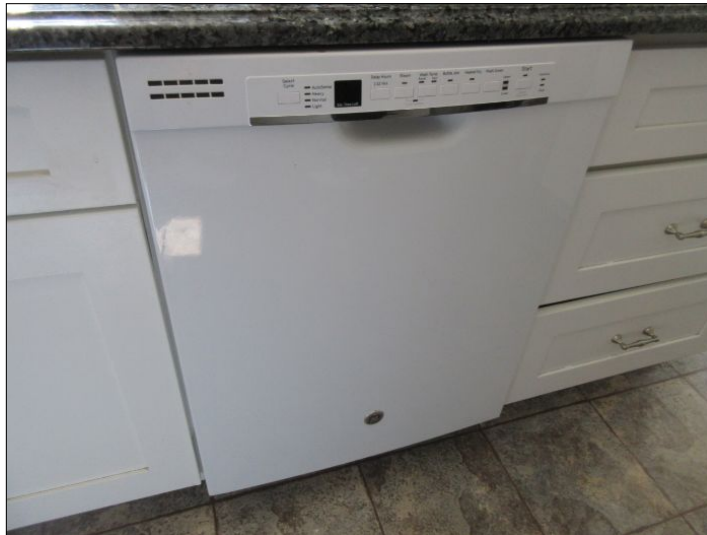
Not Inspected - Personal items in machine.

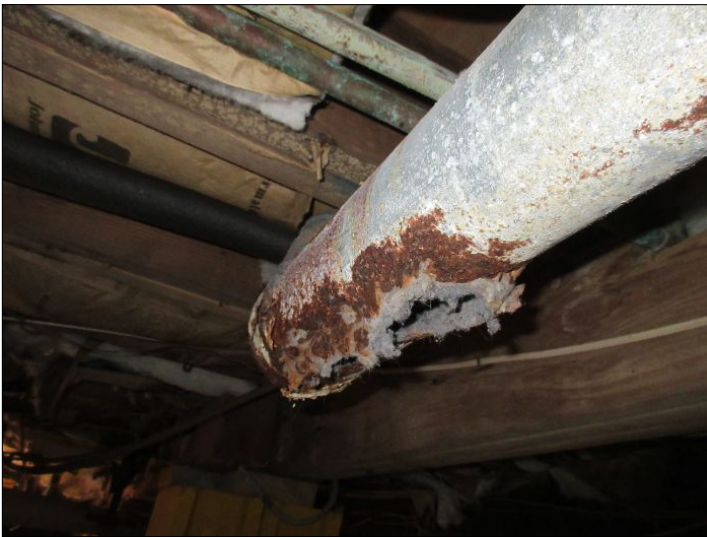
- **MAINTENANCE:** Clean the lint screen/filter before or after drying each load of clothes. Annual/periodic cleaning of dryer vent duct recommended, as fire safety.
- The dryer vent duct has failed and the dryer exhaust vents into the crawlspace. Recommend repairs to prevent additional moisture from entering the crawlspace as well as any CO generated by the dryer unit.
- **Prevent Carbon Monoxide Poisoning:** Many dryers emit carbon monoxide. With a normally functioning dryer vent, the carbon monoxide is vented outdoors. However, venting inside the building, carbon monoxide is very dangerous and can result in illness and death.

The dryer vent duct has failed and the dryer exhaust vents into the crawlspace

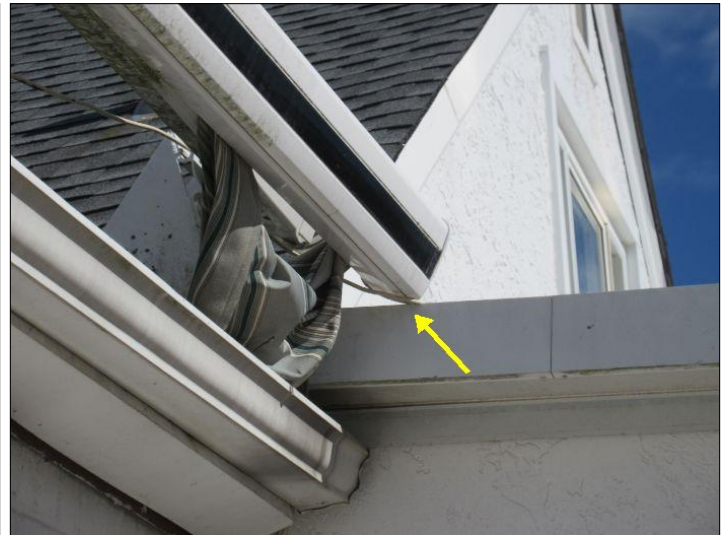
Rear awning rubs against roof. Does not operate correctly.

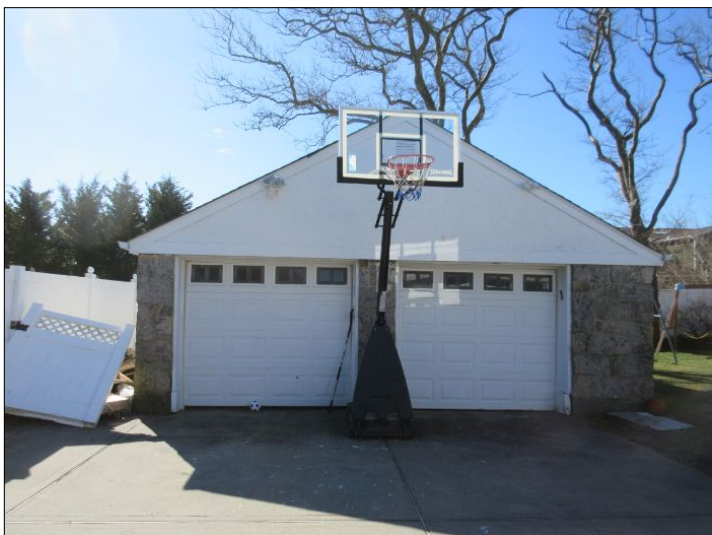
Not tested due to stored items behind doors

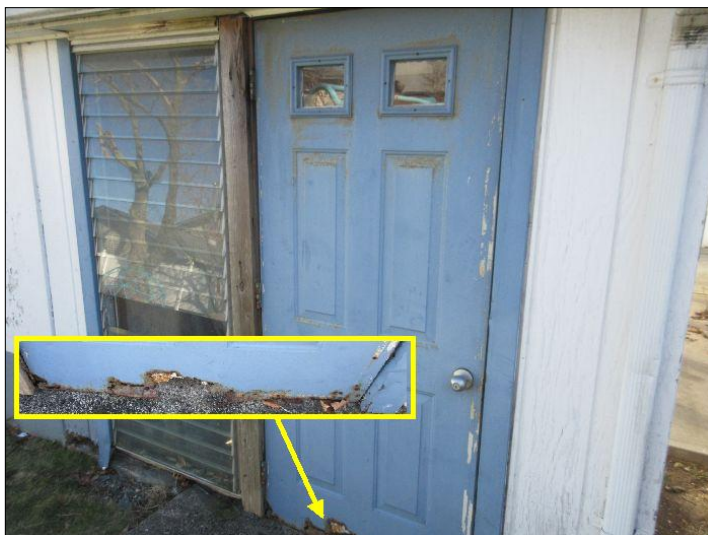
Side door deteriorated - Requires replacement

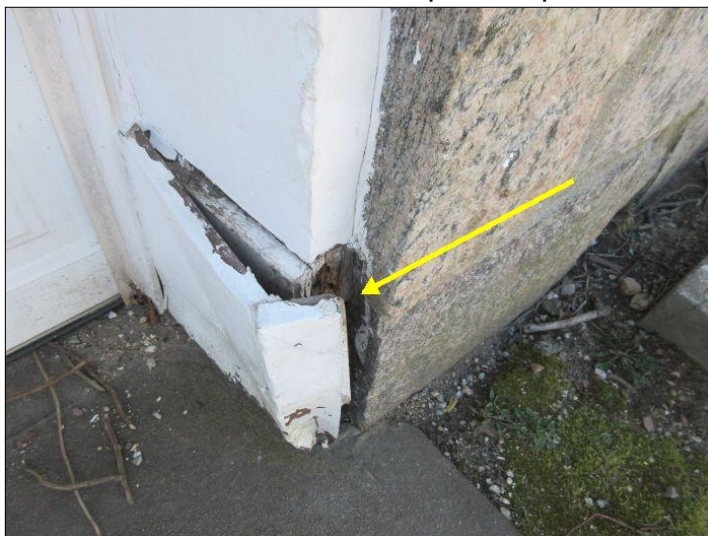
Deteriorated trim noted

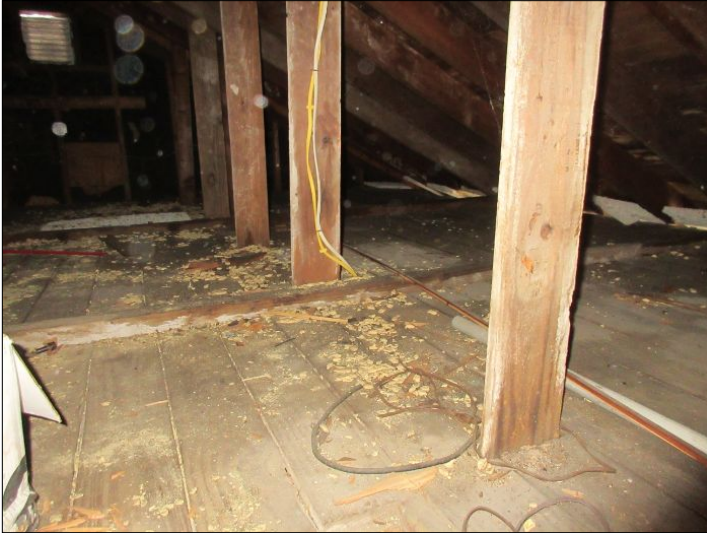
Front area - Viewed from access hole. Visible areas appeared satisfactory. Evidence of previous pest intrusion. Recommend garage is sealed to prevent further pest intrusion.

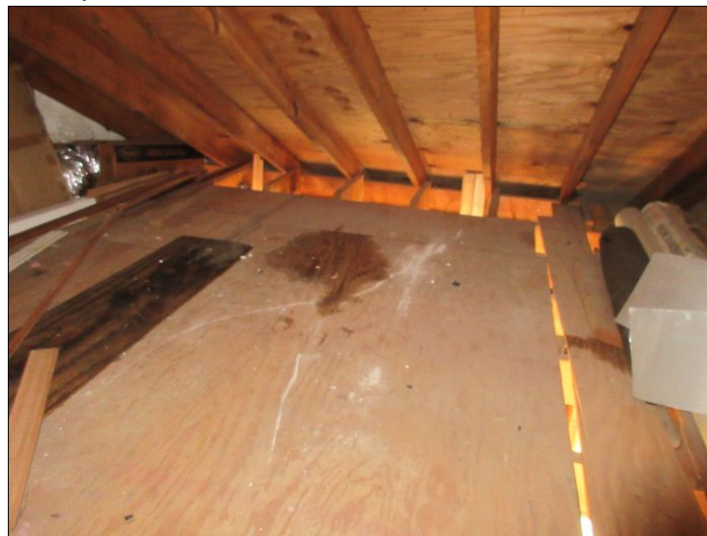
Rear area - Satisfactory

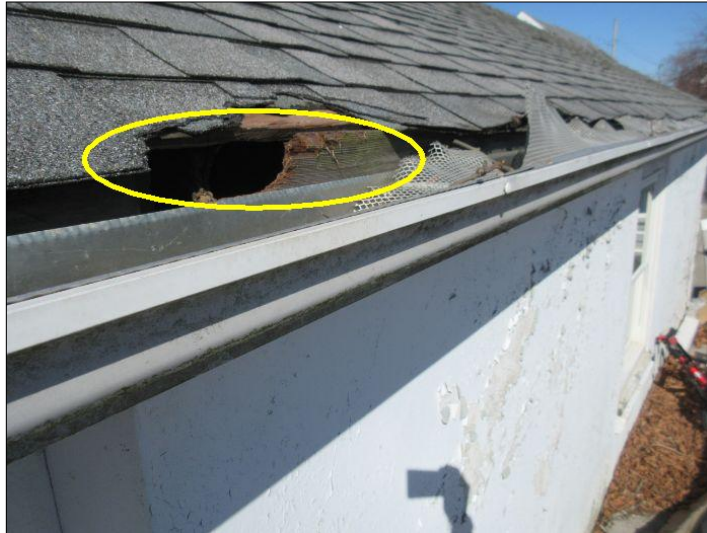
Damaged area(s) noted - Likely area of pest entrance

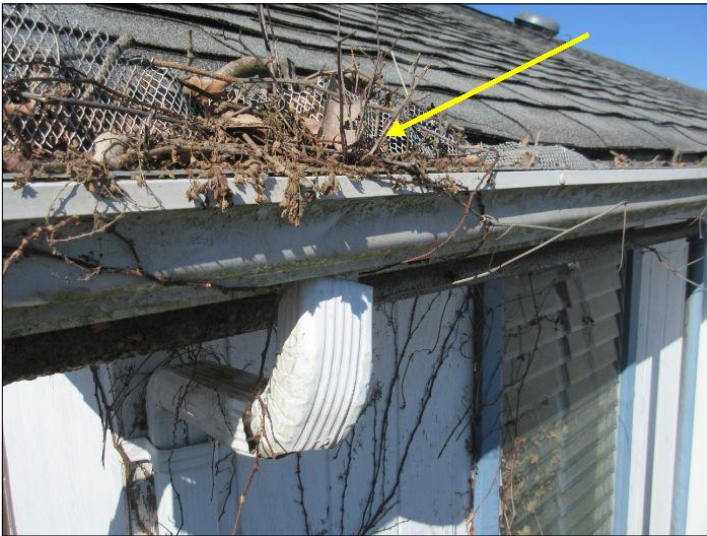
Areas of gutters clogged

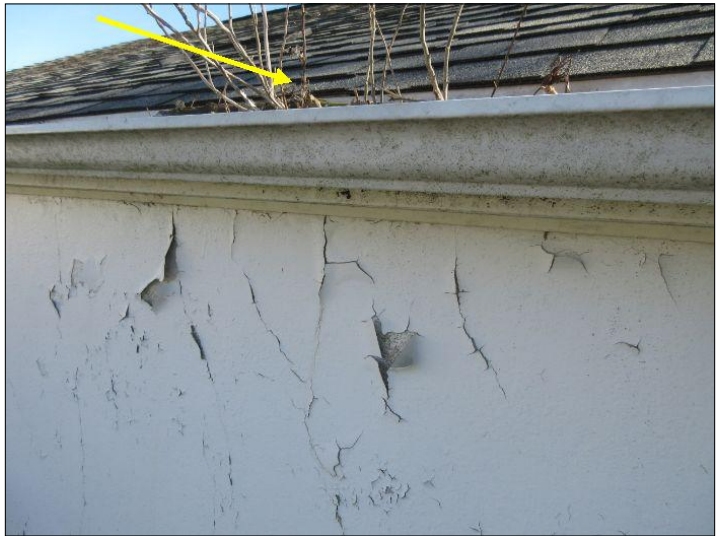
Areas of gutters clogged

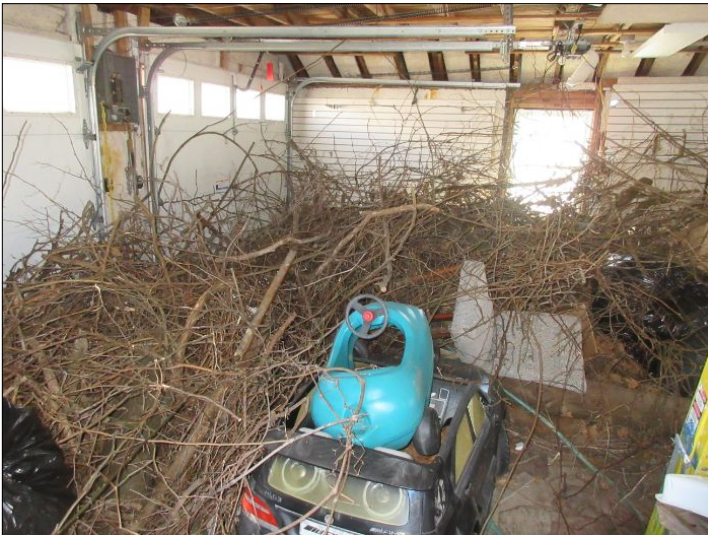
Unable to view / access interior of garage due to stored debris

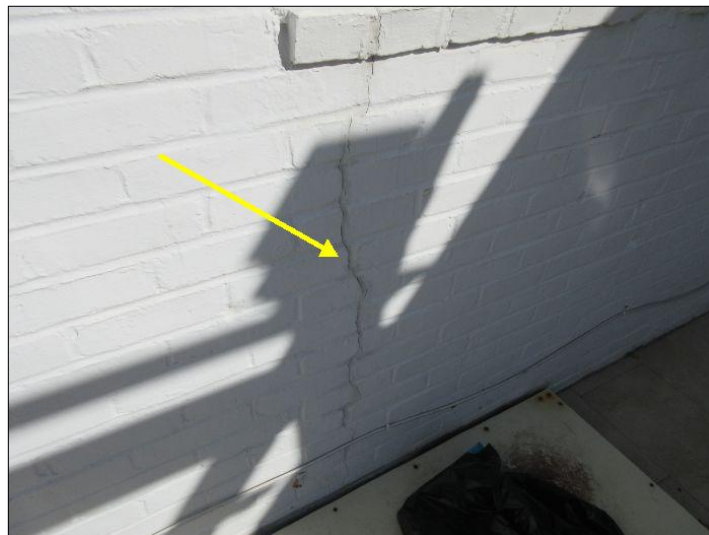
Cracking noted - Likey caused by deteriorated sill plates at rear of home

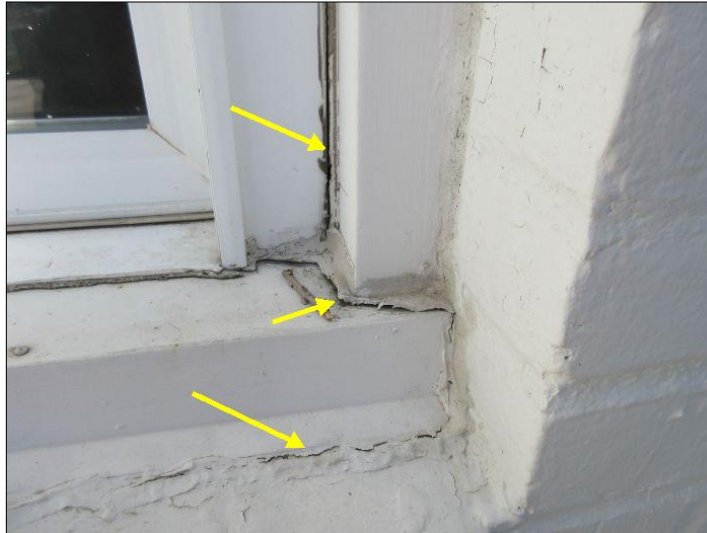
Page 11 Item: 8 Door/Window Frames, Trim

Gaps noted at rear window trim - Additional results from rear sill plate deterioration

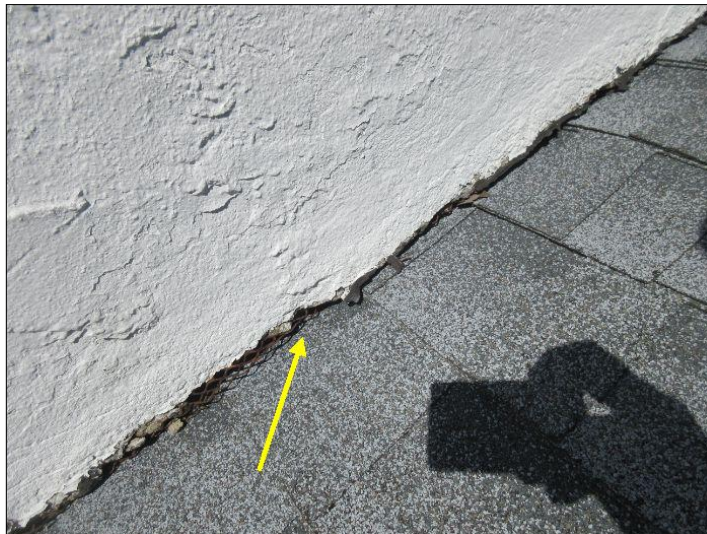
Page 16 Item: 4 Flashings

• Evidence of active leak noted. Recommend evaluation and correction by licensed roofing contractor **See **Flashing****

Recommend installing of step flashing to prevent water penetration

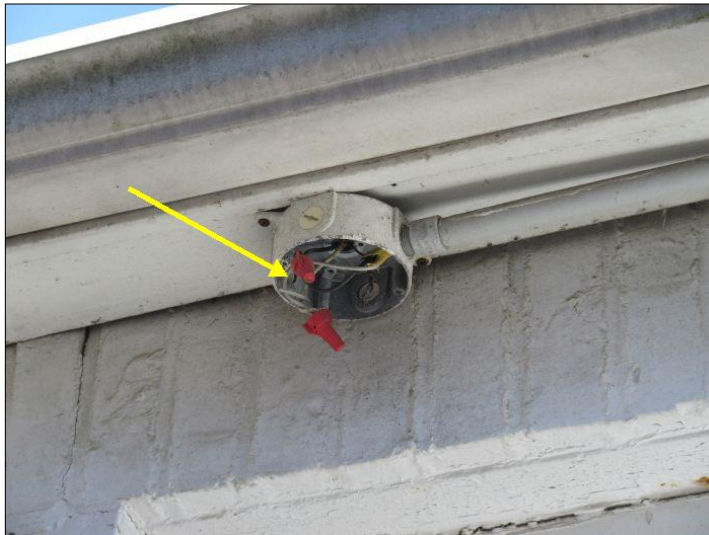
Light fixture missing. Exposed wires noted. (Left side)

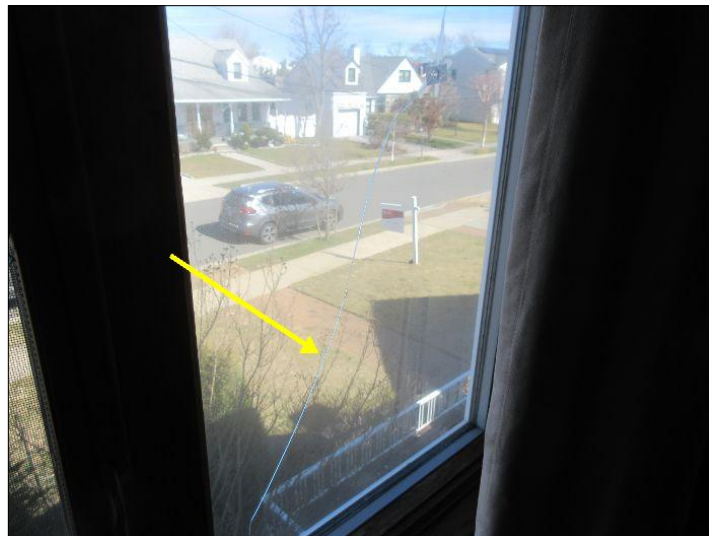
Page 53 Item: 3	Floor Finishes	<ul style="list-style-type: none"> • Uneven and sagging areas noted. Refer to "Structural Components" for additional information
Page 53 Item: 4	Windows	<ul style="list-style-type: none"> • SAFETY: Cracked or broken window glass was noted. Recommend repair or replacement of the damaged glass.

Broken glass (Master Bedroom)

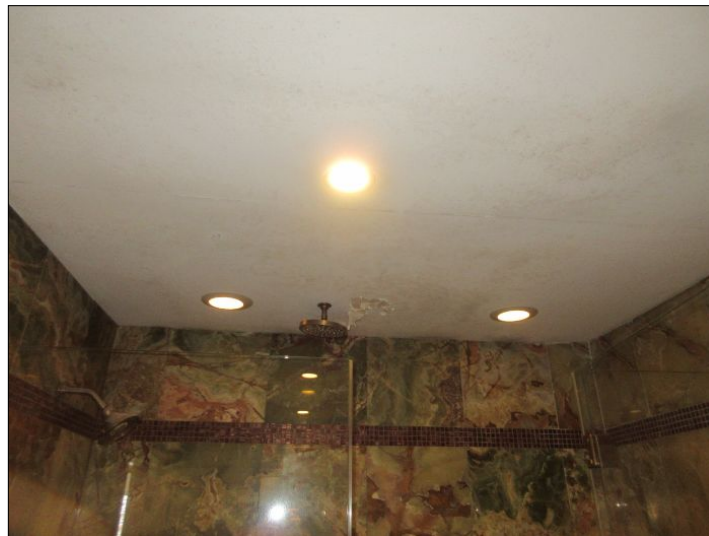
Mold like bio growth stains observed. Professional testing and evaluation is advised. Repair as needed.

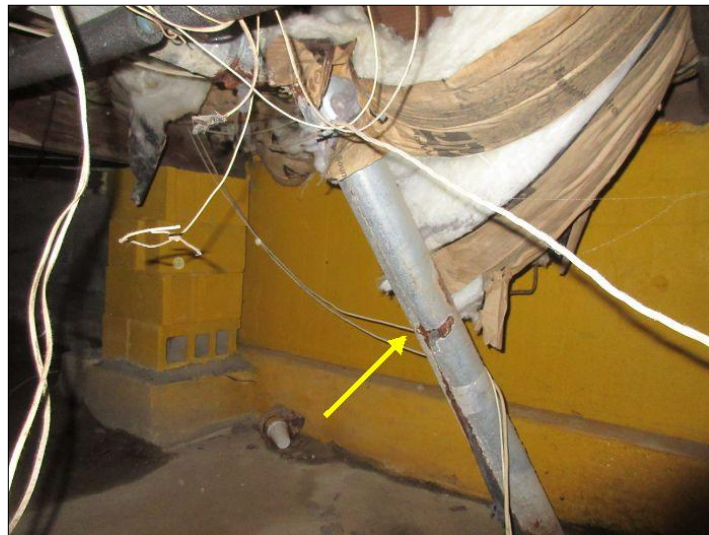
Page 69 Item: 3	Dryer Vent	<ul style="list-style-type: none"> • The dryer vent duct has failed and the dryer exhaust vents into the crawlspace. Recommend repairs to prevent additional moisture from entering the crawlspace as well as any CO generated by the dryer unit. • Prevent Carbon Monoxide Poisoning: Many dryers emit carbon monoxide. With a normally functioning dryer vent, the carbon monoxide is vented outdoors. However, venting inside the building, carbon monoxide is very dangerous and can result in illness and death.
-----------------	------------	--

Dryer vent has failed and collapsed
