PROPERTY INSPECTION REPORT

456 Sample St, Anytown, NY 12345

DATE OF INSPECTION: 8/11/2022

SQUARED AWAY
HOME INSPECTIONS

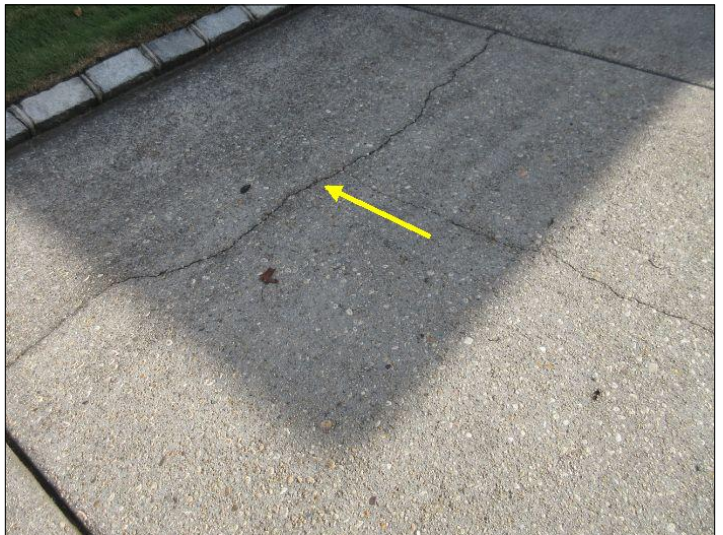
Common cracking noted

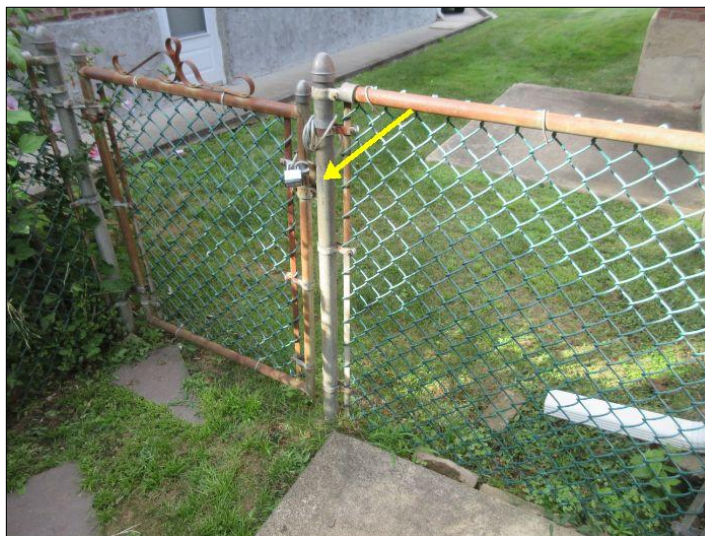
Gate requires adjustment

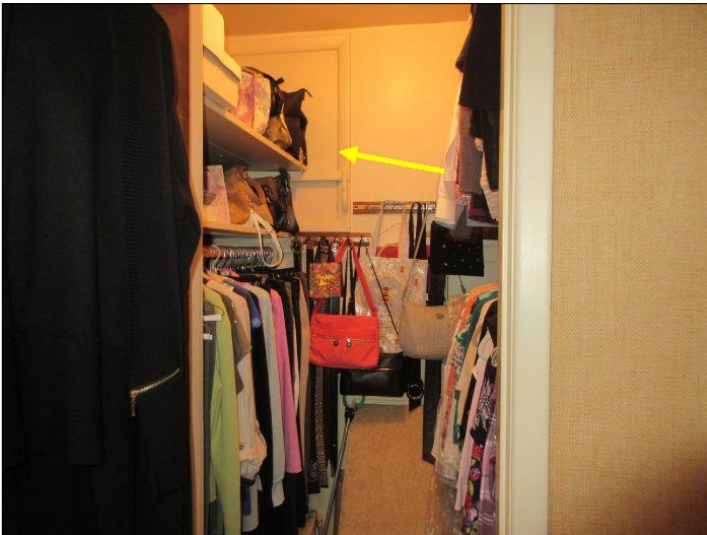
- NOT INSPECTED
- Both attic access points were blocked by personal belongings.

Access in Master Bedroom closet restricted due to personal belongings

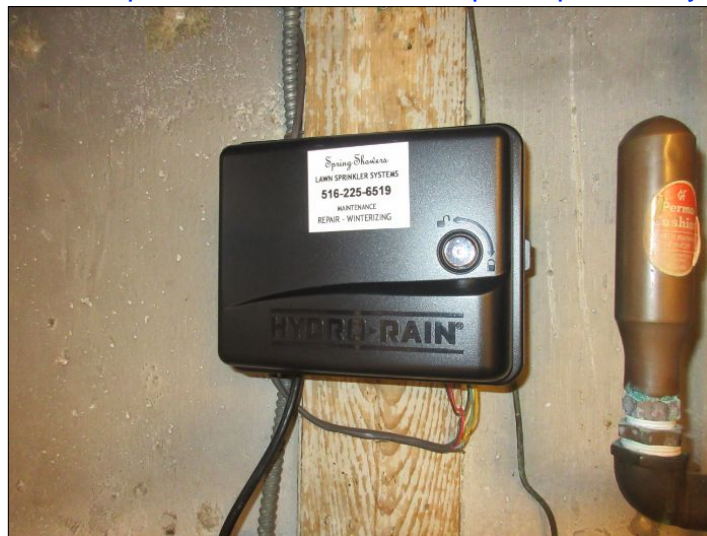
Sprinkler system timer

- Sprinkler System **backflow preventer** PRESENT. Sprinkler systems are beyond the scope the house inspection. Recommend qualified contractor to inspect sprinkler system.

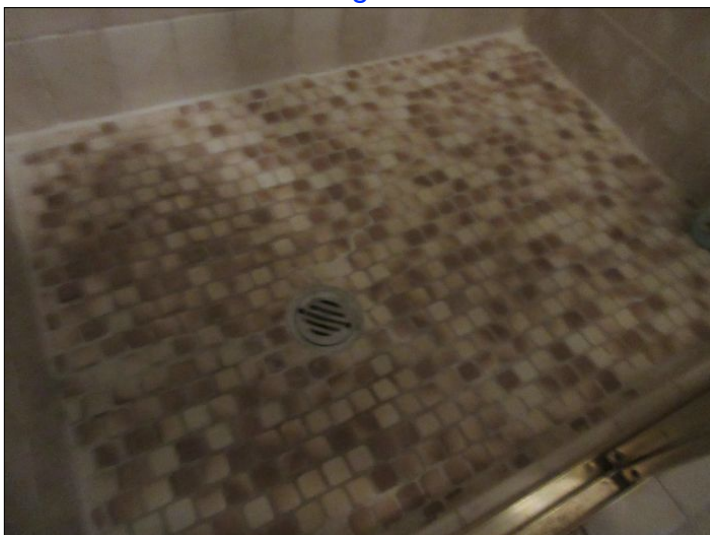
Appeared functional, at the time of inspection

- Appeared functional, at the time of inspection - except where noted.
- Recommend all tile edges at shower walls be caulked and sealed to prevent moisture penetration.

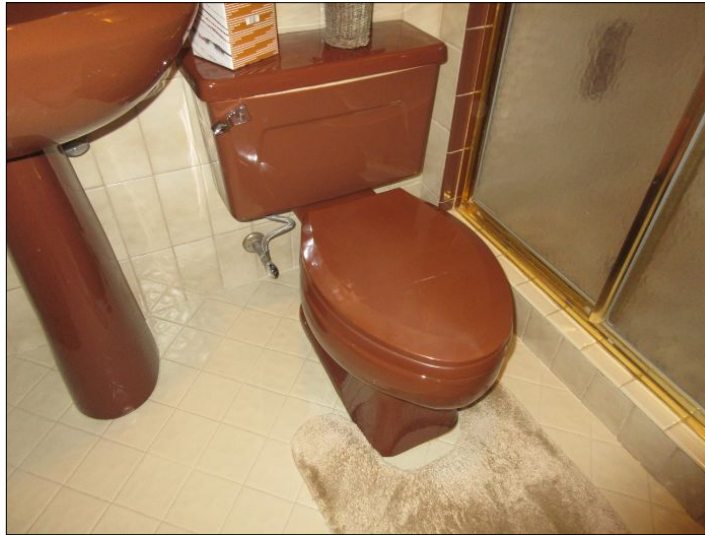
Operated when tested. No deficiencies noted.

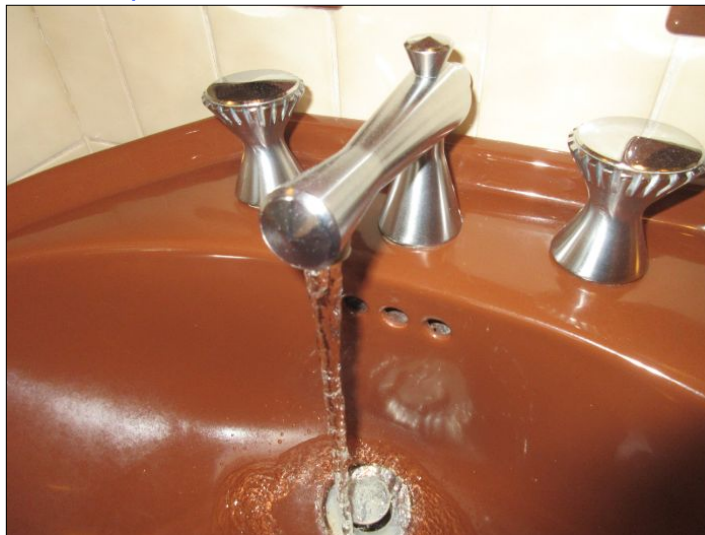
No deficiencies noted on the inspected faucets.

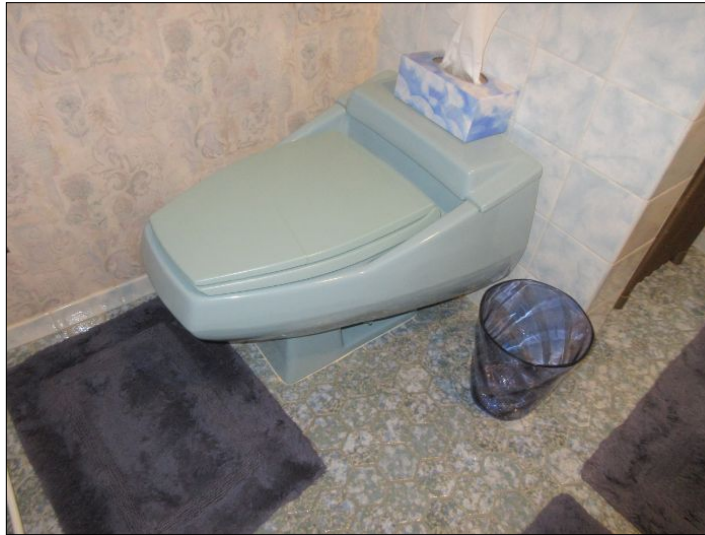
Operated when tested. No deficiencies noted.

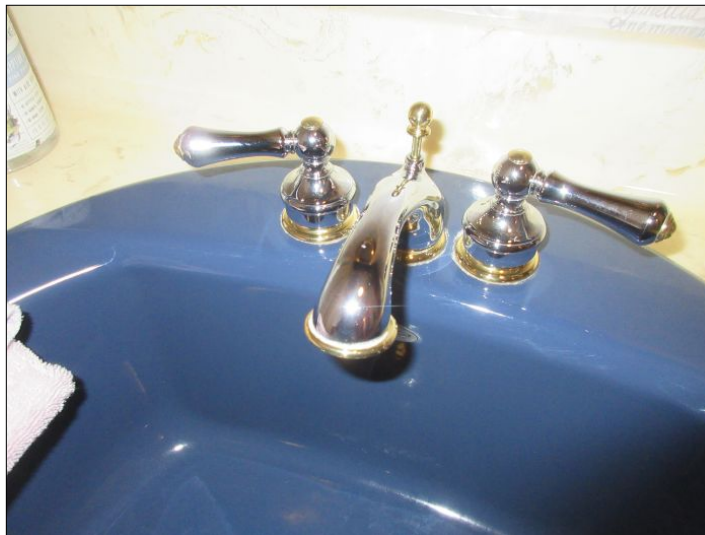
Left faucet - No deficiencies noted

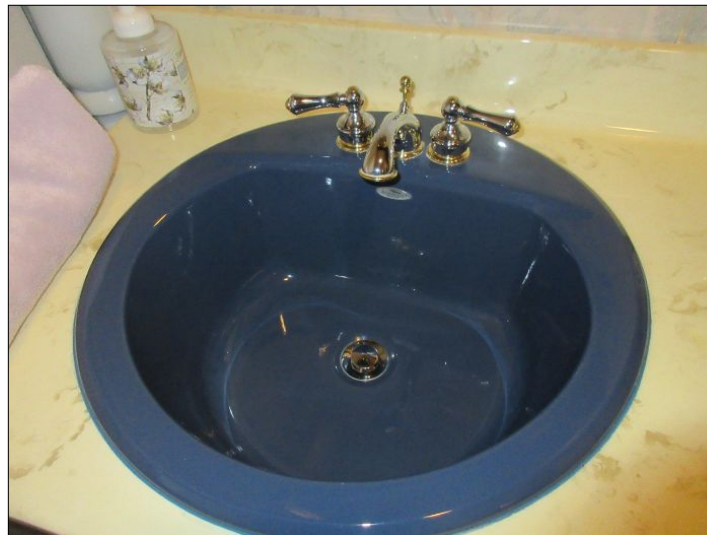
No deficiencies observed (Left sink)

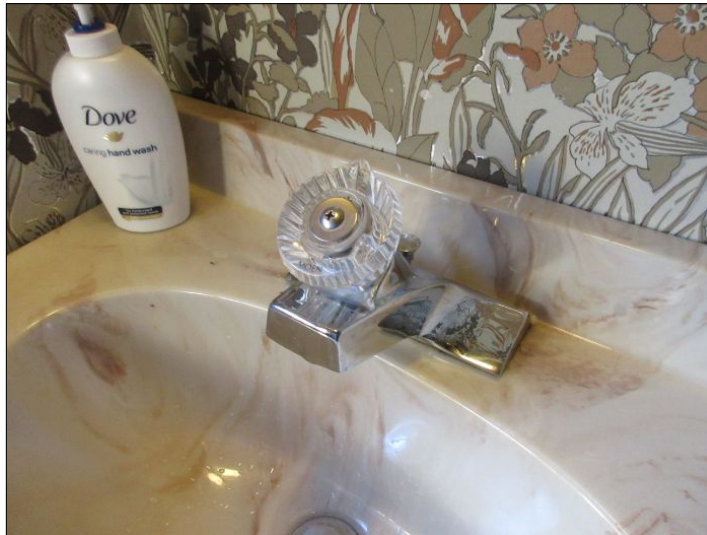
4. Faucets

No deficiencies noted on the inspected faucets.

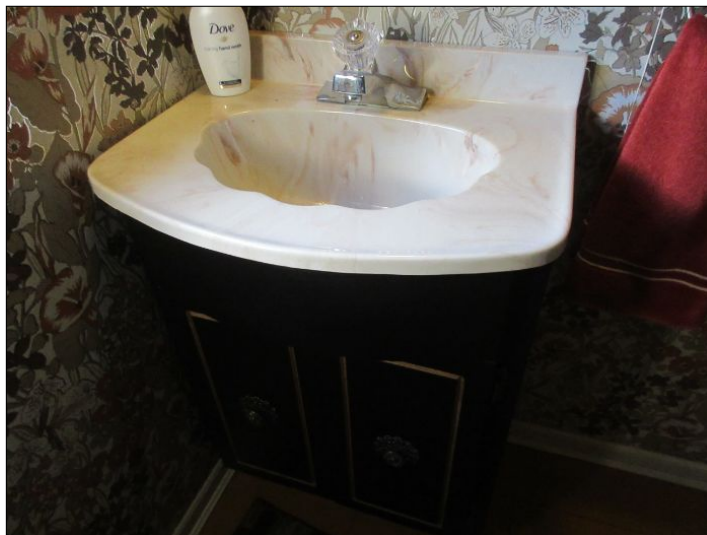
5. Sinks

No deficiencies observed.

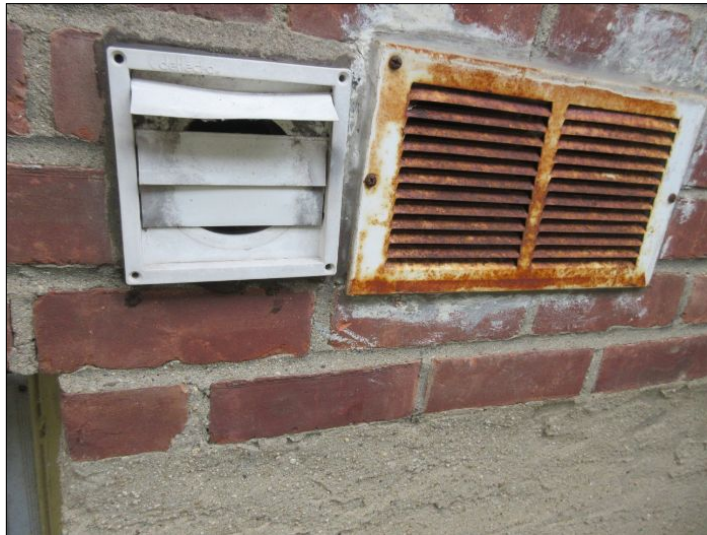
3. Dryer Vent

Properly vented to exterior
