PROPERTY INSPECTION REPORT

123 Main St, , NY 12345

DATE OF INSPECTION: 9/14/2023

Year Built: 1946

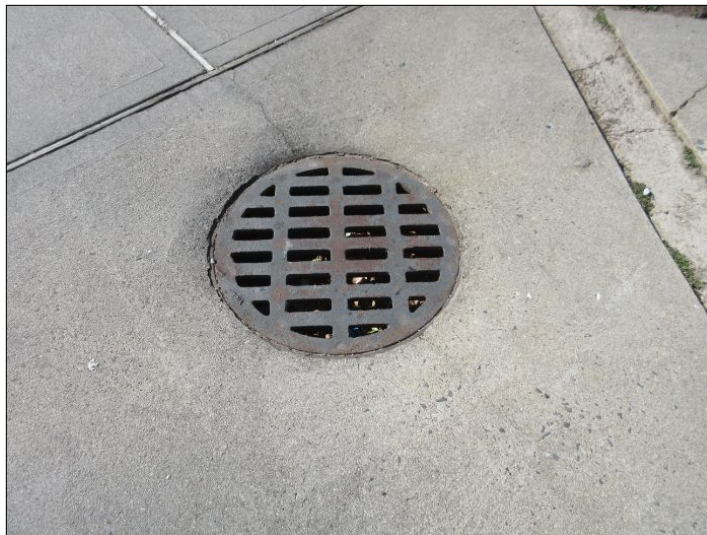
Ensure drywell is maintained clear of debris

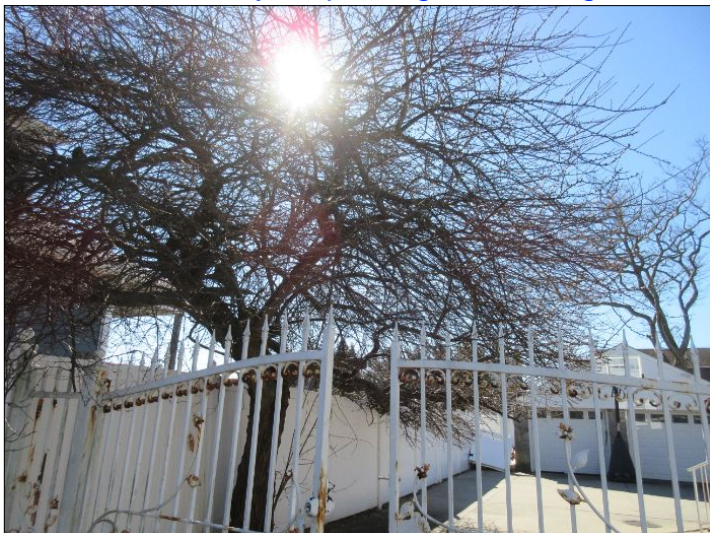
- Vegetation should not encourage water to flow towards the structure
- **MONITOR:** There are trees in close proximity to the front and/or rear of the home. Trees can potentially damage the home, clog drainage pipes and block gutters. Large trees should be reviewed annually for pruning, de-limbing, and/or removal.

Recommend trimming

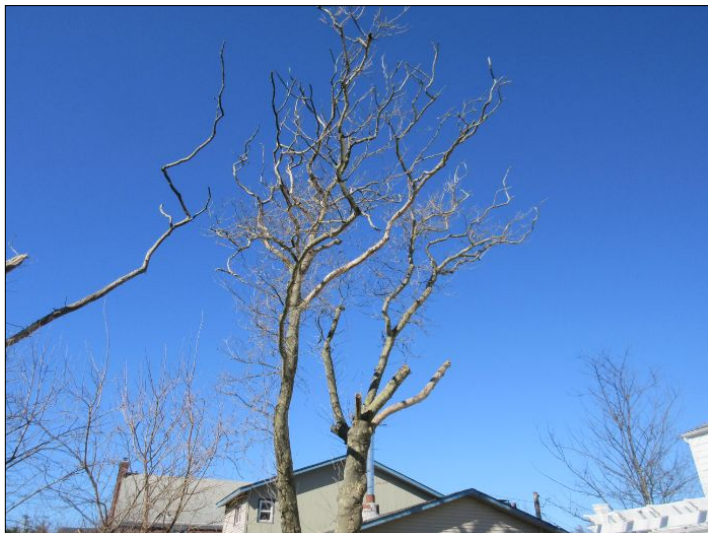
Recommend trimming

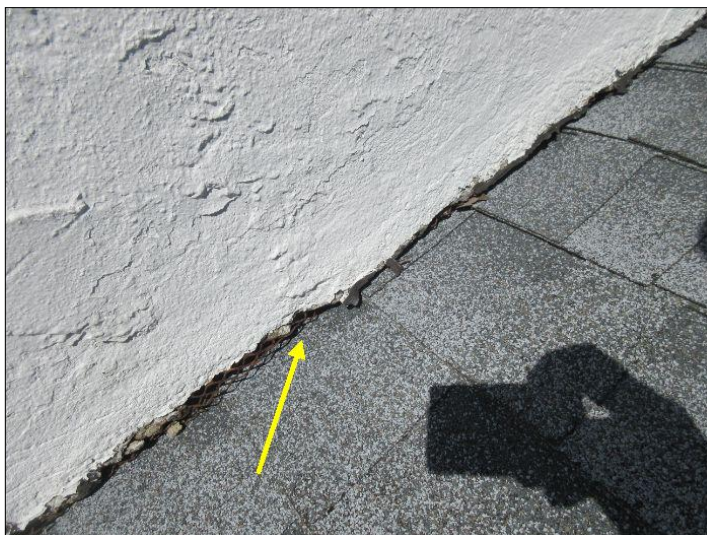
• Evidence of active leak noted. Recommend evaluation and correction by licensed roofing contractor **See **Flashing****

Recommend installing of step flashing to prevent water penetration

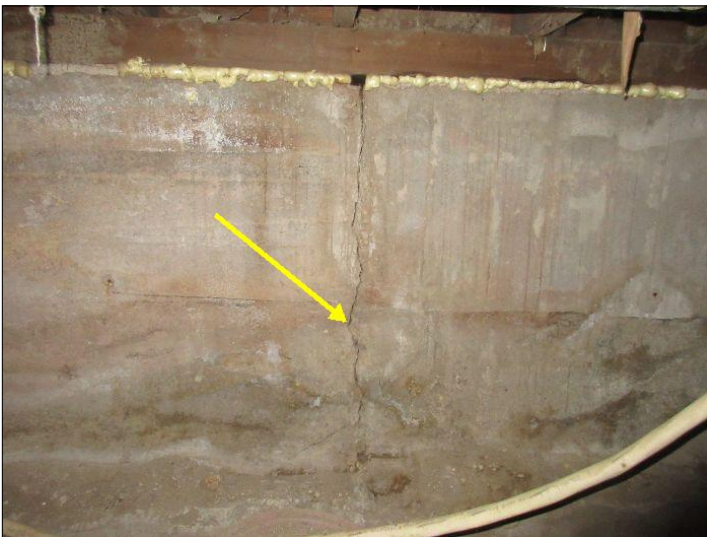
- Undermining noted at front left corner of the home's **foundation wall**.
- Numerous cracks noted at the foundation, both interior and exterior of the home. This is an indication that the structural integrity of the home has been compromised.
- Recommend consulting with a structural engineer for additional information and guidance.
- **WDO** evidence noted at sill plates

Crack at front wall extends to base of foundation

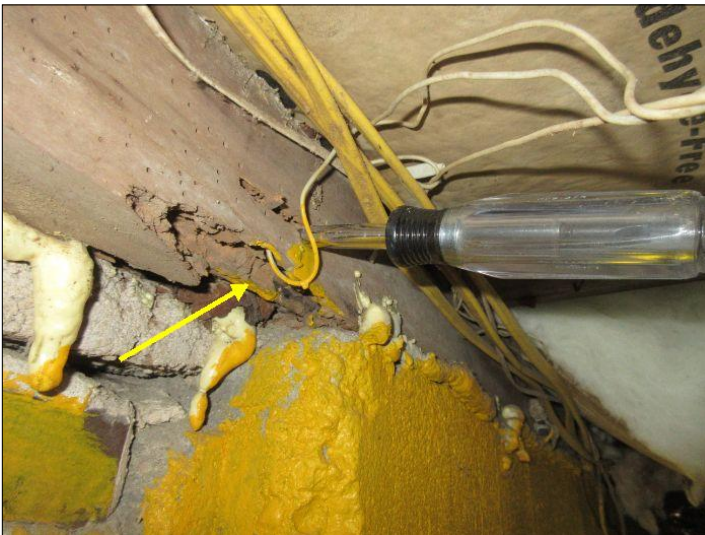
- Approximately 20' of sill plate at the rear foundation wall has been deteriorated and has failed. Structural repairs are required. Consult with licensed contractor for guidance.
- Previous repairs to floor joists noted
- Damaged sill plates has resulted in the "sinking" of the rear wall of the home, causing the 1st and 2nd floors to sag (leaning towards the rear)

WDO damaged sill plate (Rear wall)

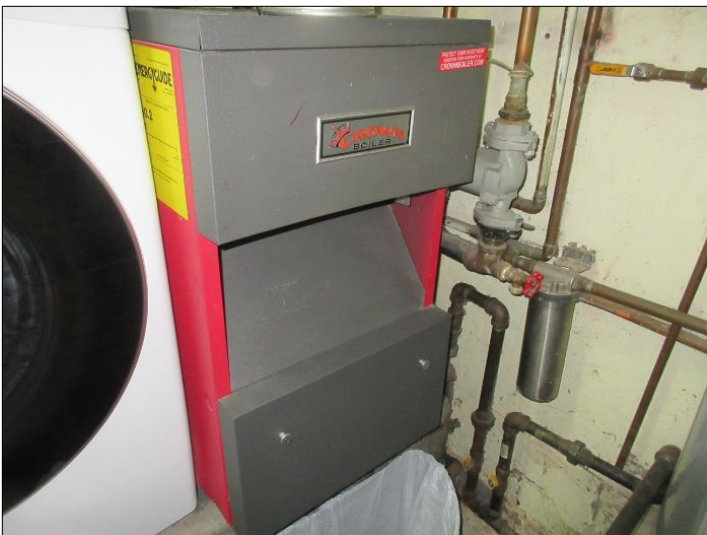
Annual/Seasonal professional inspection and cleaning service contract is recommended.

Dust buildup observed in service compartment and/or draft tubes.

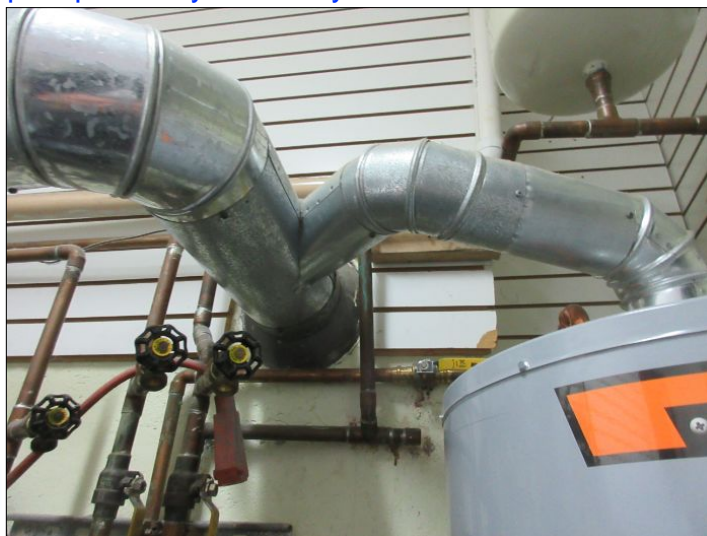
- The visible portions of the vent pipes appeared functional.
- The metal chimney liner vent **flue** pipe was not inspected or visible from end to end. Recommend a certified chimney sweep inspect for your safety.

The visible portions of the vent pipes appeared functional.

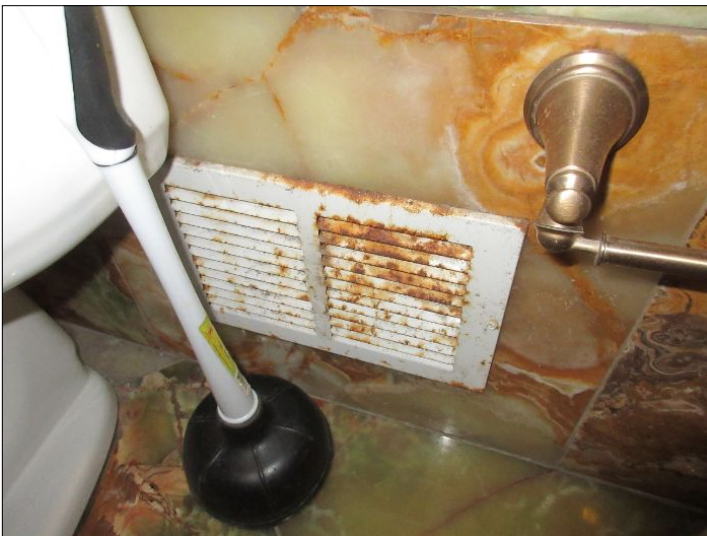
Metal ducts have been rusted / rotted resulting in the basement is a breach of the system. Conditioned air is lost to the crawlspace area, as well as moist / humid air is likely to be drawn into the home via this opening, resulting in rusting of floor register covers.

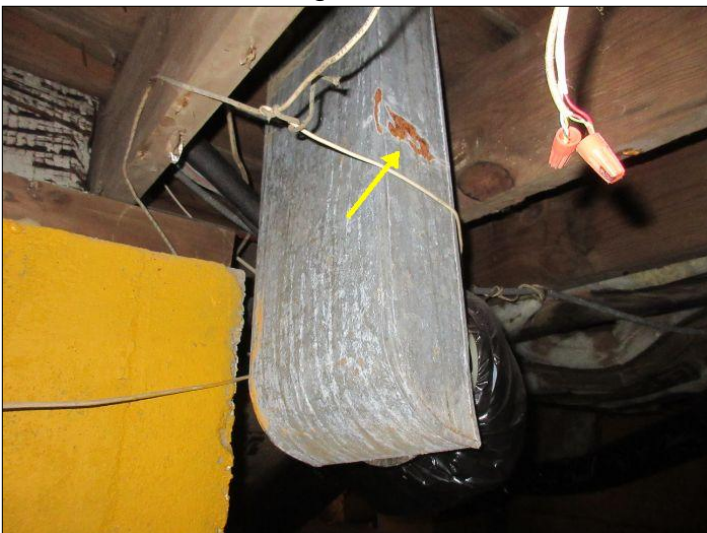
Deterioration noted

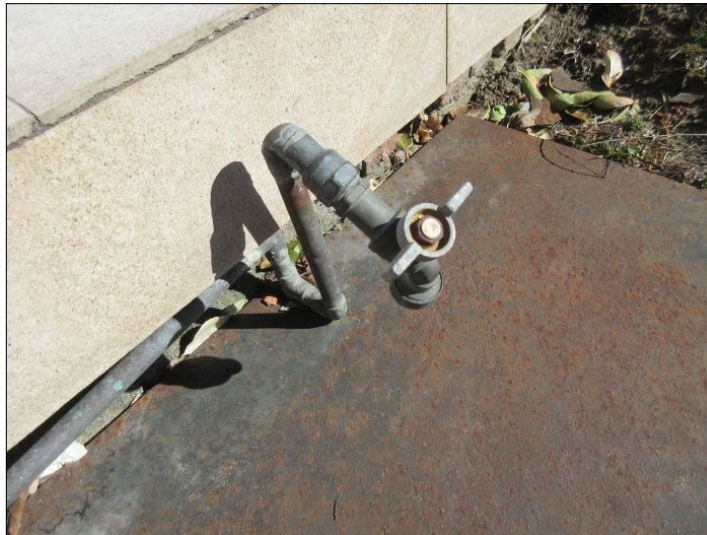
Appeared to have been winterized, at time of inspection.

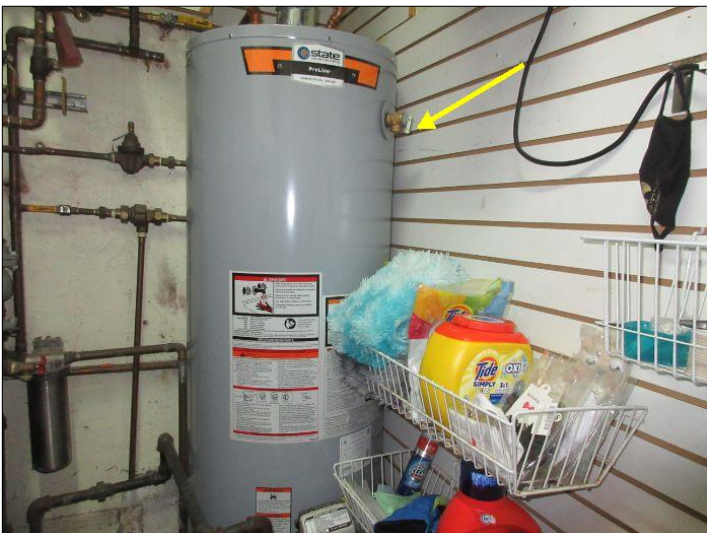
SAFETY: Temperature Pressure Relief (TPR) Valve extension pipe is missing

- **SAFETY:** Temperature Pressure Relief (TPR) Valve extension pipe is missing. It is recommended to install extension tube to terminate within 6" of floor to prevent burn injuries in event the water heater malfunctions.
- **SAFETY:** The water temperature is above the recommended temperature of 120° F. Recommend adjusting the temperature at the water heater to prevent burn injuries.

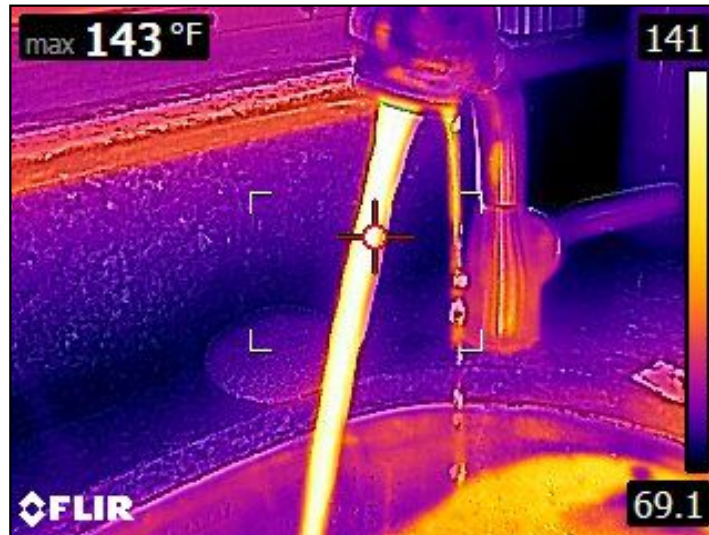
SAFETY: The water temperature is above the recommended temperature of 120° F

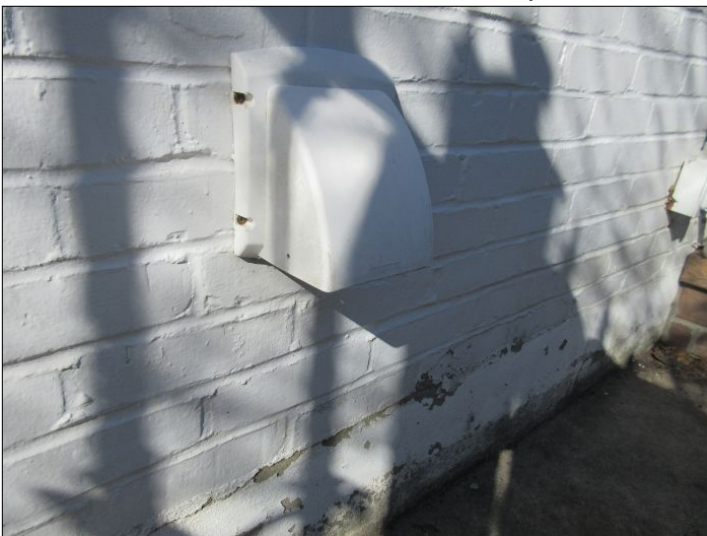
Location of dryer vent (Left side)

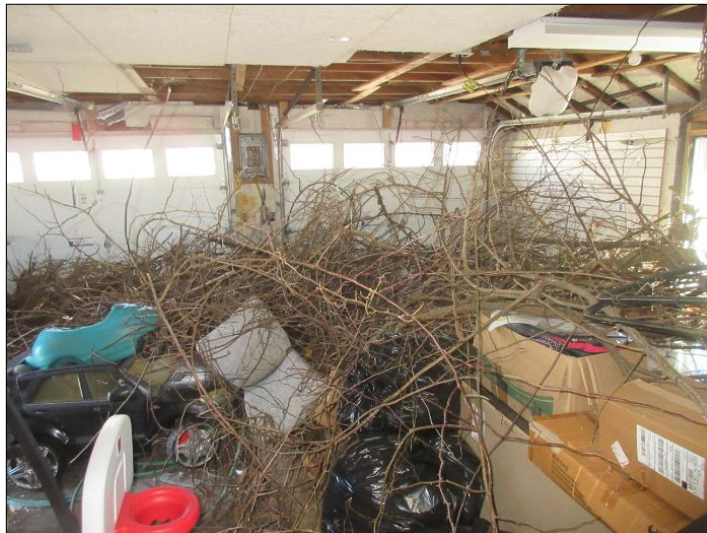
Unable to view / access interior of garage due to stored debris

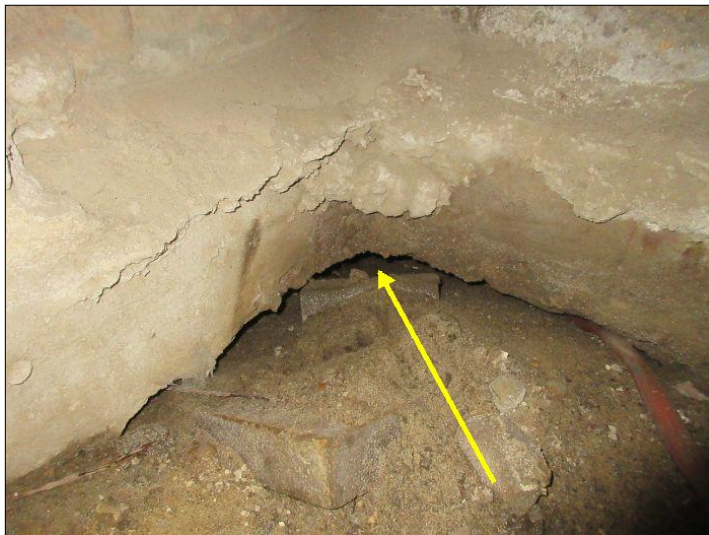
- **Undermining noted at front left corner of the home's foundation wall.**
- Numerous cracks noted at the foundation, both interior and exterior of the home. This is an indication that the structural integrity of the home has been compromised.
- Recommend consulting with a structural engineer for additional information and guidance.
- **WDC** evidence noted at **sill plates**

Undermining noted at front left corner of the home's foundation wall.

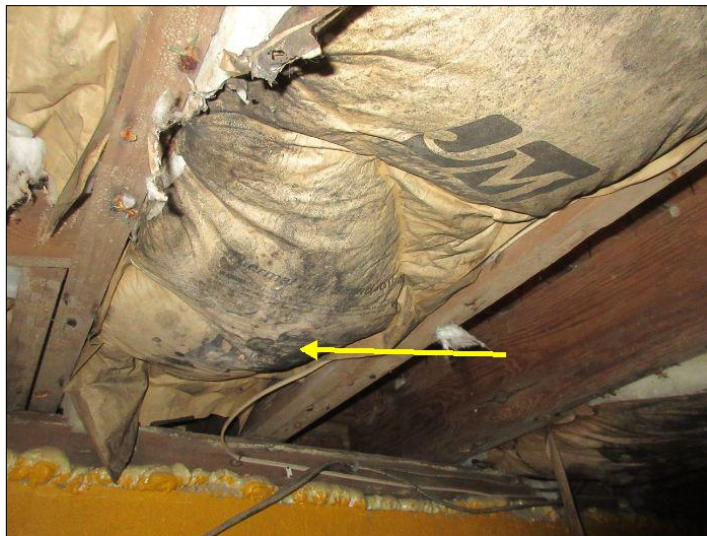
Mold-like bio growth observed. Professional testing & evaluation advised.

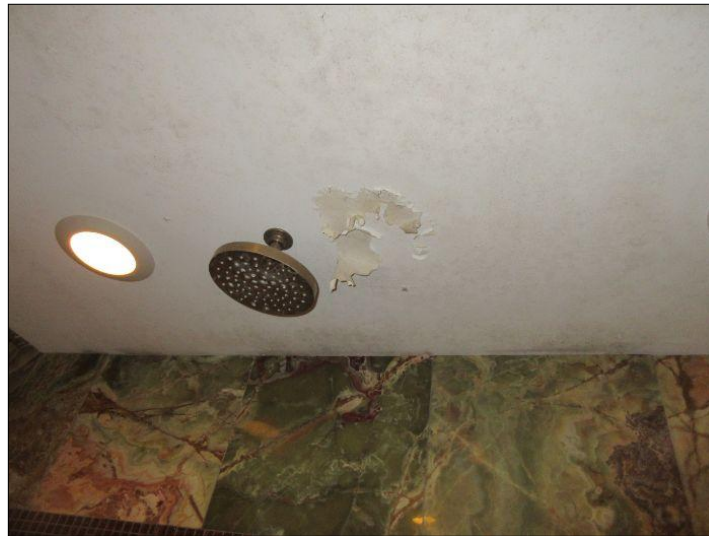
Mold-like bio growth observed. Professional testing & evaluation advised (Bathroom #1)

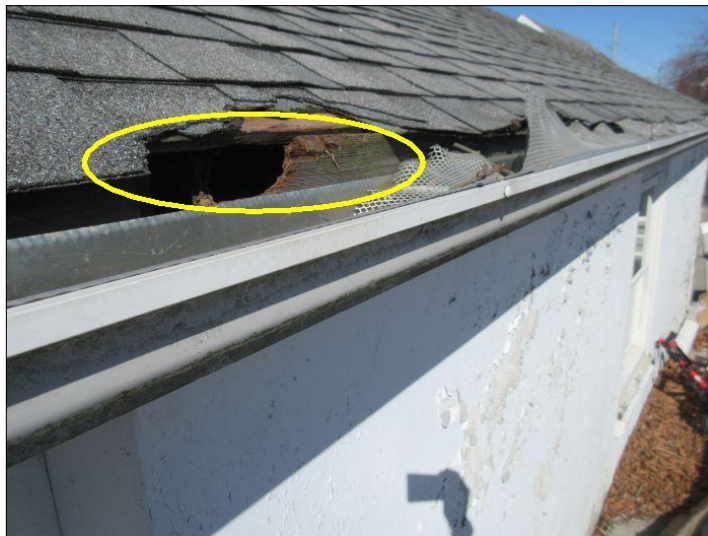
Damaged area(s) noted - Likely area of pest entrance
