PROPERTY INSPECTION REPORT

456 Sample St, Anytown, NY 12345

DATE OF INSPECTION: 8/11/2022

SQUARED AWAY
HOME INSPECTIONS

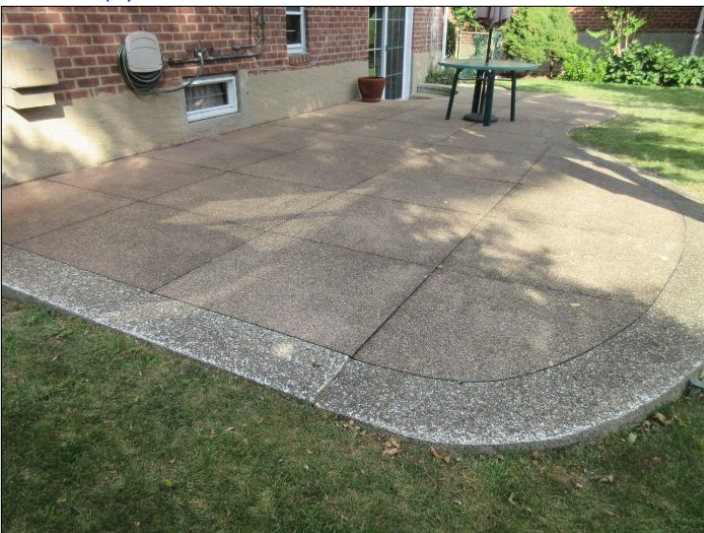
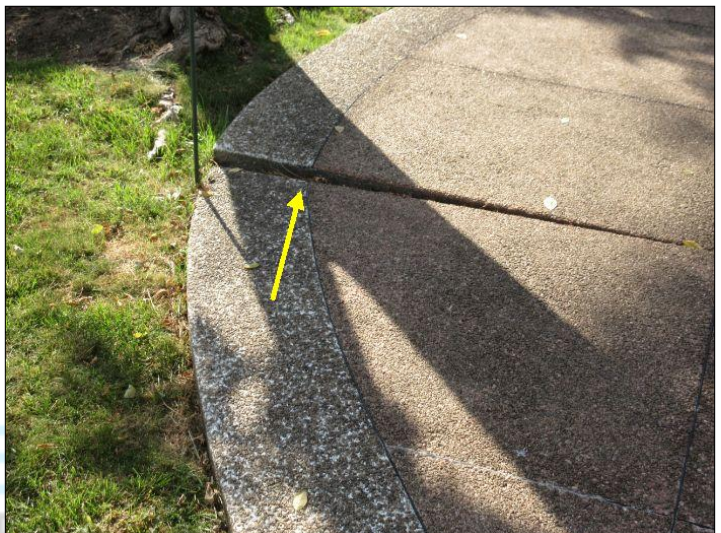
Area(s) lifted from tree roots

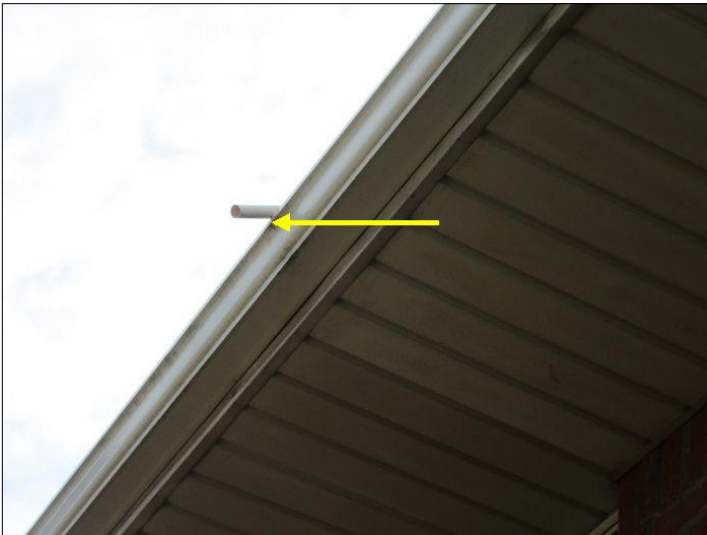
- No deficiencies noted in the condensate collection and removal system.
- Irregular installation noted. Condensate drain pipes typically exit the home through the fascia into the gutter system. This condensate removal pipes penetrate the roof covering. Recommend having area evaluated and resealed as needed.

Condensate overflow drain pipe. You should not see water dripping from this pipe. Any water present is an indication there is a issue with the primary discharge pipe, consult an HVAC technician.

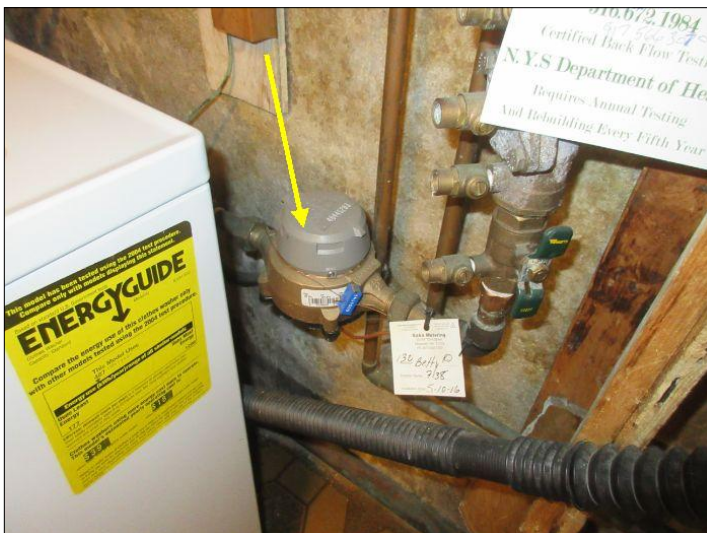
Water meter

- No deficiencies noted.
- Located and client made aware of.

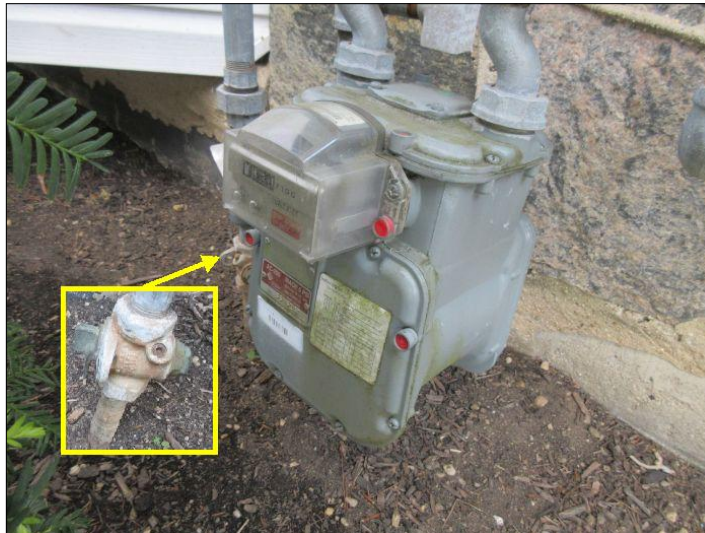
Gas Meter

- No deficiencies observed at the visible portions of the fuel supply piping.
- Meter located at exterior. All gas appliances have cut-off valves in line at each unit. No gas odors detected.

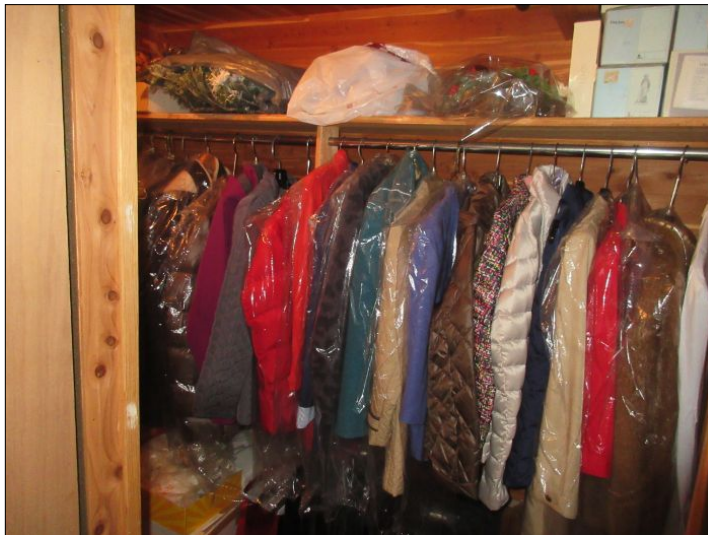
Cedar Closet (Basement)

- Appeared functional, no deficiencies noted.

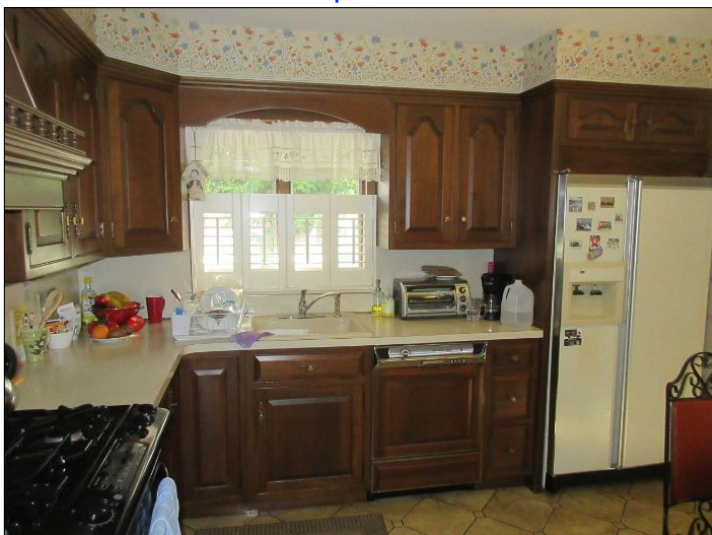
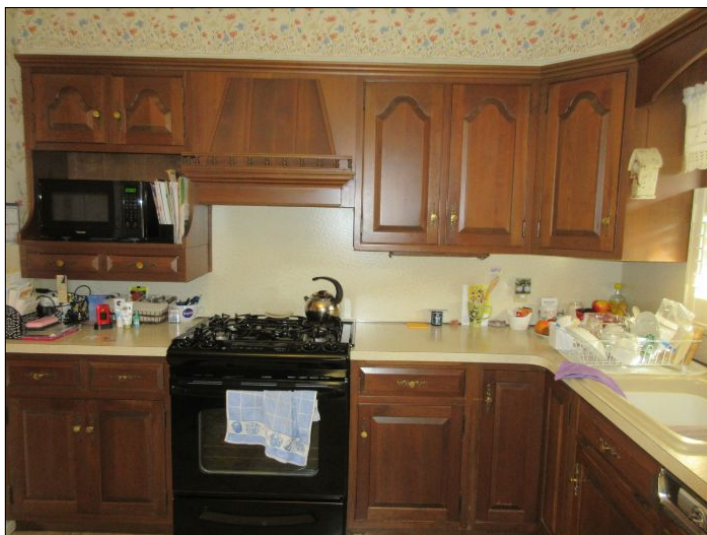
Appeared functional and in satisfactory condition, at time of inspection.

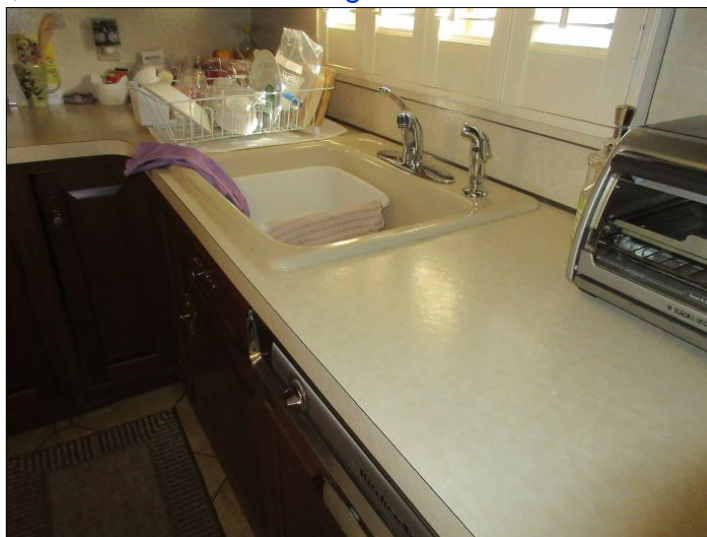
- No discrepancies noted, with normal wear for age.

Satisfactory

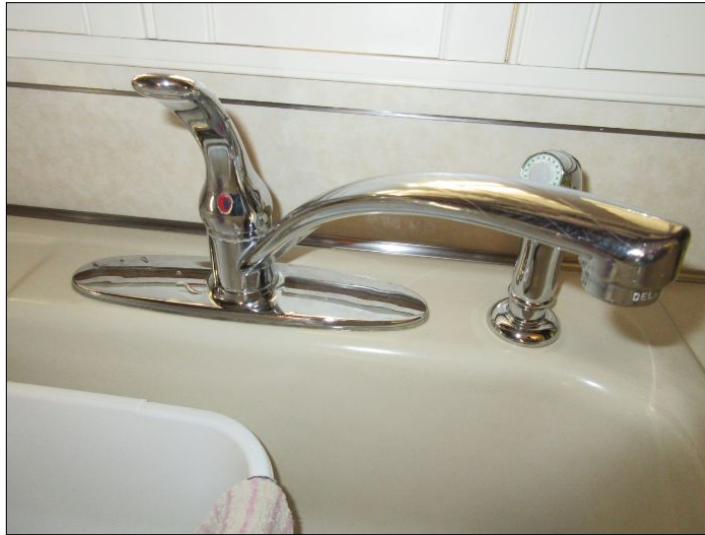
No deficiencies noted.

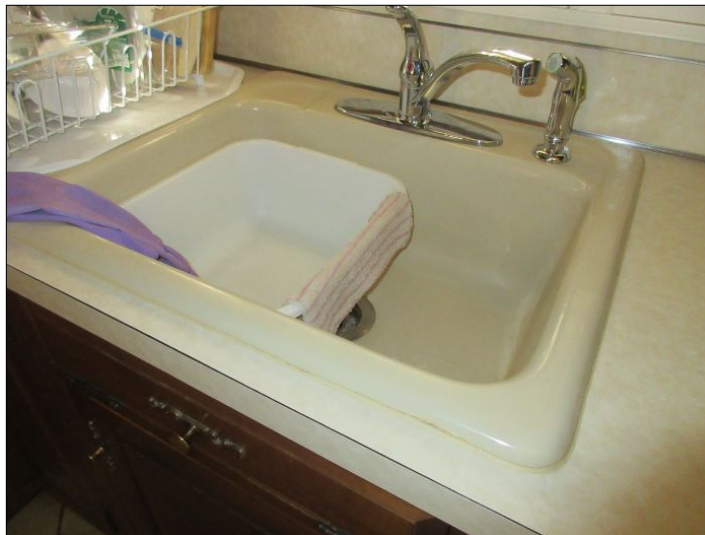
No deficiencies observed.

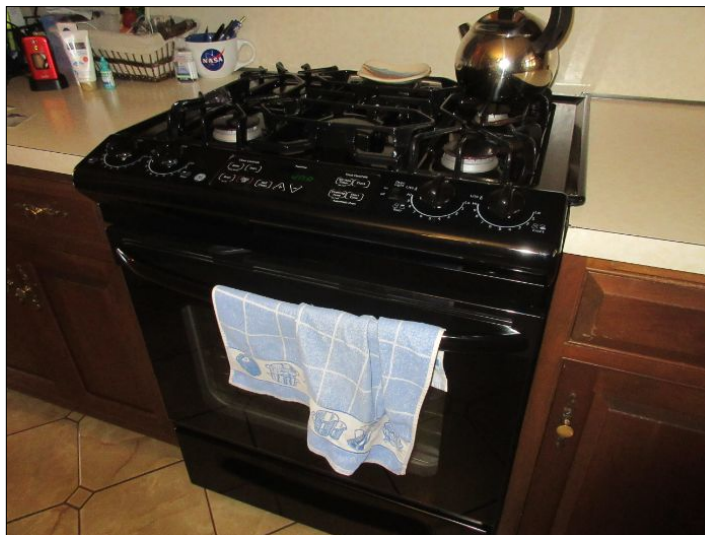
All heating elements operated when tested.

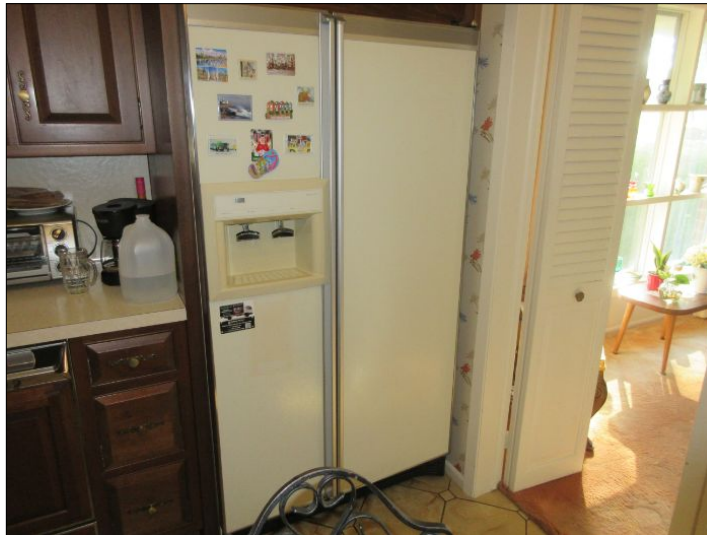
Appeared functional, at time of inspection.

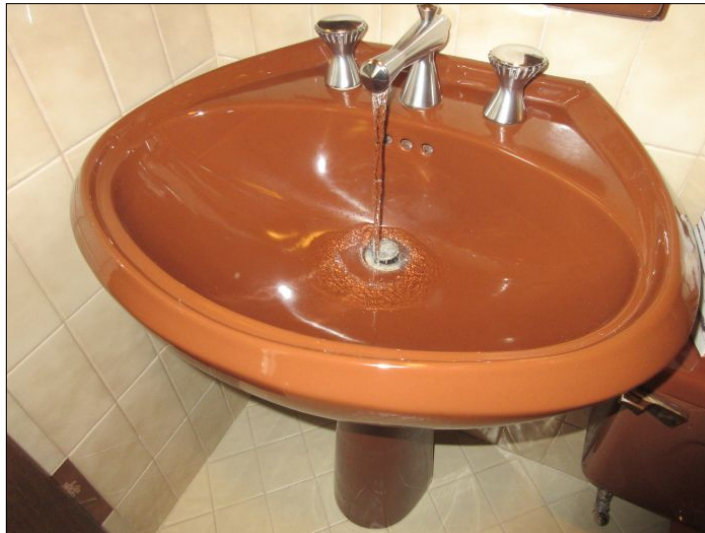
No deficiencies observed.

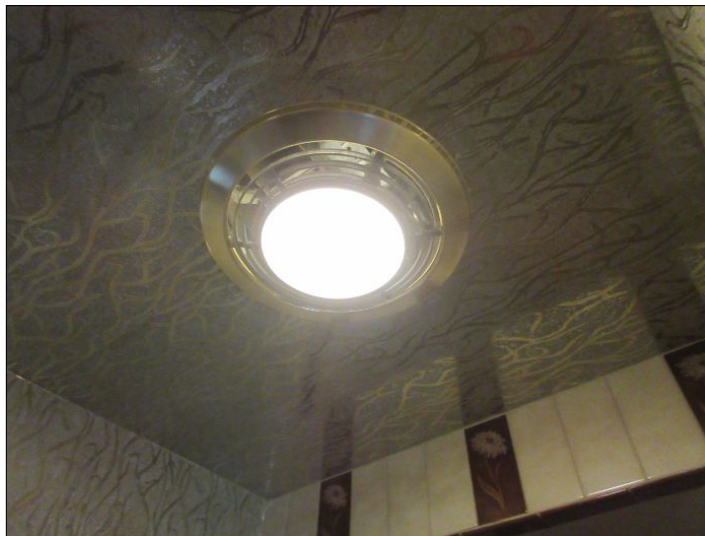
Exhaust fan did not operate when tested, heater fan operated

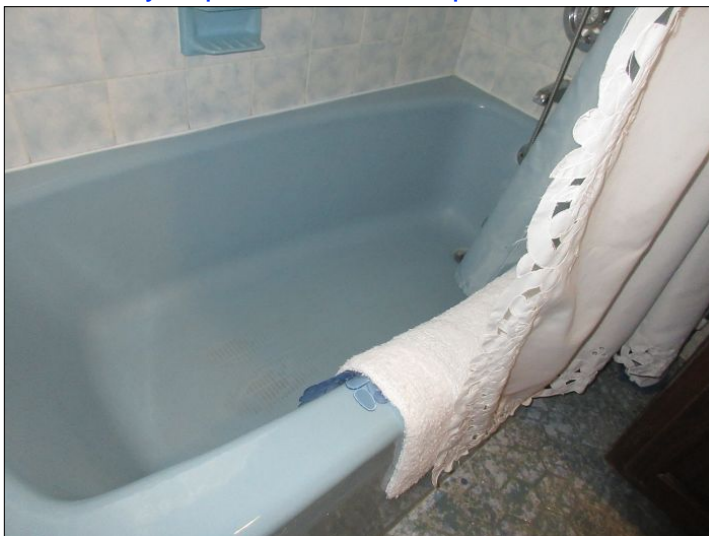
Appeared satisfactory and functional, at time of inspection.

- Appeared satisfactory and functional, at time of inspection.
- Recommend all tile edges at tub walls be periodically checked -- then caulked and sealed as necessary to prevent moisture penetration.

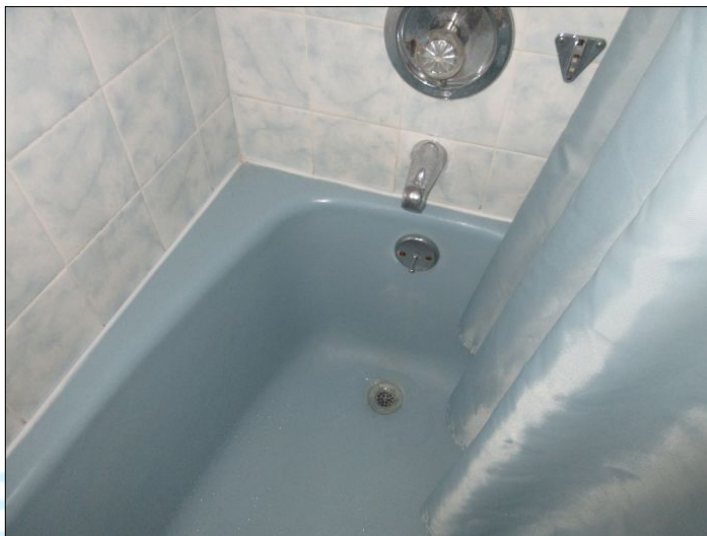
Operated as intended

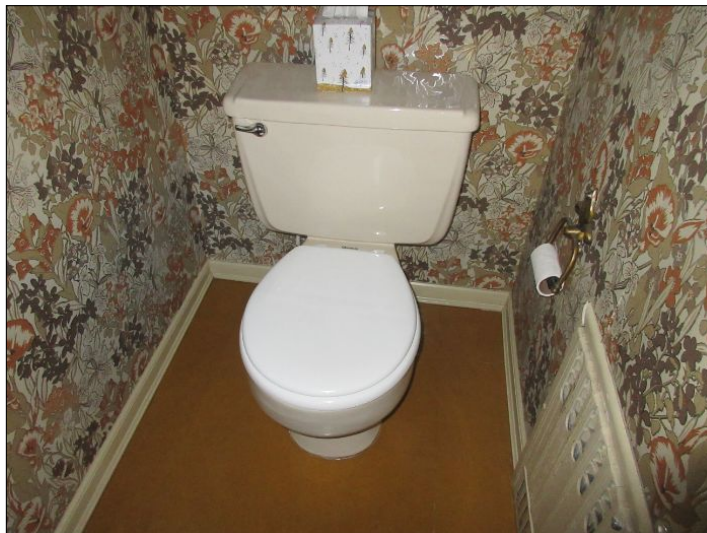
3. Toilet(s)

Operated when tested. No deficiencies noted.

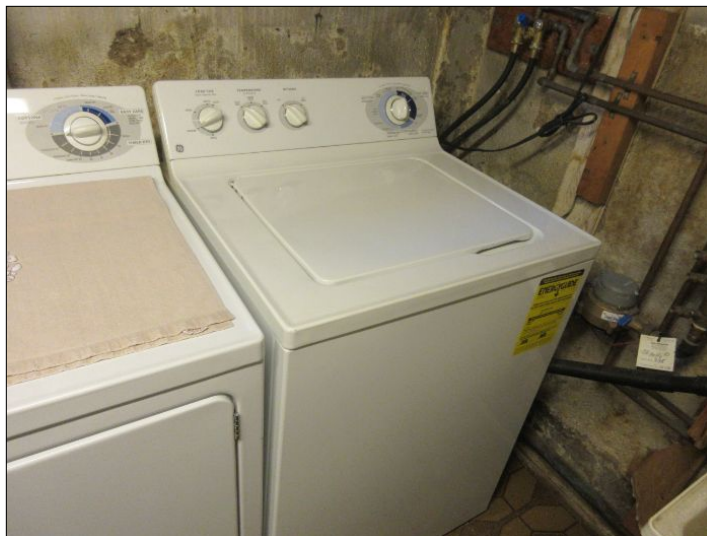
Tested Rinse Cycle. No deficiencies noted.

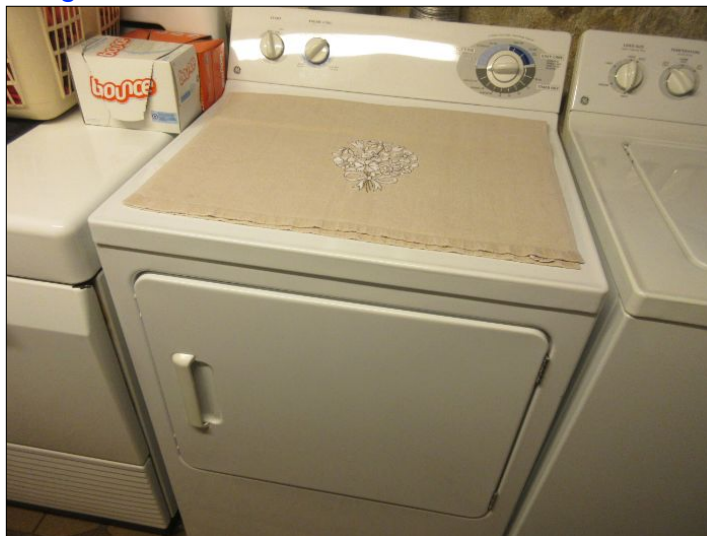
2. Dryer

Operated as designed using normal controls

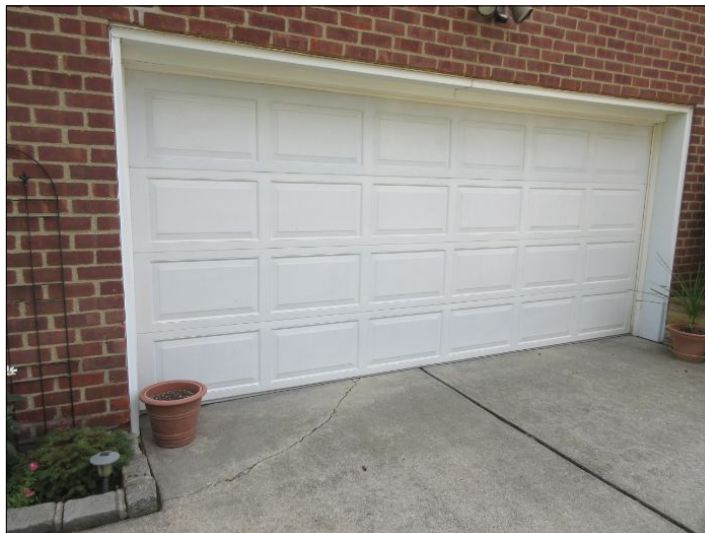
2. Garage Door(s)

Satisfactory

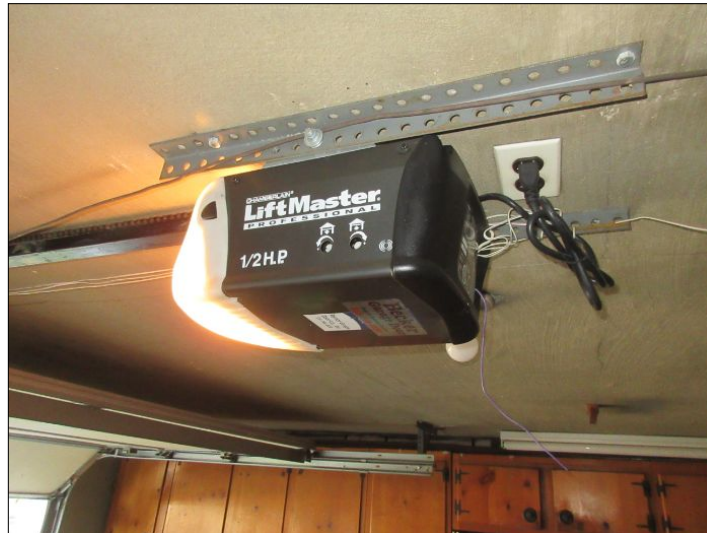
3. Garage Door Opener(s)

Appeared functional using normal controls, at time of inspection
