PROPERTY INSPECTION REPORT

456 Sample St, Anytown, NY 12345

DATE OF INSPECTION: 8/11/2022

SQUARED AWAY
HOME INSPECTIONS

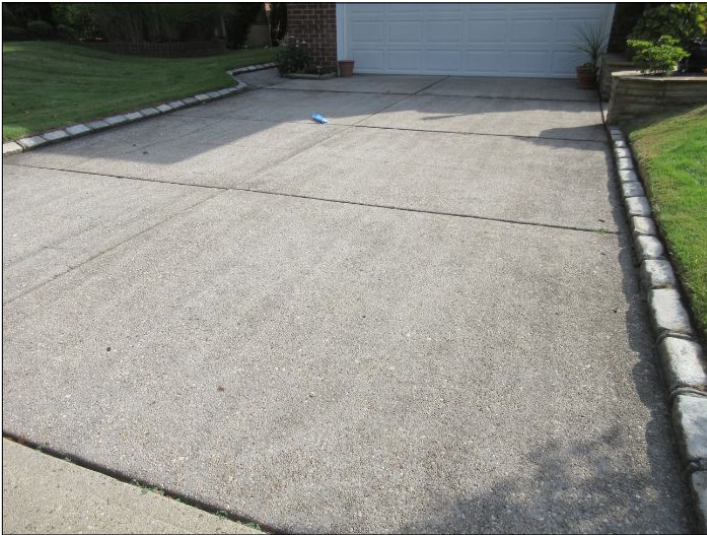
Satisfactory

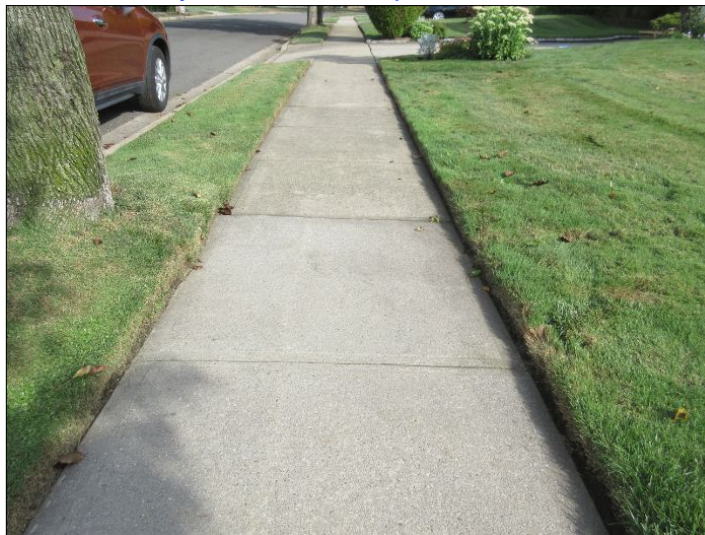
Satisfactory

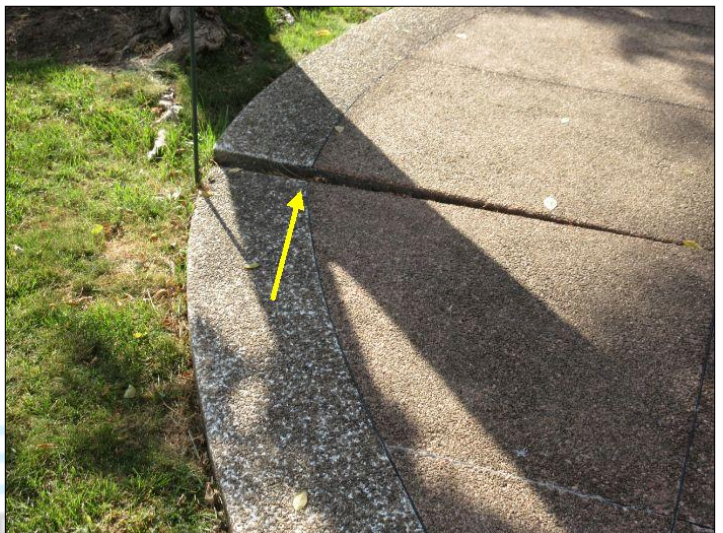
Area(s) lifted from tree roots

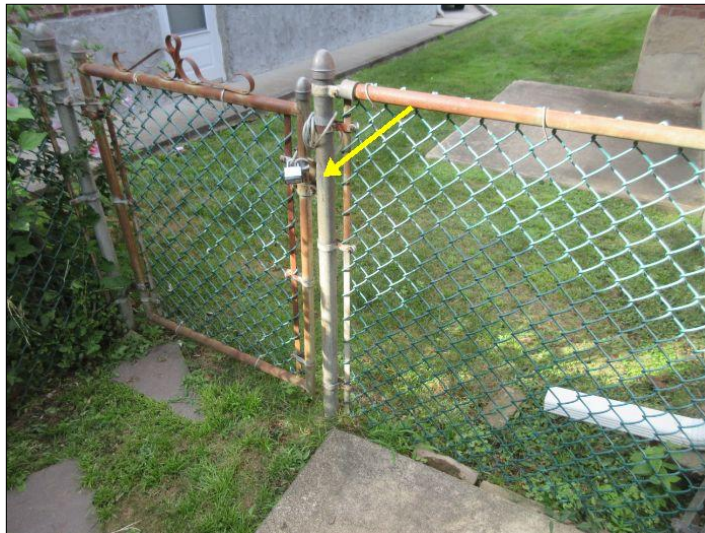
Gate requires adjustment

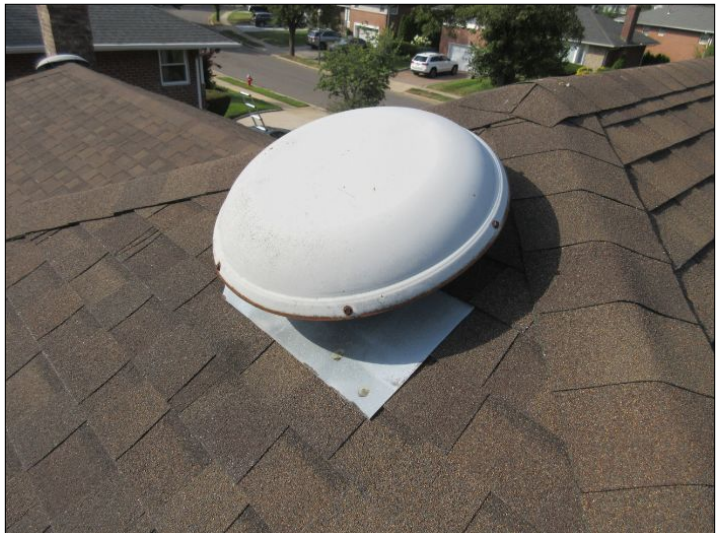
Visible area(s), appeared functional, at time of inspection.

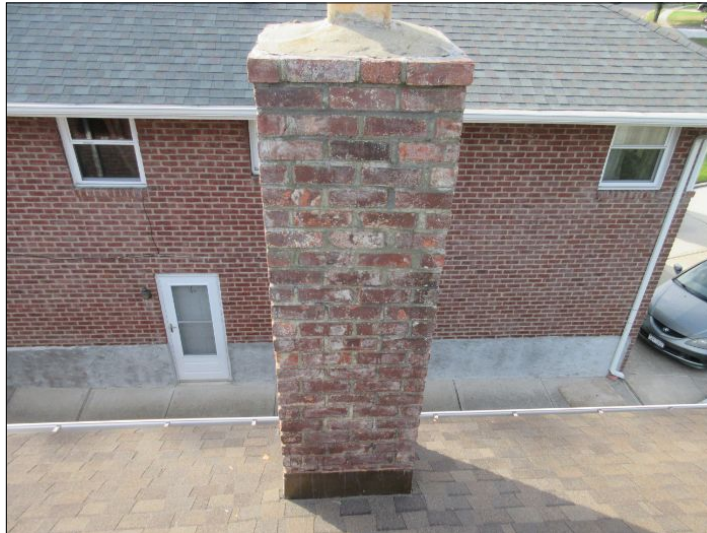
Appeared functional at time of inspection

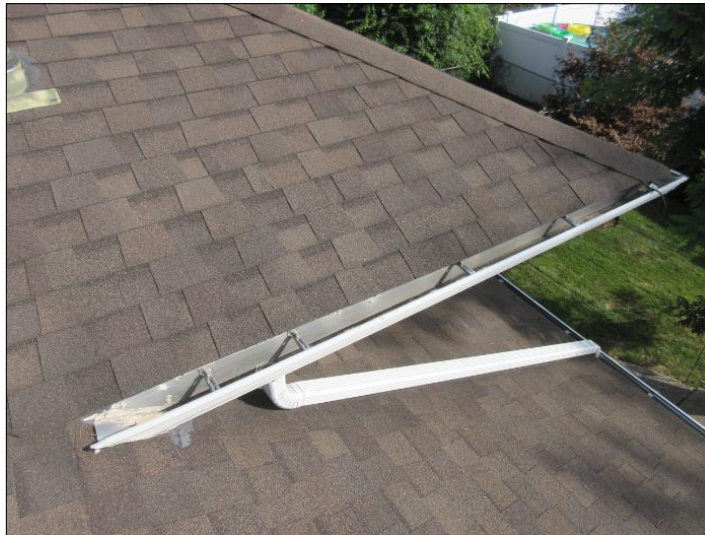
- The roof drainage system appeared in serviceable condition, at time of inspection.
- Recommend extending downspout(s) away from foundation
- Downspouts which discharge onto the ground - above grade - should discharge a good distance away from the house -- four (4) to six (6) feet or more, if possible. The slope of the ground in this area should be away from the house to direct water away from the foundation.

Satisfactory

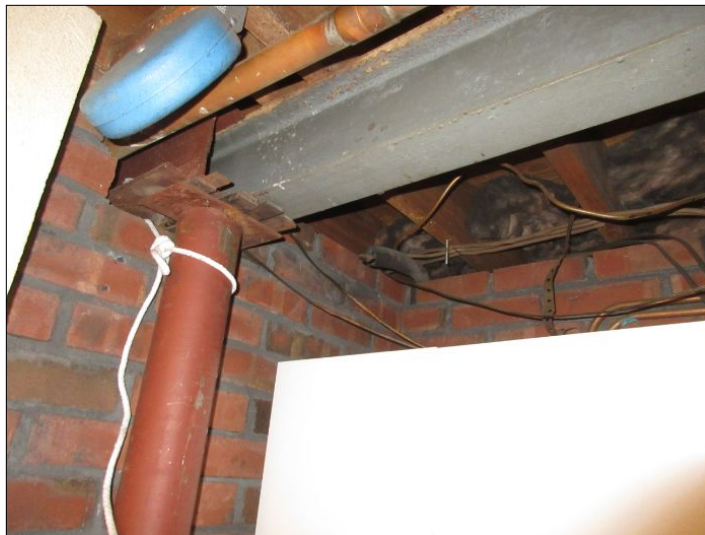
No deficiencies noted at the visible areas.

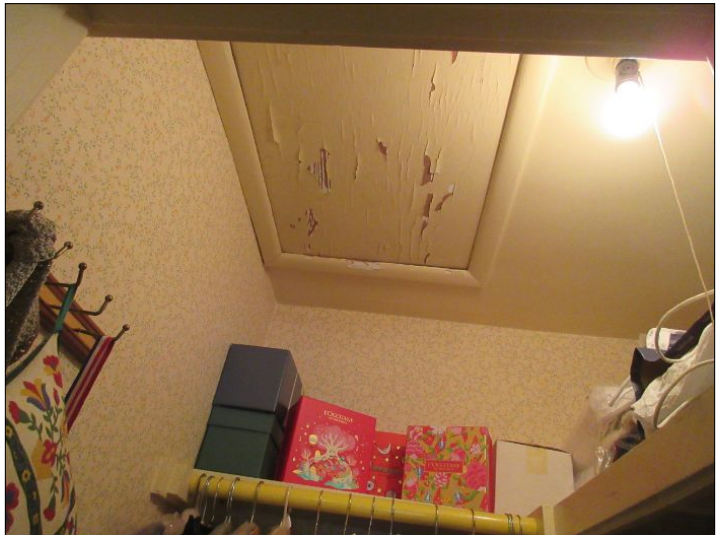
Access in Bedroom #2 closet

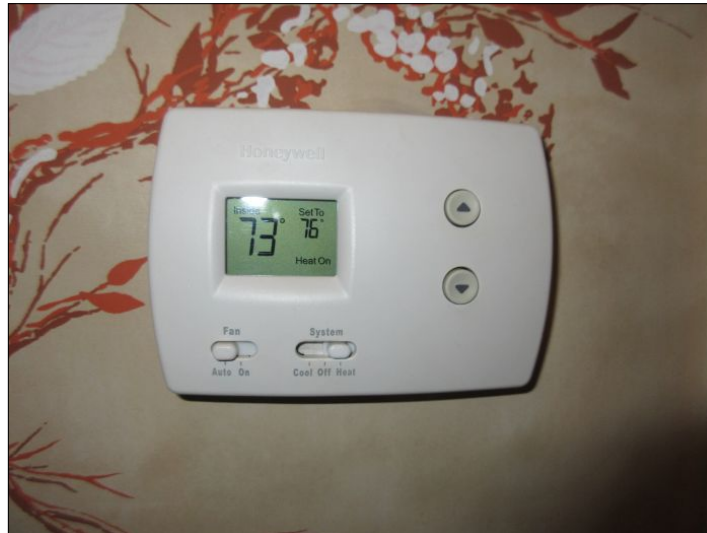
Upper Level - A/C

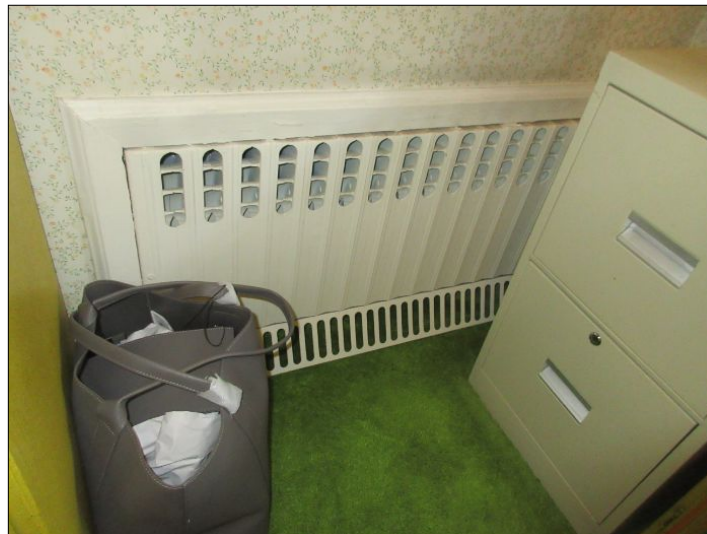
No deficiencies noted.

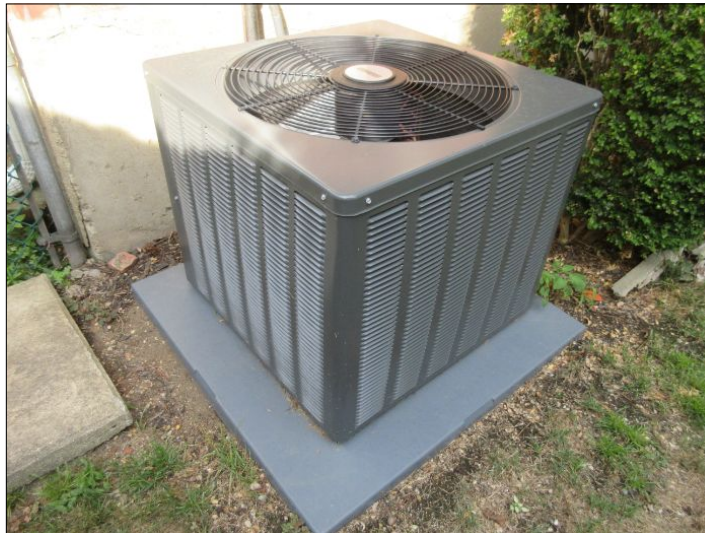
No deficiencies noted at the time of inspection.

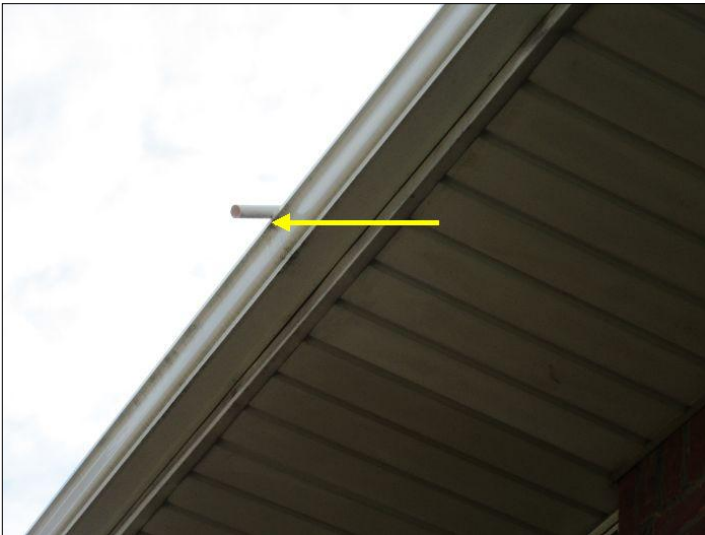
Condensate overflow drain pipe. You should not see water dripping from this pipe. Any water present is an indication there is a issue with the primary discharge pipe, consult an HVAC technician.

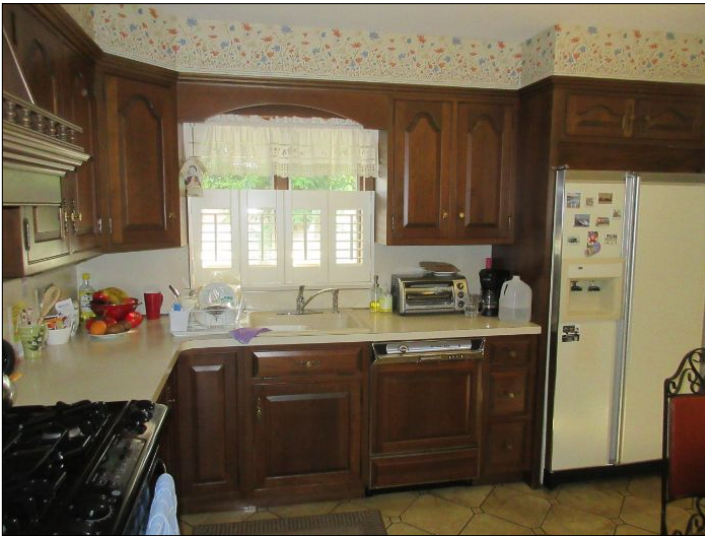
Appeared functional and in satisfactory condition,
at time of inspection.

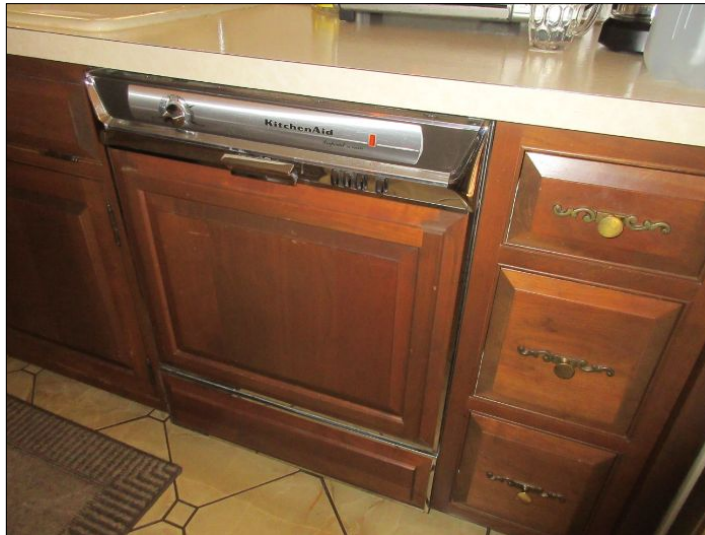
DEFERRED COST: Older dishwasher. Normally, dishwashers last about 10 years.

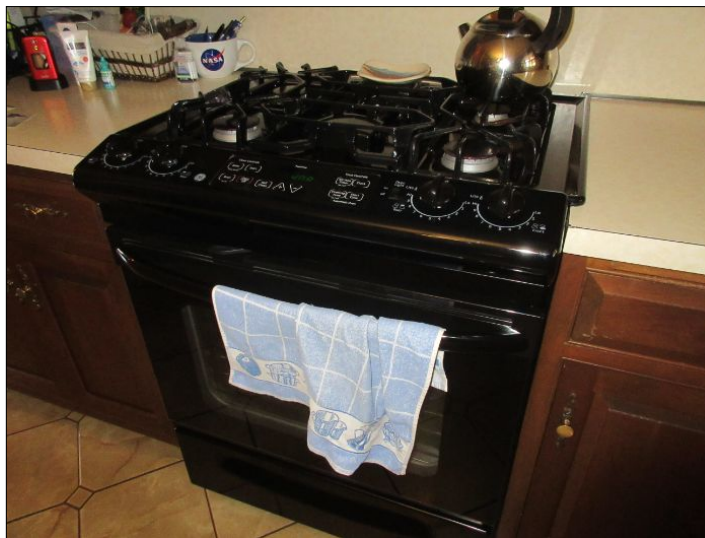
All heating elements operated when tested.

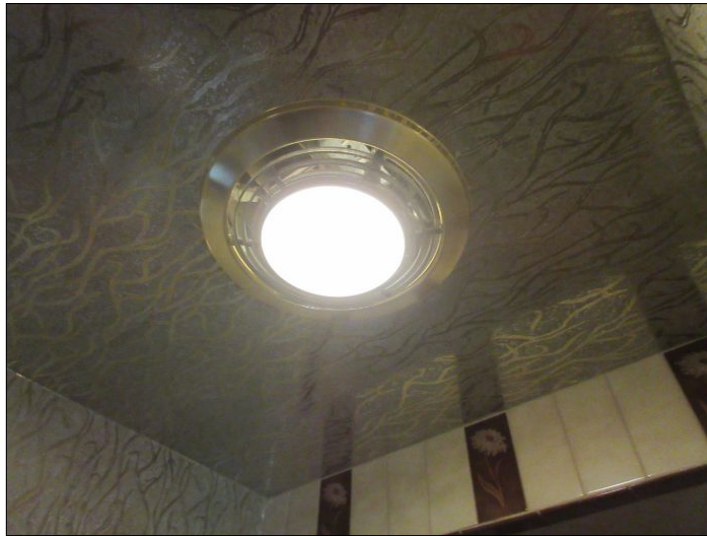
Exhaust fan did not operate when tested, heater fan operated

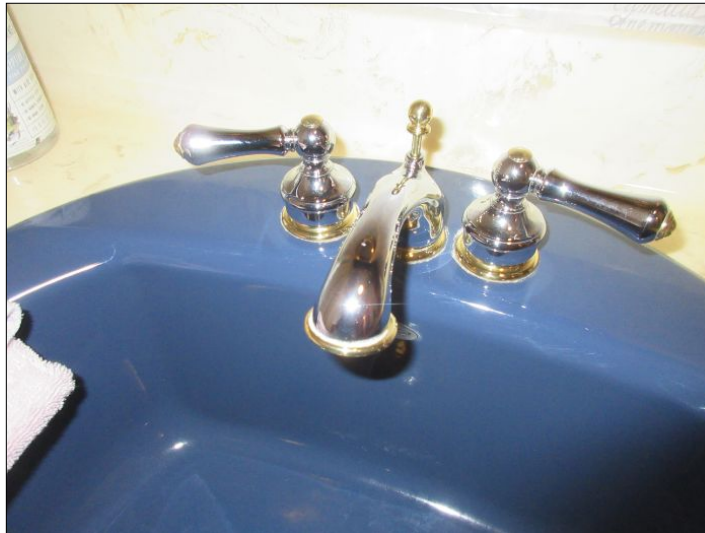
Left faucet - No deficiencies noted

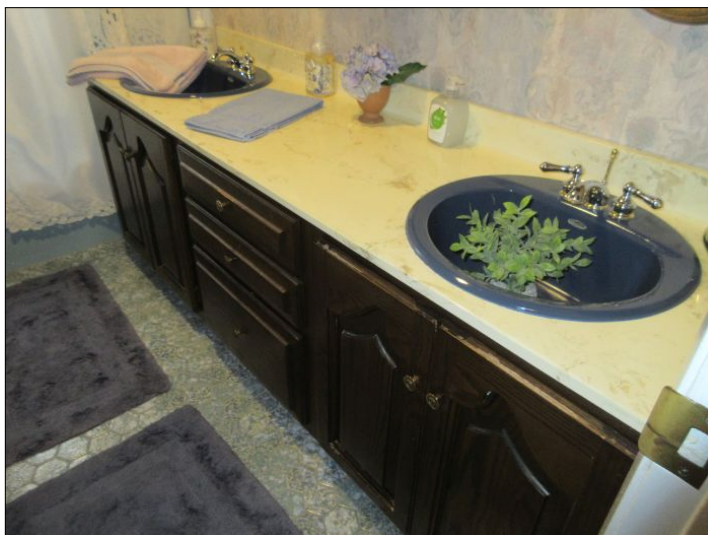
Satisfactory

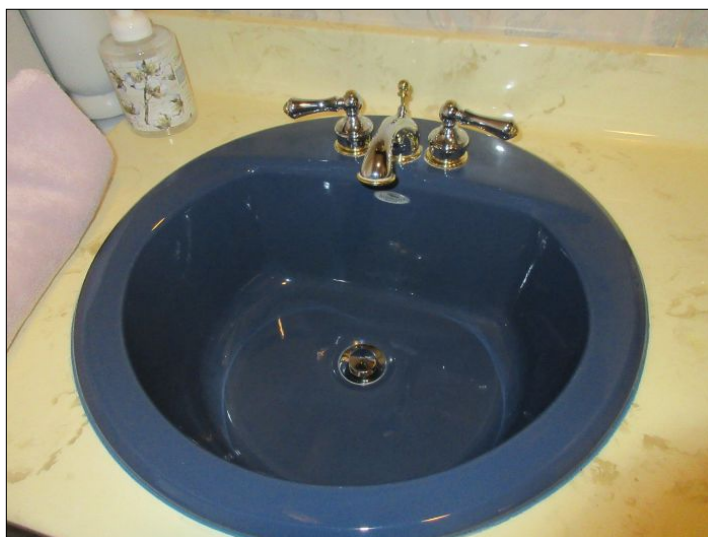
No deficiencies observed (Left sink)

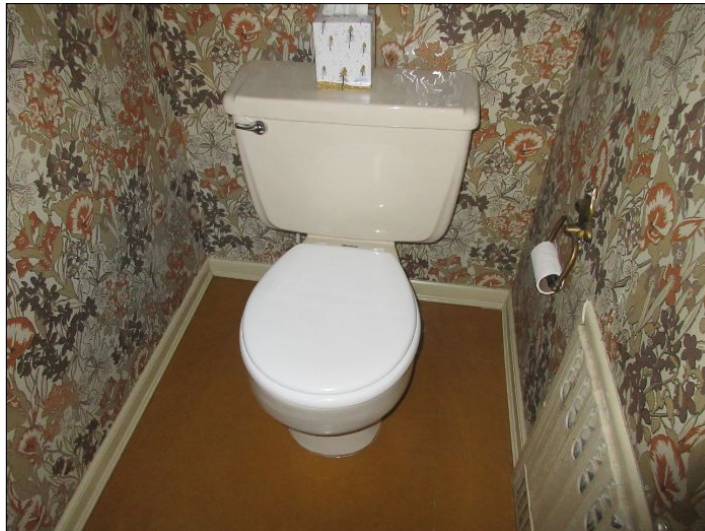
Operated when tested. No deficiencies noted.

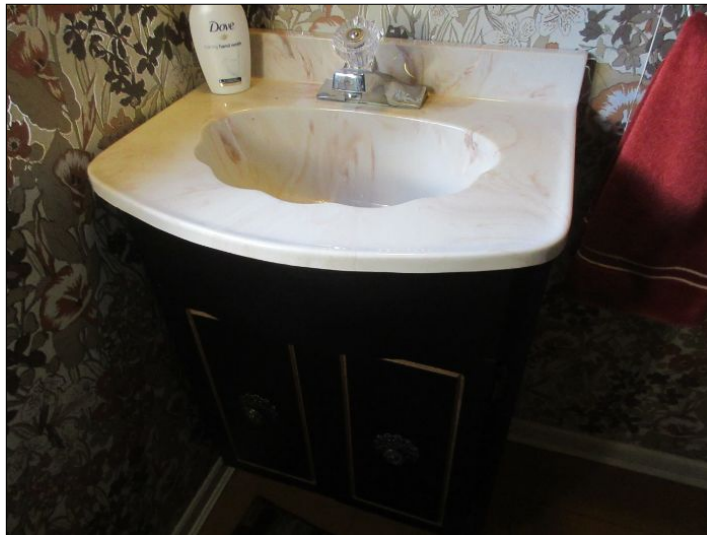
No deficiencies observed.

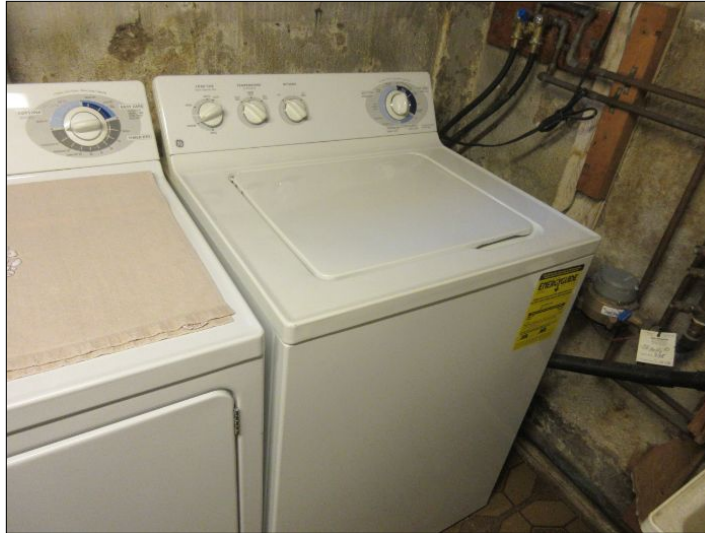
Tested Rinse Cycle. No deficiencies noted.

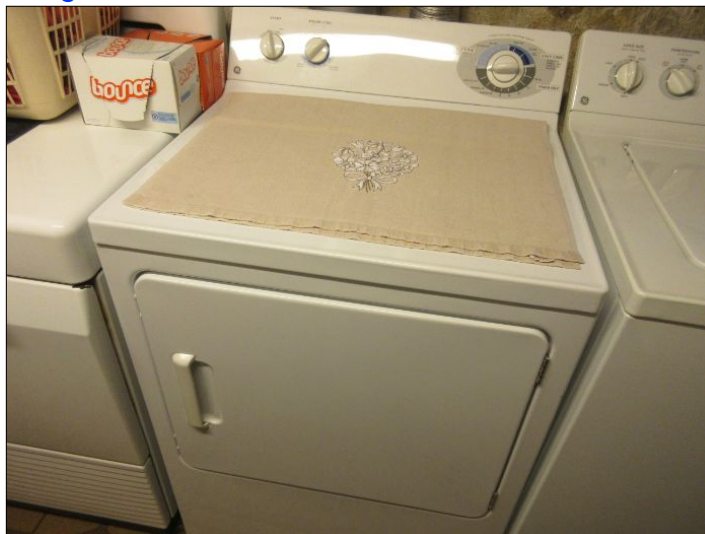
Operated as designed using normal controls

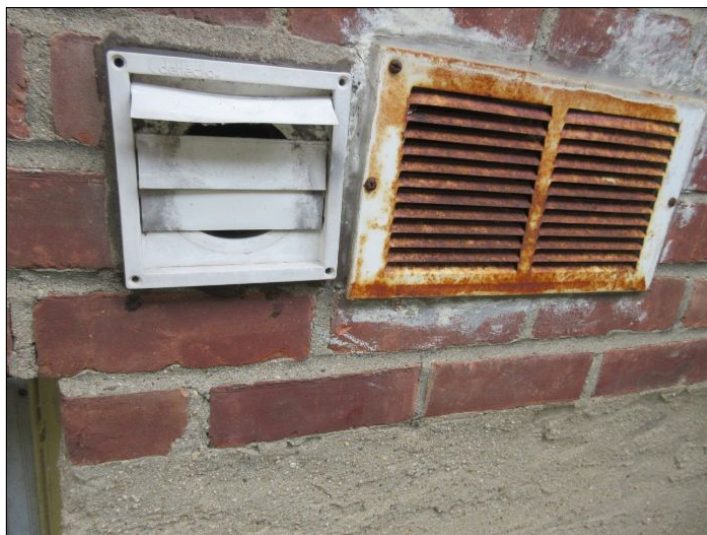
Properly vented to exterior

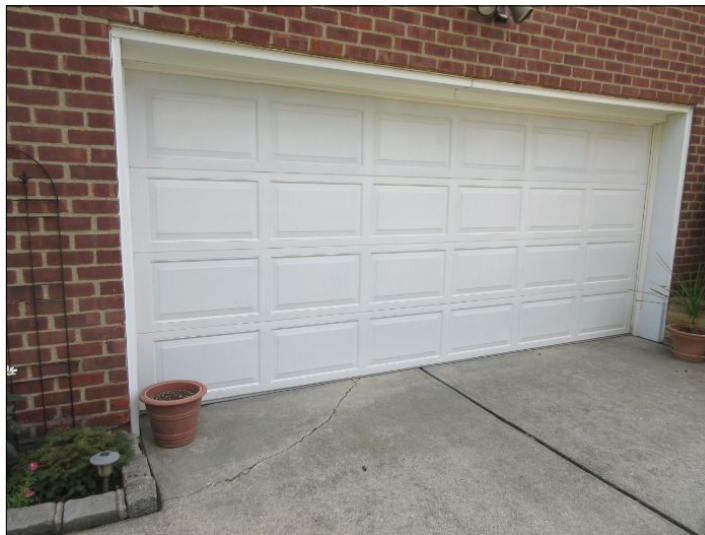
Satisfactory

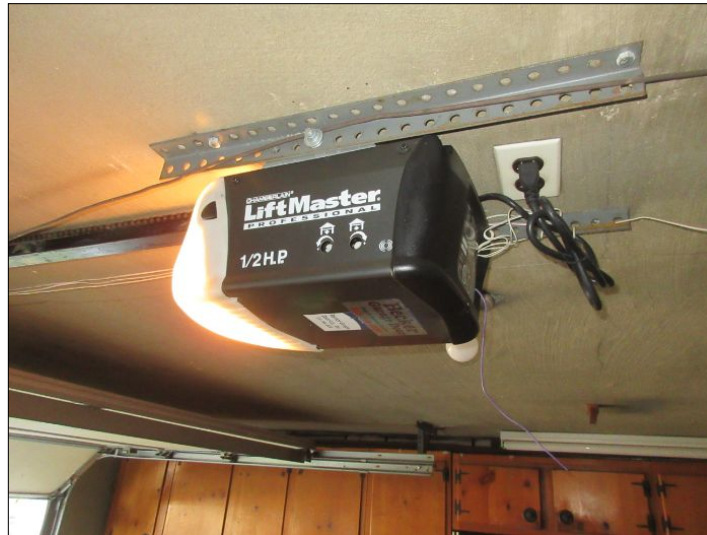
Appeared functional using normal controls, at time of inspection
